# Flood and Water Management Act 2010

## Section 19 Flood Investigation Report

### Storm Dennis – Flood Investigation Area RCT03 (Cwmbach)

April 2022

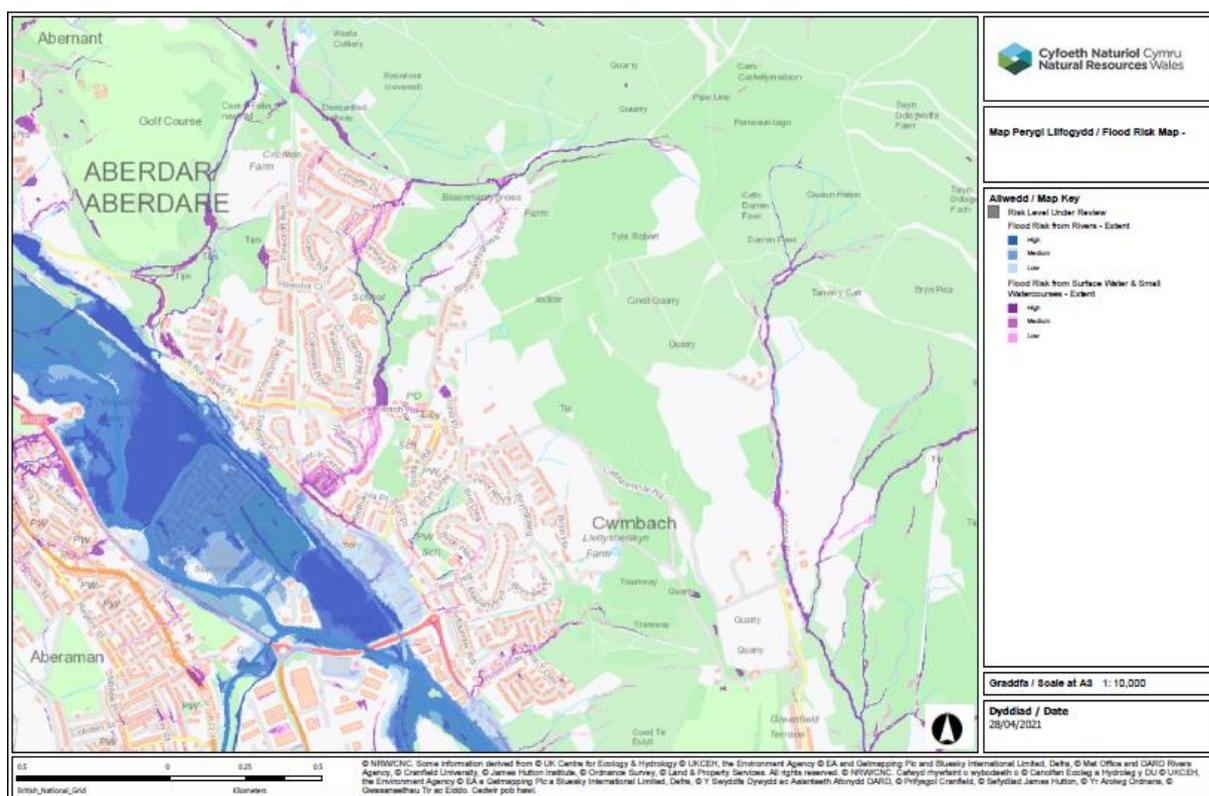
**Figure 2:** Natural Resources Wales' Flood Risk Assessment Wales (FRAW) map for rivers and ordinary watercourse and surface water flood risk at investigation area RCT03. Contains Natural Resources Wales information © Natural Resources Wales and database right. All rights reserved.

Flood risk is generally associated with ordinary watercourses within Cwmbach, notably from culvert inlets and bank breaches. A high flood risk is presented in Figure 2 associated with the Nant y Groes watercourse, particularly from the culvert inlet adjacent to Cwmbach Road and downstream at Canal Road.

NRW's Flood Risk Assessment Wales (FRAW) maps also note a low risk of main river flooding along the eastern floodplains of the River Cynon and Aberdare Canal. This area lies to the south of RCT03 within the Cwmbach Industrial Estate. A high to medium risk of main river flooding is noted along the western floodplains however this area falls outside of the investigation area (Figure 2).

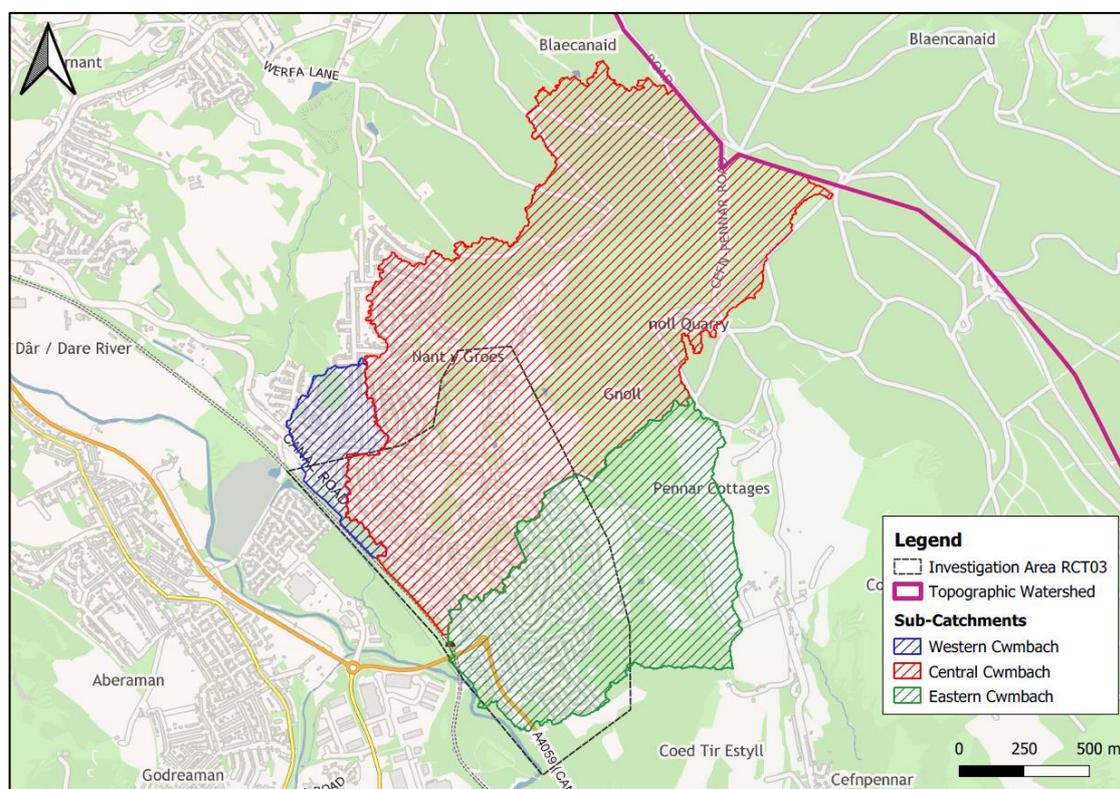
**Figure 3:** Rainfall Topographic Watershed and Sub-catchments above investigation area RCT03

Figure 3 depicts the topographic watershed for the Cynon River valley (bold pink line) based on LIDAR data, with rainfall falling to the east of the watershed draining to the Cynon River catchment. The catchment above investigation area RCT03 can be subdivided into further sub-catchments to illustrate the area of land that would expect to drain towards the investigation area (hatched areas in Figure 3). The flood incident at RCT03 will be further described in three parts: the incident at Eastern Cwmbach

(green hatched area, Figure 3), the incident at Central Cwmbach (red hatched area, Figure 3), and the incident at Western Cwmbach (blue hatched area, Figure 3).

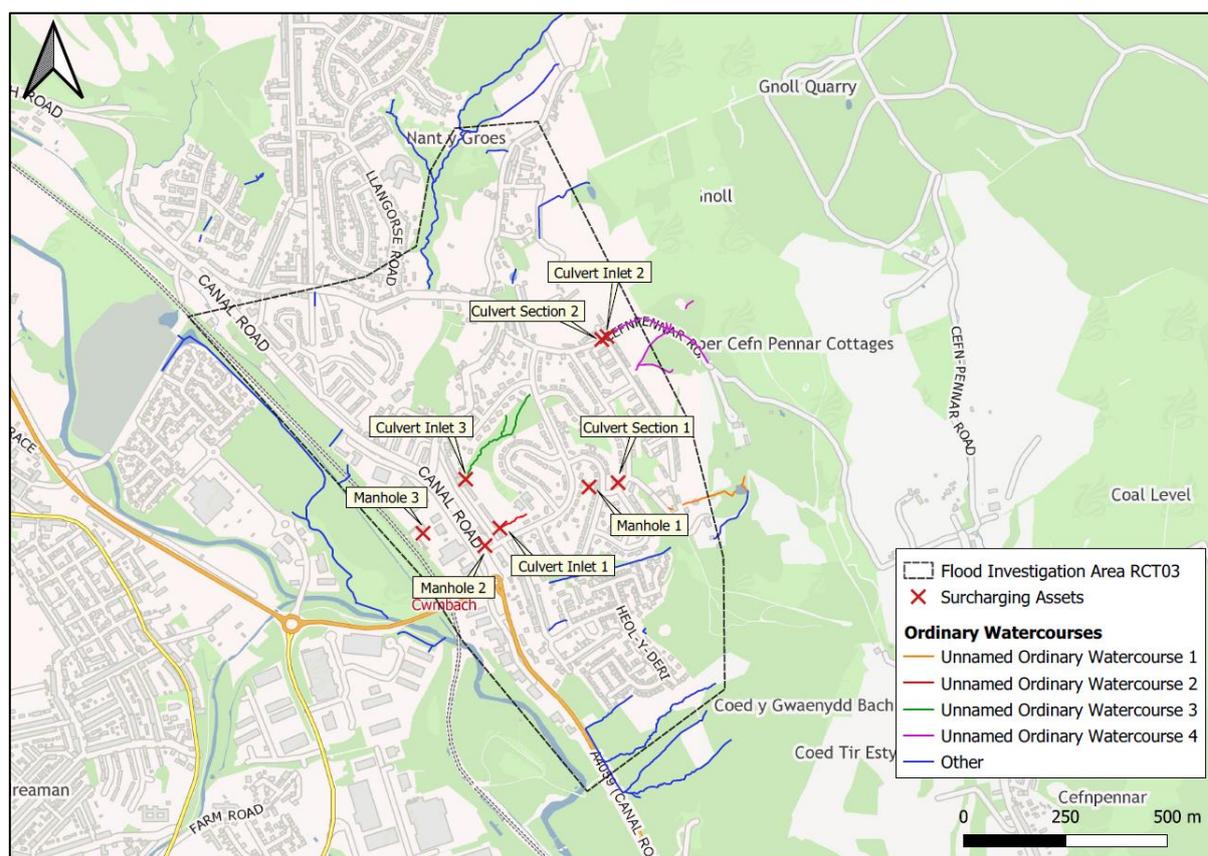
**Figure 26:** Map of Ordinary Watercourses which feed into investigation area RCT03.

Several sections of natural ditches and open watercourses which drain the steep hillsides above RCT03 are identified to flow through the investigation area and discharge into the Aberdare Canal / Cwmbach Ditch and River Cynon to the south of RCT03 (Figure 26).

Following the storm event, RCT Flood Risk Management officers carried out a site walk-over assessment, where possible, of the ordinary watercourses upstream of the culverted infrastructure identified as sources of flooding (highlighted in Figure 26) to assess the condition of the watercourses for any signs of overtopping, evidence of scour and any land movement of the hillsides.

'Culvert Inlet 1' takes inflow from a small section of unnamed ordinary watercourse (labelled 'unnamed ordinary watercourse 2', Figure 26) to the rear of Tirfounder Road.

'Culvert Inlet 3' takes inflow from 'unnamed ordinary watercourse 3' to the rear of Sion Terrace (Figure 26).

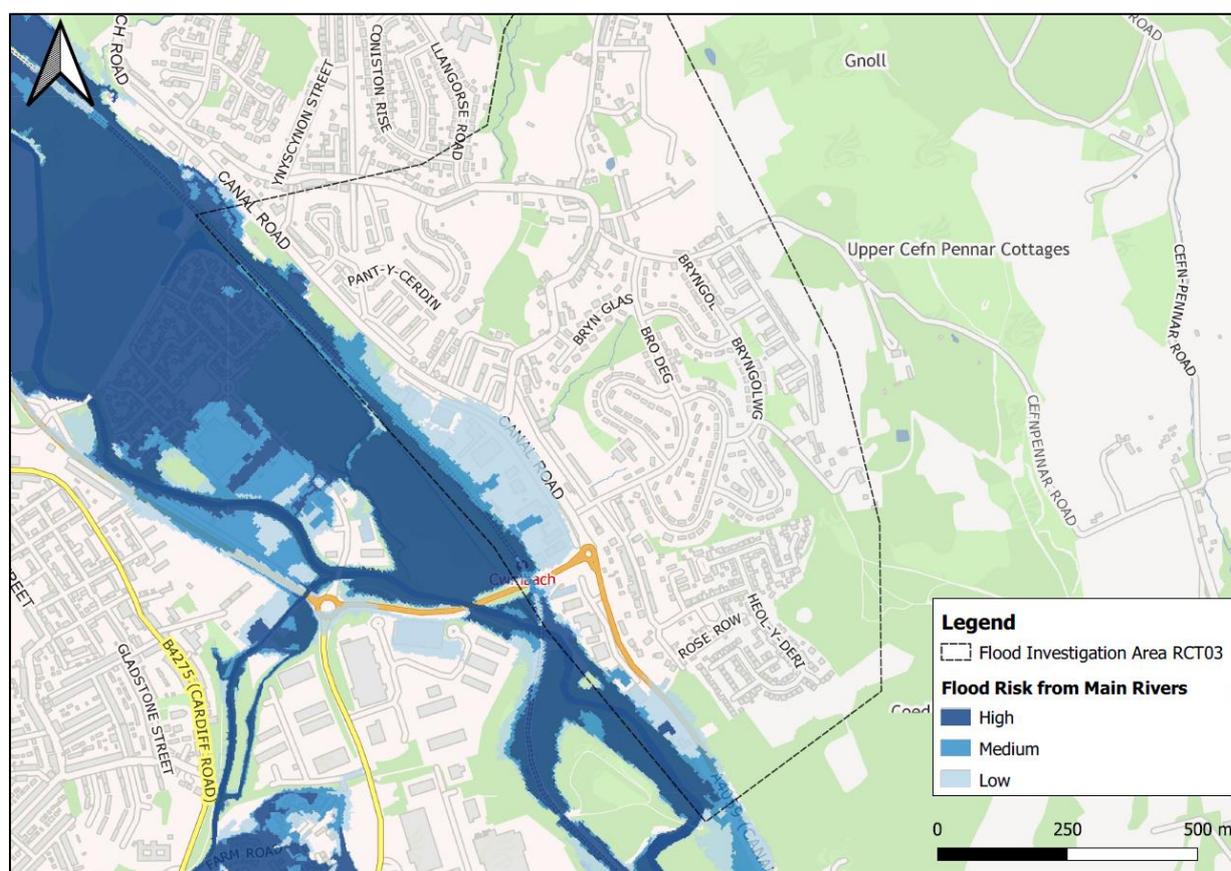
**Figure 33:** Natural Resources Wales' Flood Risk Assessment Wales (FRAW) map for River sources at RCT03. Contains Natural Resources Wales information © Natural Resources Wales and database right. All rights reserved.

Figure 33 is an excerpt from NRW's Flood Risk Assessment Wales (FRAW) mapping exercise which depicts the main river flood extents for the 'Defended' scenario, i.e., with the presence of flood defence infrastructure. The darker shading identifies areas at higher risk of flooding (more frequent/less extreme rainfall events) and lighter shading showing the lower risk areas (less frequent/more extreme rainfall events).

The commercial properties impacted by flooding at Canal Road are situated directly adjacent to an area of high to low flood risk as depicted in Figure 33. The properties fronting the Aberdare Canal / Cwmbach Ditch are identified at high risk of main river flooding.

A high risk of flooding means that an area has a chance of flooding of greater than 1 in 30 (3.3%) each year; a medium risk of flooding signifies a yearly chance of flooding between 1 in 100 (1%) and 1 in 30 (3.3%); meanwhile a low risk of flooding means that an area has a chance of flooding of between 1 in 1000 (0.1%) and 1 in 100 (1%) each year. Considering Storm Dennis was estimated as in excess of a 1 in 200 annual probability (Q200) flood event, the area of flooding during Storm Dennis aligns with those depicted by the high and medium extents.

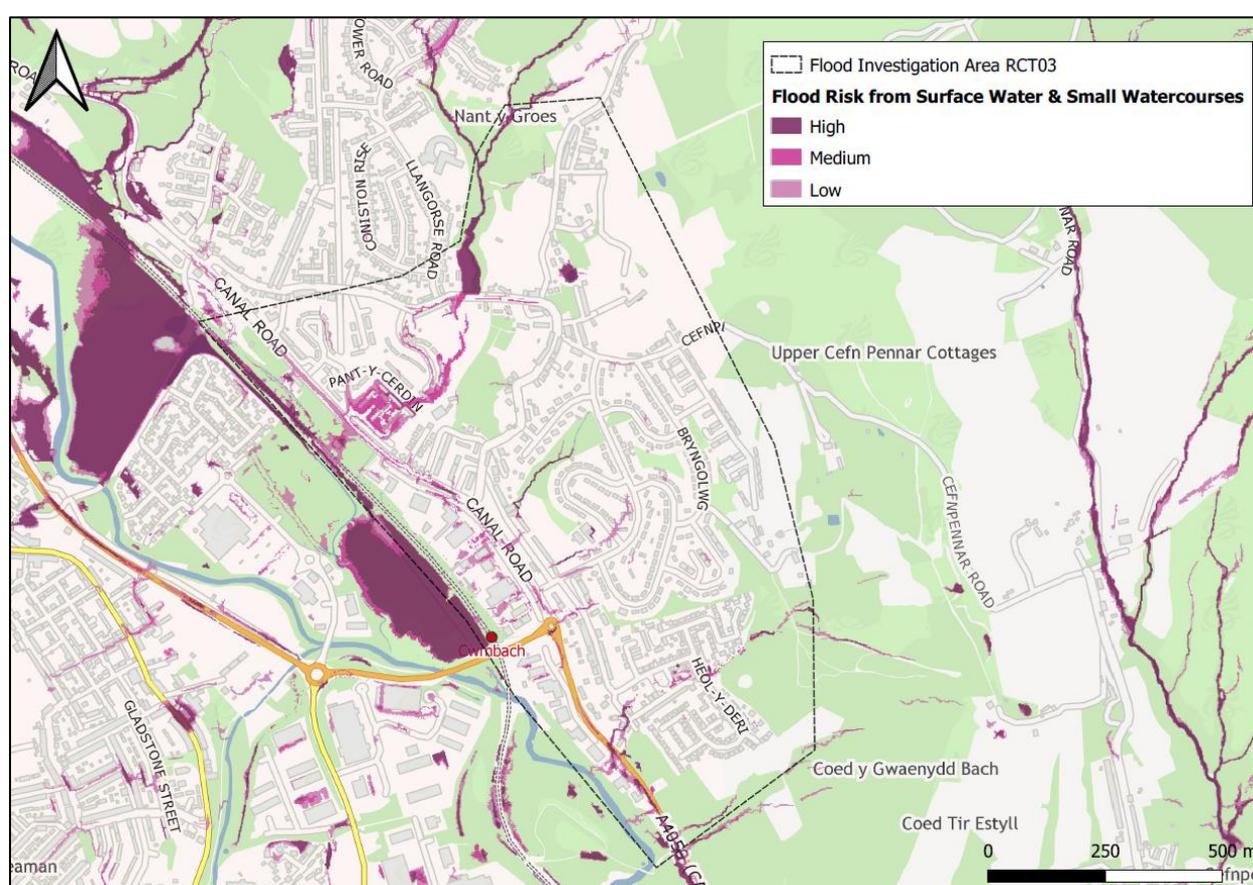
**Figure 36:** Natural Resources Wales' FRAW map for surface water and ordinary watercourse sources within investigation area RCT03. Contains Natural Resources Wales information © Natural Resources Wales and database right. All rights reserved.

Surface water flooding as a result of ordinary watercourse flooding associated to blocked, damaged and overwhelmed culvert infrastructure, in addition to overland flows originating from areas of hillside, has been determined as a contributing source of flooding to several residential and commercial properties within the lower reaches of Cwmbach, particularly along Canal Road and Tre Telynog, where water naturally accumulates. This is highlighted in Figure 36 which depicts the surface water and ordinary watercourse flood extents based on NRW's FRAW mapping exercise.
