# Flood and Water Management Act 2010

## Section 19 Flood Investigation Report

### Storm Dennis – Flood Investigation Area RCT05 (Abercwmboui & Fernhill)

June 2022

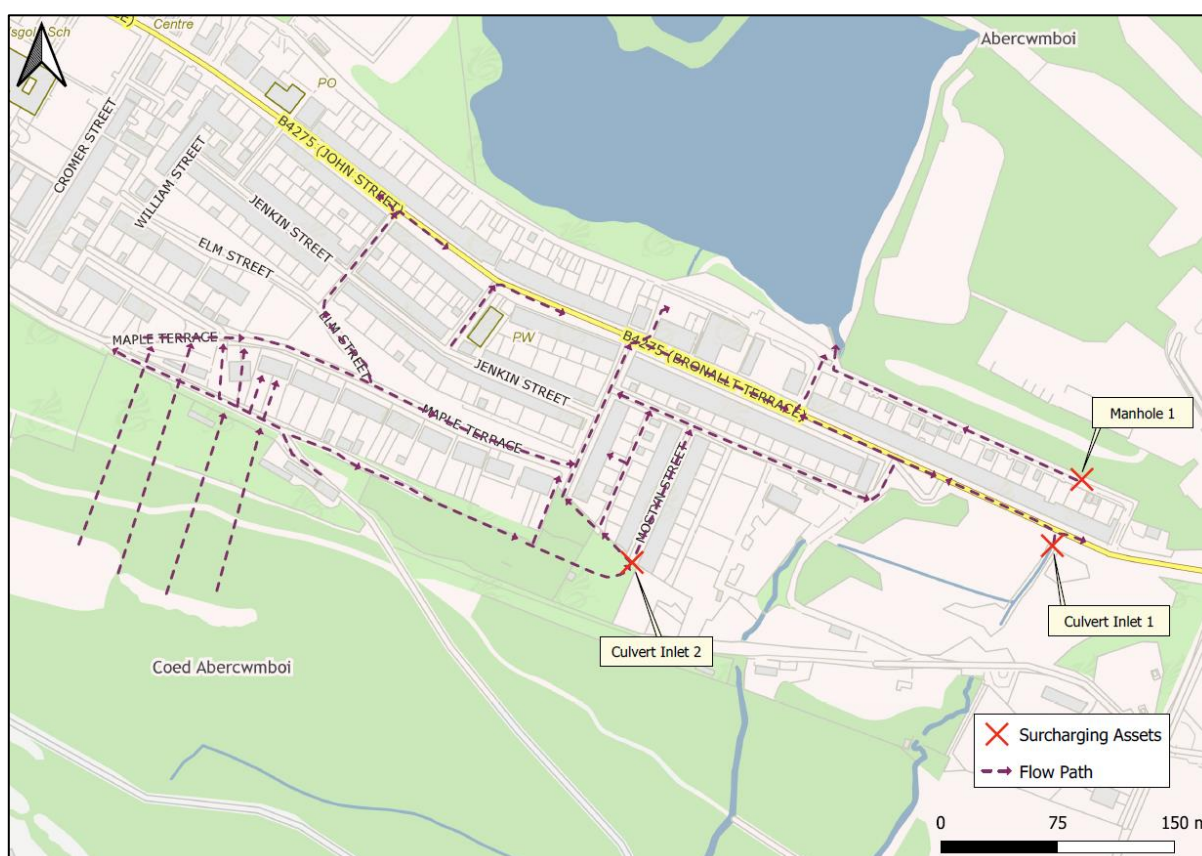
**Figure 4:** Observed flow paths within 'Abercwmboi' sub-catchment during Storm Dennis (15-16<sup>th</sup> February 2020)

The steep hillsides above Abercwmboi are drained by a network of unnamed ordinary watercourses which form the 'Abercwmboi' sub-catchment to the west of RCT05. Figure 4 shows the pathways of flooding within the 'Abercwmboi' sub-catchment during Storm Dennis. The infrastructure known to have surcharged and contributed to the flooding are also illustrated in Figure 4.

During the early hours of Sunday 16<sup>th</sup> February, RCT received a large volume of calls from residents at Bronallt Terrace referencing significant flooding emanating from a culvert inlet located at the eastern end of Bronallt Terrace. The location of the inlet, named 'Culvert Inlet 1', is provided in Figure 4.

Storm event inspections undertaken by RCT's Flood Risk Management team on 16<sup>th</sup> February identified 'Culvert Inlet 1' as having surcharged at the inlet due to a blockage caused by debris accumulation on the inlet's debris screen. This resulted in water overtopping the inlet structure and flowing in a westerly direction along the highway

The site inspection also identified a manhole located in the rear lane behind Bronallt Terrace, downstream of 'Culvert Inlet 1', to have surcharged (labelled 'Manhole 1' in Figure 4). It was confirmed by RCT's on-site inspector that 'Manhole 1' surcharged prior to the inlet, resulting in initial flooding to the rear of the affected properties at Bronallt Terrace. Water sourced by 'Manhole 1' flowed down the rear lane before out-falling into the pond behind Bronallt Terrace.

Upon a site inspection of land to the rear of Maple Terrace, it was evident that significant overland flows originating from the steep hillside had caused some minor scouring on the hillslopes and vegetation appeared to have been flattened by overland flows. On review of the hillside, an open ditch to the rear of properties along Maple Terrace was identified (Figure 7). The open ditch generally slopes towards the east of Maple Terrace before being culverted beneath the highway at Mostyn Street ('Culvert Inlet 2', Figure 4).

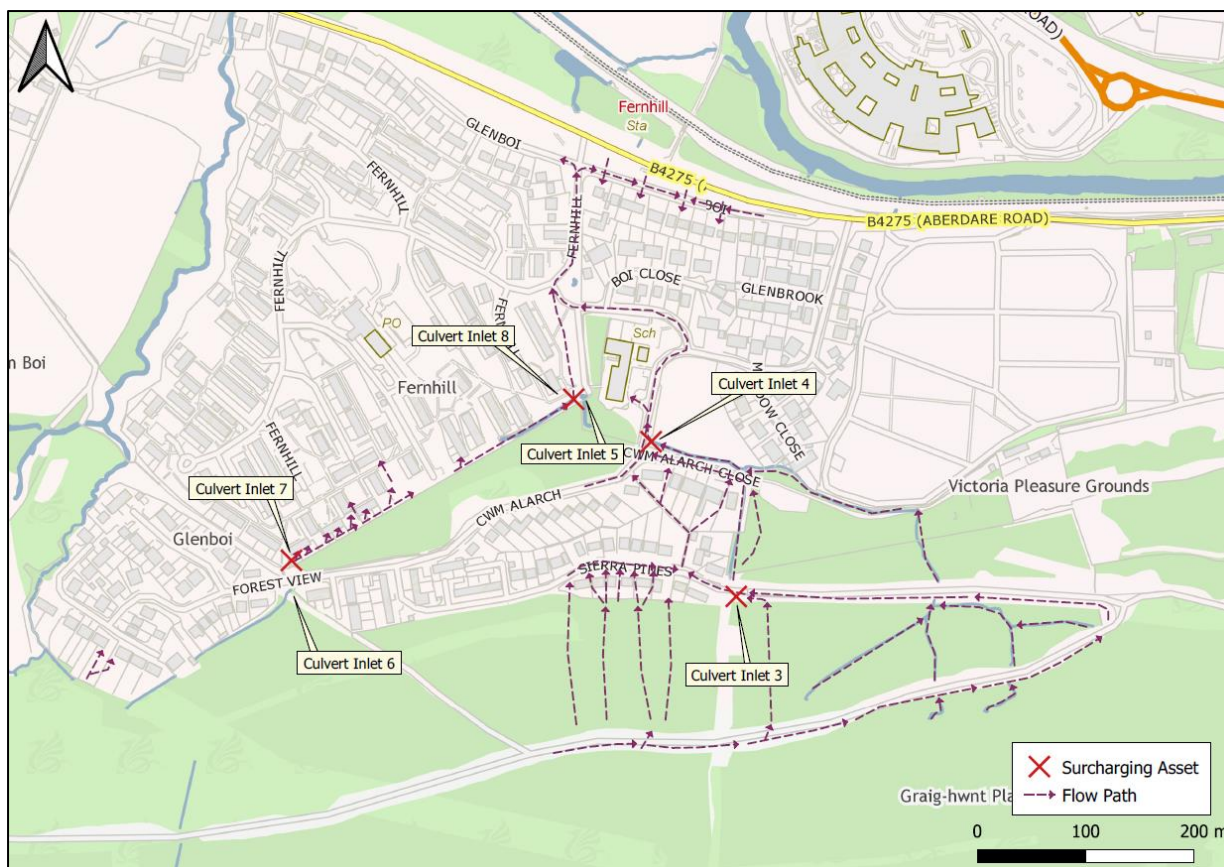
**Figure 9:** Observed flow paths within 'Fernhill & Glenboi' sub-catchment during Storm Dennis (16<sup>th</sup> February 2020)

The steep hillsides above Fernhill are drained by a network of unnamed ordinary watercourses which form the 'Fernhill & Glenboi' sub-catchment to the east of RCT05. Figure 9 shows the pathways of flooding within the 'Fernhill & Glenboi' sub-catchment during Storm Dennis. The infrastructure known to have surcharged and contributed to the flooding are also illustrated in Figure 9.

Flow pathways in this sub-catchment capture overtopping surface runoff from the hillsides above Fernhill which overwhelmed several watercourses and contributed to the surcharging of four culvert inlets.

Significant overland flows originating from the forested hillside to the southeast of Fernhill, to the rear of Sierra Pines, was reported by residents as a significant flow path in this area. This pathway contributed to the surcharging of culvert inlets at Sierra Pines ('Culvert Inlet 3', Figure 9) and Cwm Alarch Close ('Culvert Inlet 4', Figure 9), contributing to the flow of surface water towards Glenboi highway.

Surface water runoff from the hillside above Sierra Pines flows into a roadside channel which is taken by a culvert pipe towards Cwm Alarch Close ('Culvert Inlet 3', Figure 9). During the storm event, water was observed to have overtopped the roadside channel and flow towards Sierra Pines. Water was prevented from flowing further down Sierra Pines by sandbags placed by residents near the forestry entrance. Instead, water was diverted towards the open watercourse on the eastern edge of Sierra Pines, causing the watercourse to overtop and flow overland towards Cwm Alarch Close, exacerbating surface water flows downstream within the investigation area.

The primary pathway down the hillside above Forest View continues downhill before entering a channel and culvert beneath Forest View (‘Culvert Inlet 6’, Figure 9), out falling and re-entering the culvert network at ‘Culvert Inlet 7’ and exiting to a channel between Fernhill and Cwm Alarch Close before being culverted underneath the highway at ‘Culvert Inlet 8’. Multiple calls were received on Sunday 16<sup>th</sup> February 2020 to report internal flooding to several residential properties at Fernhill caused by this pathway.

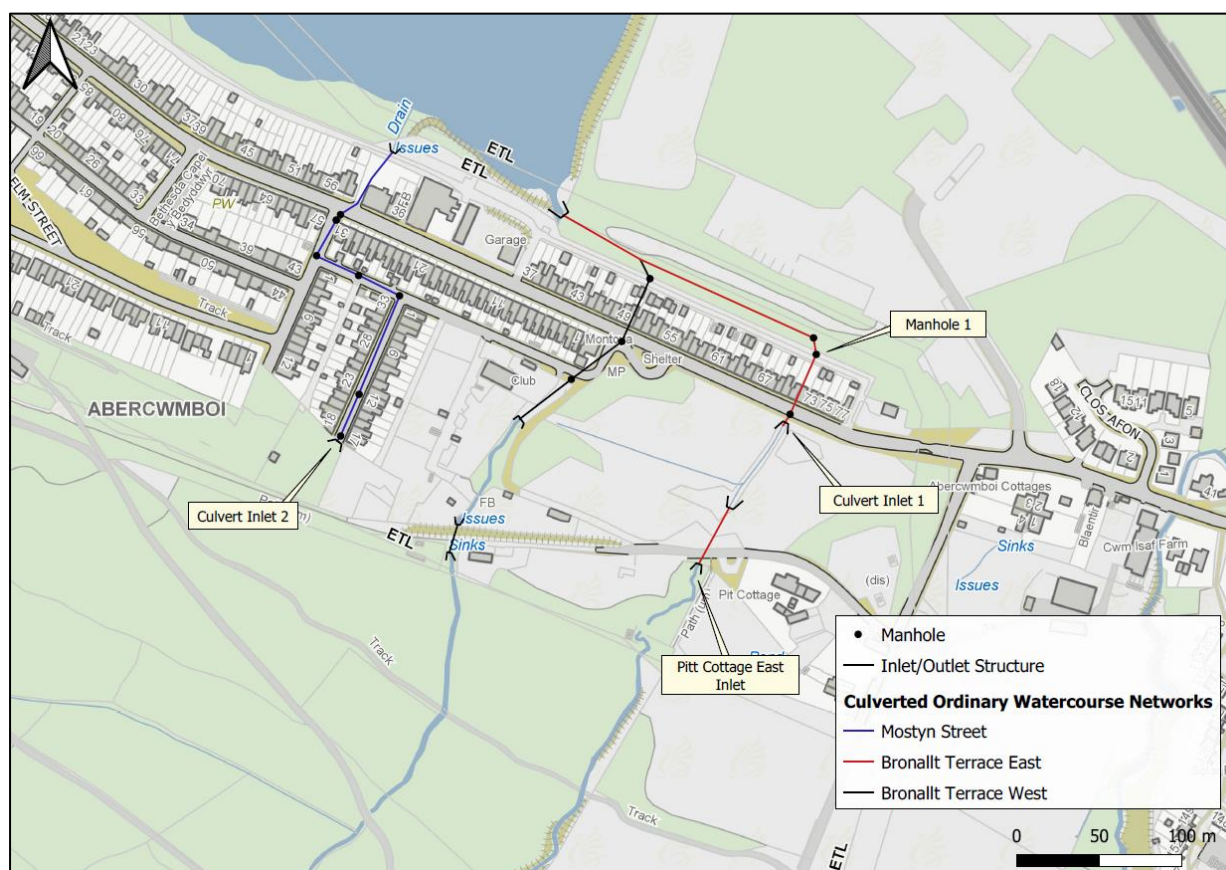
**Figure 15:** Surveyed culverted ordinary watercourse networks within the 'Abercwmbol' sub-catchment

Figure 15 outlines the three culverted ordinary watercourse networks surveyed within the 'Abercwmboi' sub-catchment and highlights the culvert inlets associated to those networks. 'Culvert Inlets 1 and 2' and 'Manhole 1' were known to have surcharged during the storm event.

'Culvert Inlet 1', associated to the 'Bronallt Terrace East' culvert network (Figure 15), was identified as a source of flooding to properties along Bronallt Terrace during Storm Dennis. The culvert inlet is identified as the responsibility of RCT as the Highway Authority.

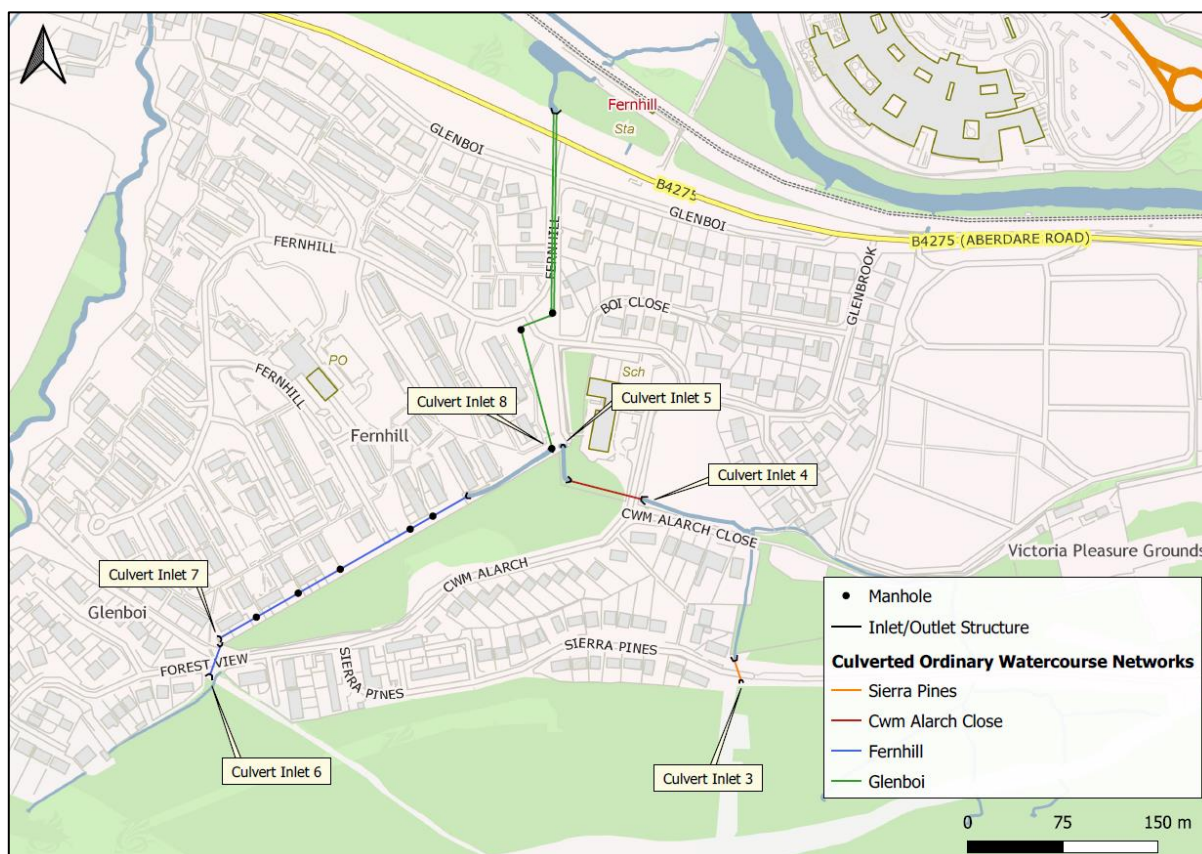
**Figure 19:** Surveyed culverted ordinary watercourse networks within the 'Fernhill & Glenboi' sub-catchment

Figure 19 outlines the four culvert networks surveyed within the 'Fernhill & Glenboi' sub-catchment and highlights the culvert inlets associated to those networks. 'Culvert Inlets 3, 4, 7 and 8' were known to have surcharged during the storm event.

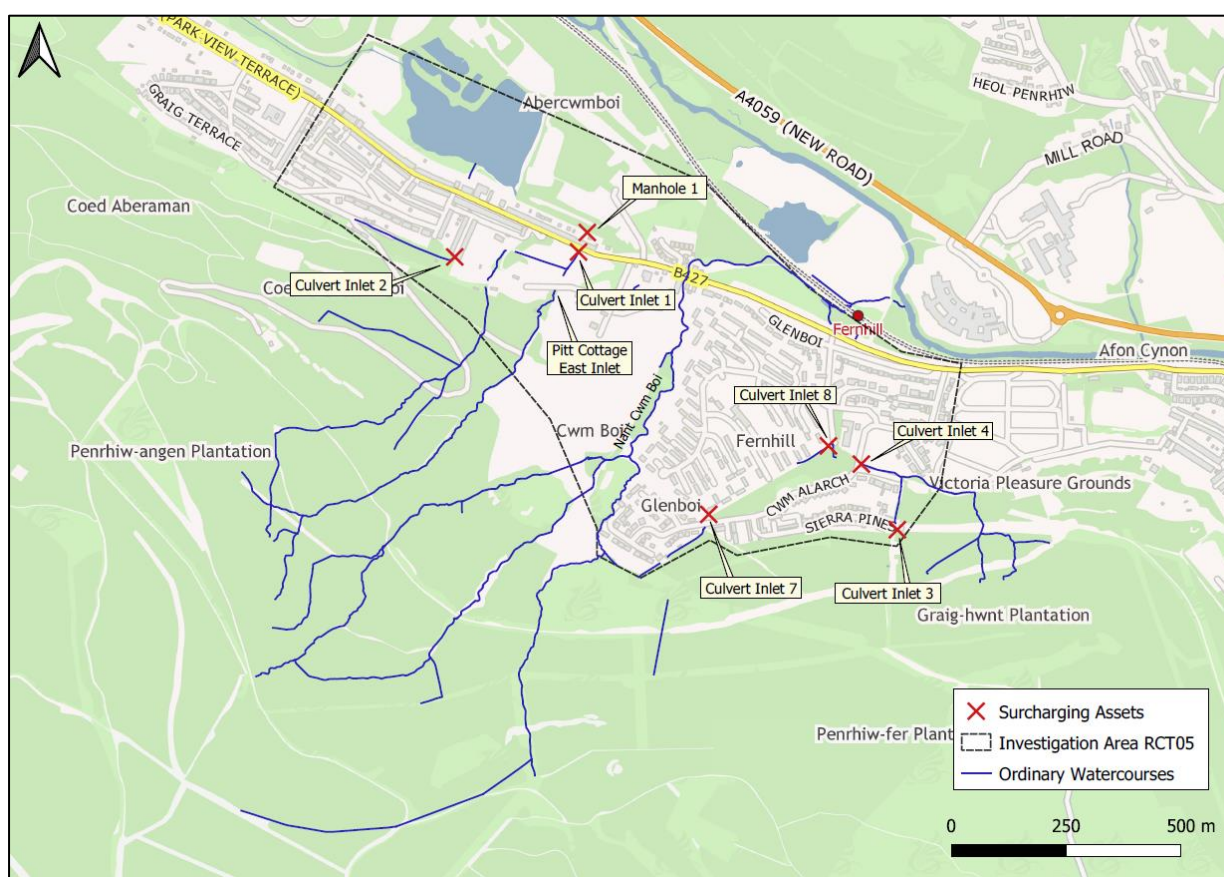
**Figure 25:** Map of Ordinary watercourses which flow through investigation area RCT05

Several sections of natural ditches and open watercourses which drain the steep hillsides above RCT05 are identified to flow through the investigation area and discharge into the River Cynon to the north of RCT05 (Figure 25).

The primary watercourse the Nant Cwm Boi and its tributaries were not identified as a source of flooding during Storm Dennis. The unnamed watercourses which drain the hillsides in the southeast and southwest of RCT05 however were identified as contributing to the flooding that occurred at Abercwmboi and Fernhill on 16<sup>th</sup> February 2020.

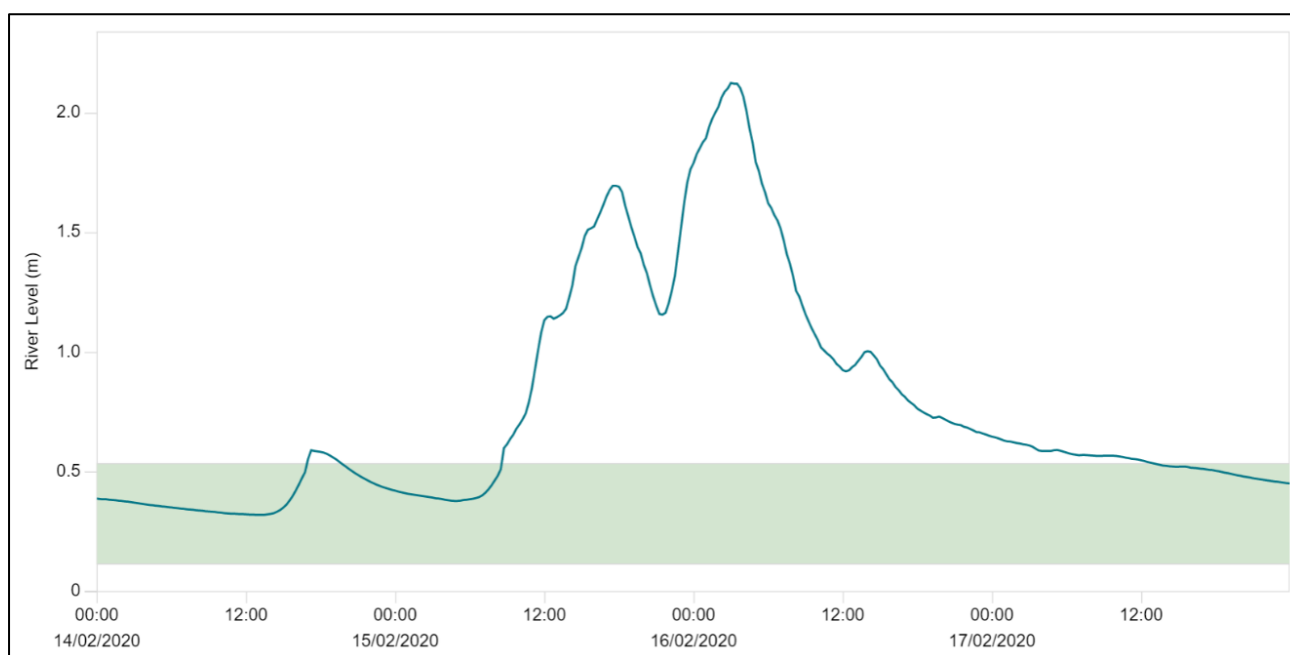
**Figure 35:** The River Cynon level at Aberdare station between the 14<sup>th</sup> and 17<sup>th</sup> February 2020  
(Natural Resources Wales)

The hydrograph in Figure 34 illustrates the rapid rise in levels on the River Cynon in response to rainfall, captured at NRW's Aberdare monitoring station which is located upstream of investigation area RCT05. The River Cynon at Aberdare reached its highest peak ever recorded at 03:00am 16<sup>th</sup> February 2020, reaching 2.13 metres.

The green bar displayed on the hydrograph shows the typical level of the River Cynon at Aberdare station, ranging between 0.1 and 0.55 metres. At its peak, the River Cynon at Aberdare was almost three times higher than its average level, stressing the extreme and unprecedented levels that RCT's rivers rose to during the storm's peak intensity. River levels in the Cynon at Aberdare subsided relatively quickly following the peak, returning to its typical levels the following day on the 17<sup>th</sup> of February 2020.

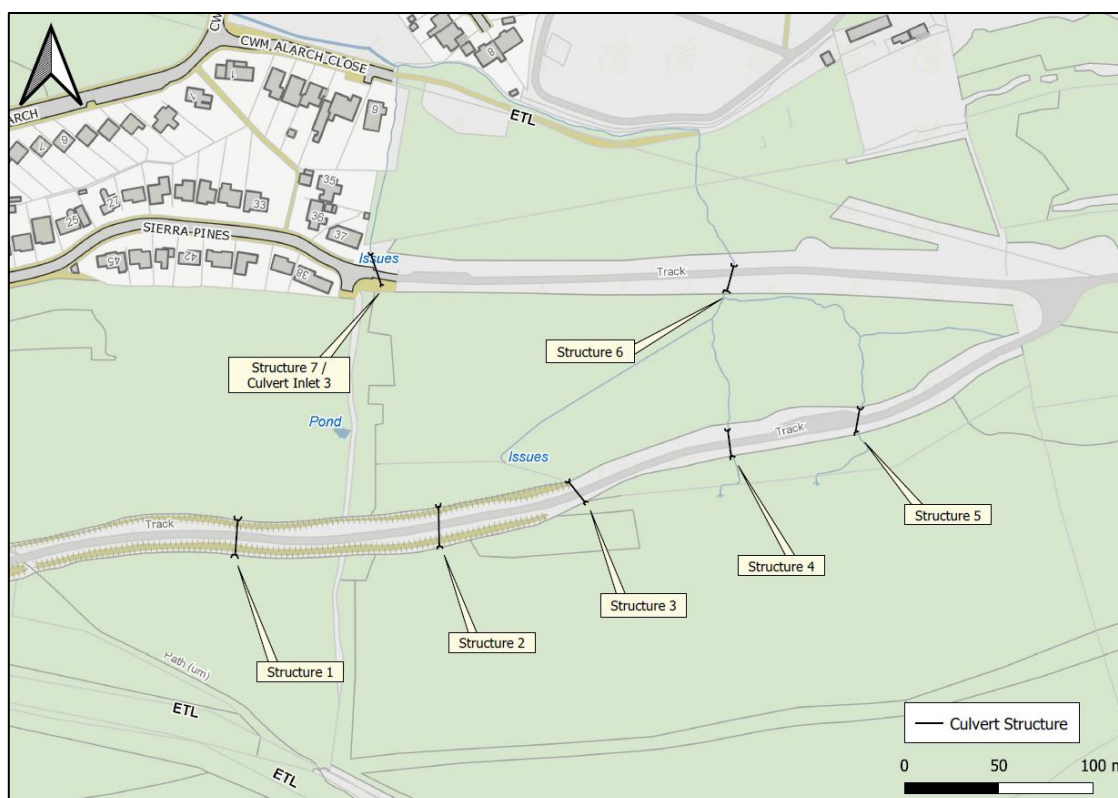
**Figure 38:** Location plan of the ordinary watercourse surface water drainage arrangements (culvert structures) on the hillside above Sierra Pines that was present during Storm Dennis

A site walk-over assessment of the upper catchment above Sierra Pines was undertaken by RCT's Flood Risk Management team post event to inspect the drainage arrangements of the hillside. The ordinary watercourse culvert structures identified on the hillside were mapped following the site visit and are presented in Figure 38.

On review of the culvert structures on the hillside, RCT as the Land Drainage Authority reviewed its records associated to consents under Section 23 of the Land Drainage Act 1991 and identified that several structures did not have consent. The unconsented structures were observed to be redirecting ordinary watercourse and surface water flows from the hillside above the track towards ‘Structure 7 / Culvert Inlet 3’ via undefined channels. Figure 39 depicts the undefined channel below ‘Structure 3’ which is considered to have contributed to the discharge of flows towards ‘Structure 7 / Culvert Inlet 3’.

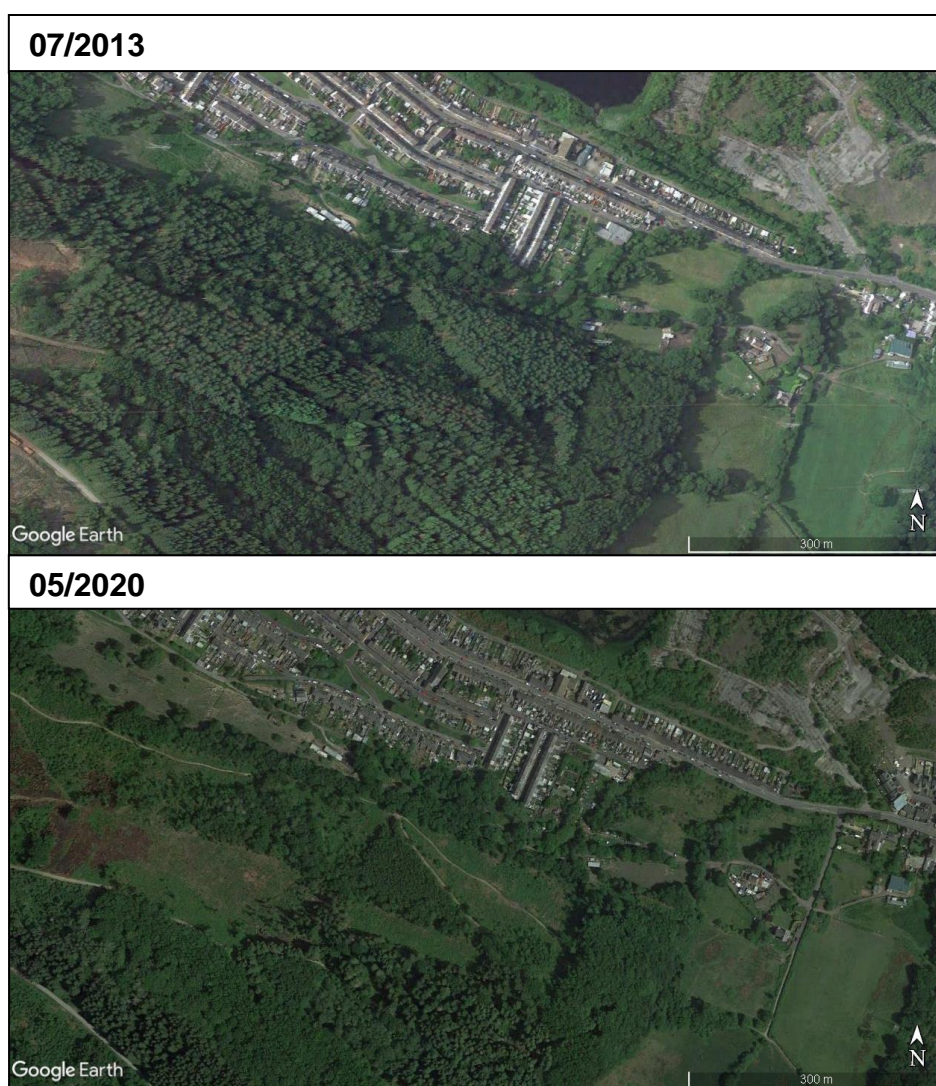
**Figure 41:** Google Earth imagery of area above Abercwmboi showing change in tree cover between 2013 and 2020

Areas of woodland to the north of Abercwmboi and Fernhill have been felled in recent years. The areas in which tree felling has occurred forms part of the WGWE. Figures 41 and 42 illustrate the woodland loss observed between 2013 and 2020 in areas of Abercwmboi and Fernhill's upper catchments, respectively, using historic aerial imagery from Google Earth.
