# Flood and Water Management Act 2010

## Section 19 Flood Investigation Report

### Storm Dennis – Flood Investigation Area RCT06 (Mountain Ash)

October 2022

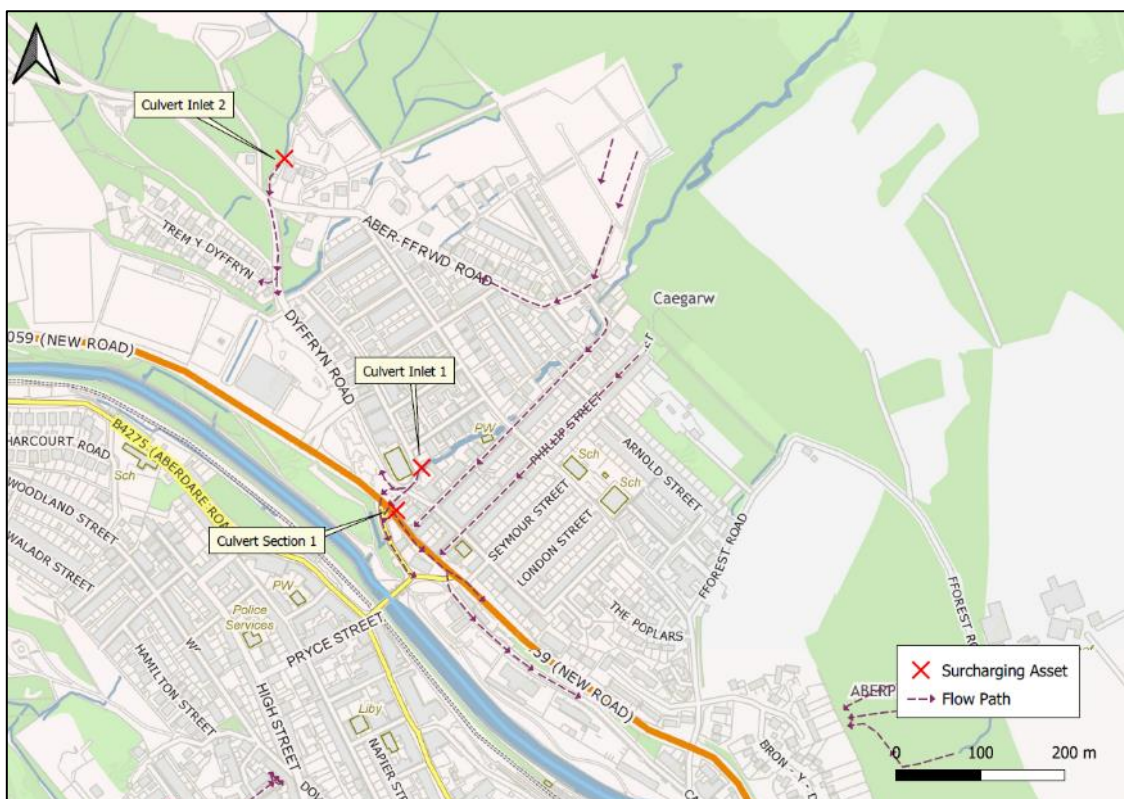
**Figure 4:** Observed flow paths and surcharged assets within 'Mountain Ash East - Sub-Catchments 1 & 2' during Storm Dennis (15-16<sup>th</sup> February 2020)

Figure 4 and 5 depicts the observed pathways of flooding within the 'Mountain Ash East' catchment area, within sub-catchments 1 and 2 (Figure 4) and sub-catchment 3 and 4 (Figure 5), during Storm Dennis. The infrastructure known to have surcharged and contributed to the flooding are also illustrated within both Figures.

Post event inspections also identified a section of the footpath adjacent to the A4059 (New Road) to have suffered from subterranean hydraulic pressure, i.e., the footpath appears to indicate that water from the culvert network, downstream of ‘Culvert Inlet 1’, erupted through the ground and contributed to the flooding along the highway. The section of damaged culvert is labelled ‘Culvert Section 1’ in Figure 2.

To the north-west of ‘Culvert Inlet 1’, a second culvert inlet (labelled ‘Culvert Inlet 2’, Figure 4) was reported as surcharging and causing flooding to properties at Trem y Dyffryn during Storm Dennis. ‘Culvert Inlet 2’ is located to the rear of a property at Aber-Ffrwd Road.

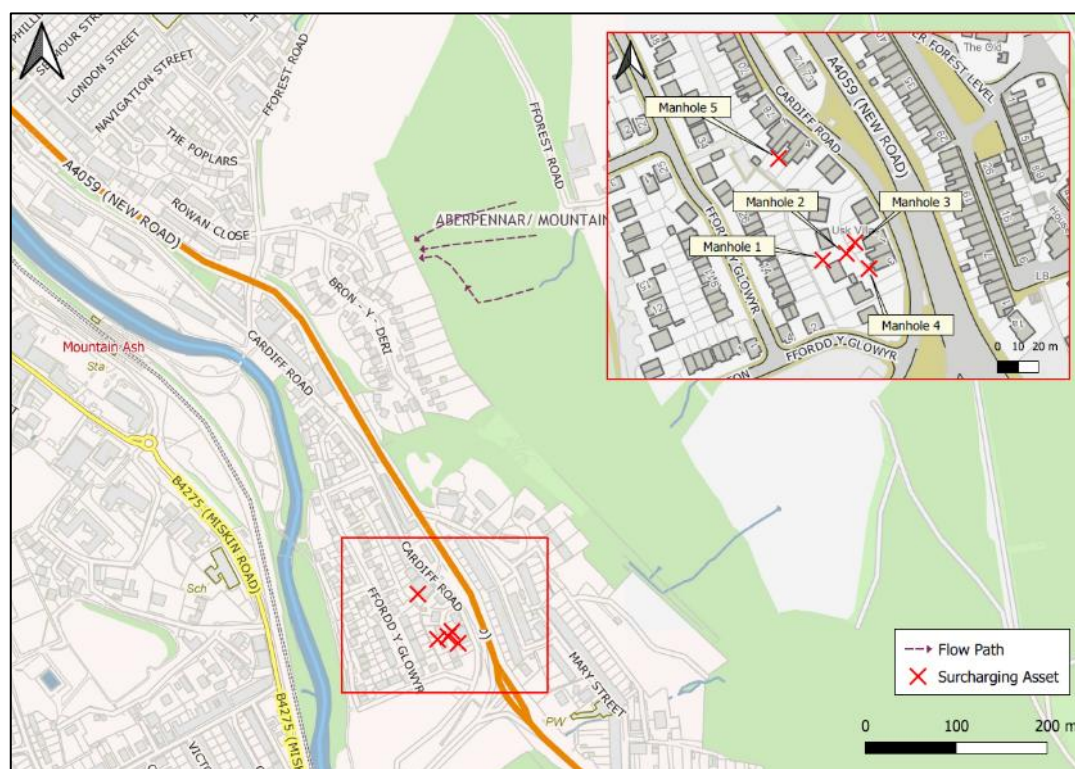
**Figure 5:** Observed flow paths and surcharged assets within 'Mountain Ash East - Sub-Catchments 3 & 4' during Storm Dennis (15-16<sup>th</sup> February 2020)

Within ‘Mountain Ash East – Sub-catchment 3’, water ingress to properties at Clas-y-Dderwen was reported during the storm event. According to residents, water was flowing overland down the hillside to the rear of the impacted properties and subsequently flooding several rear gardens. Indicative flow paths are illustrated in Figure 5.

Further south within 'Mountain Ash East – Sub-catchment 4', flooding to several residential properties at Cardiff Road and Usk Villas was reported by residents during Storm Dennis. Based upon accounts provided by residents, as well as reports from investigating officers, several surface water and combined sewer manholes were reported as surcharging foul and surface water flows during the storm event after becoming overwhelmed by intense rainfall. The surcharged infrastructure is illustrated in Figure 5.

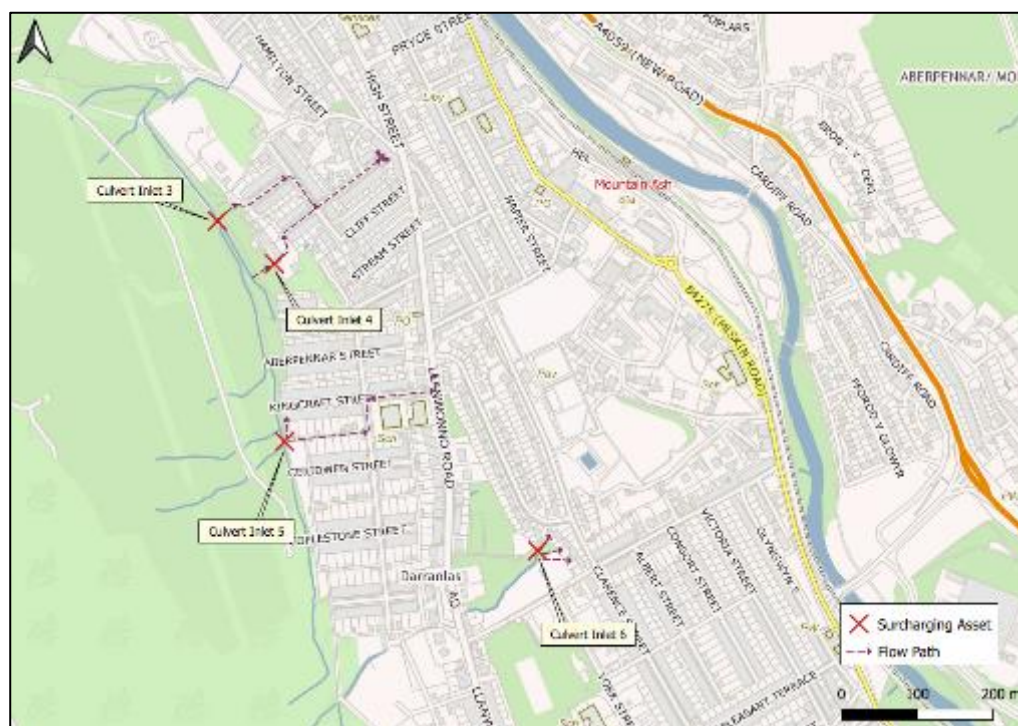
**Figure 11:** Observed flow paths and surcharged assets within 'Mountain Ash West/Penrhwiwceiber - Sub-Catchments 1 & 2' during Storm Dennis (15-16<sup>th</sup> February 2020)

Figures 11 and 12 depict the observed pathways of flooding within the 'Mountain Ash West/Penrhiwceiber' catchment area, within sub-catchments 1 and 2 (Figure 11) and sub-catchments 3 and 4 (Figure 12), during Storm Dennis. The infrastructure known to have surcharged and contributed to the flooding are also illustrated within both Figures.

A third culvert inlet situated at the top of Kingcraft Street within 'Mountain Ash West/Penrhiwceiber – sub-catchment 2' (labelled 'Culvert Inlet 5' in Figure 11) was also reported by residents as surcharging during Storm Dennis. During post event inspections, material and debris were identified to have caused an obstruction of flow at 'Culvert Inlet 5', resulting in its surcharge. One residential property immediately adjacent to 'Culvert Inlet 5' reported internal flooding, with exceedance flows eroding the adjacent hillside and conveying into the property from the rear.

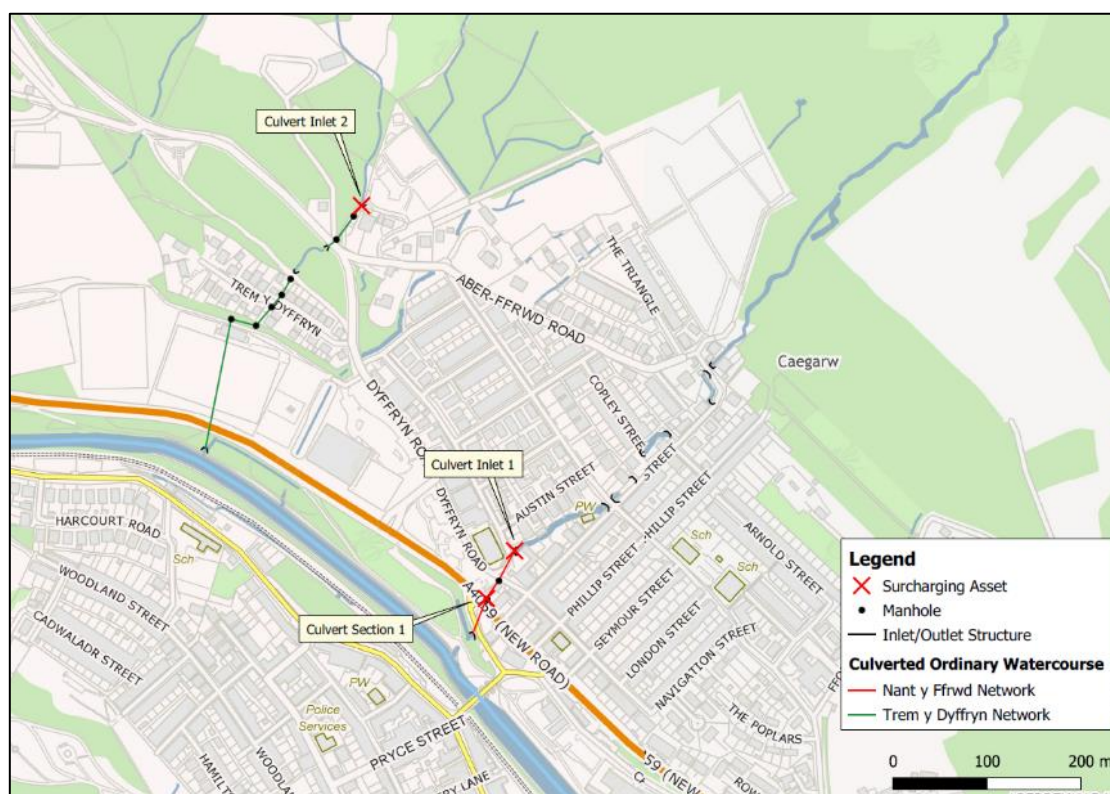
**Figure 18:** Surveyed culverted ordinary watercourse networks and the infrastructure identified as surcharging within the ‘Mountain Ash East’ catchment.

Figure 18 outlines the two culvert networks surveyed within the 'Mountain Ash East' catchment and highlights the culvert inlets and manhole known to have surcharged during the storm event.

The Nant-y-Ffrwd is culverted beneath the A4059 (New Road) and the B4275 (Ffrwd Crescent) at ‘Culvert Inlet 1’ before discharging into the River Cynon approximately 120 metres downstream.

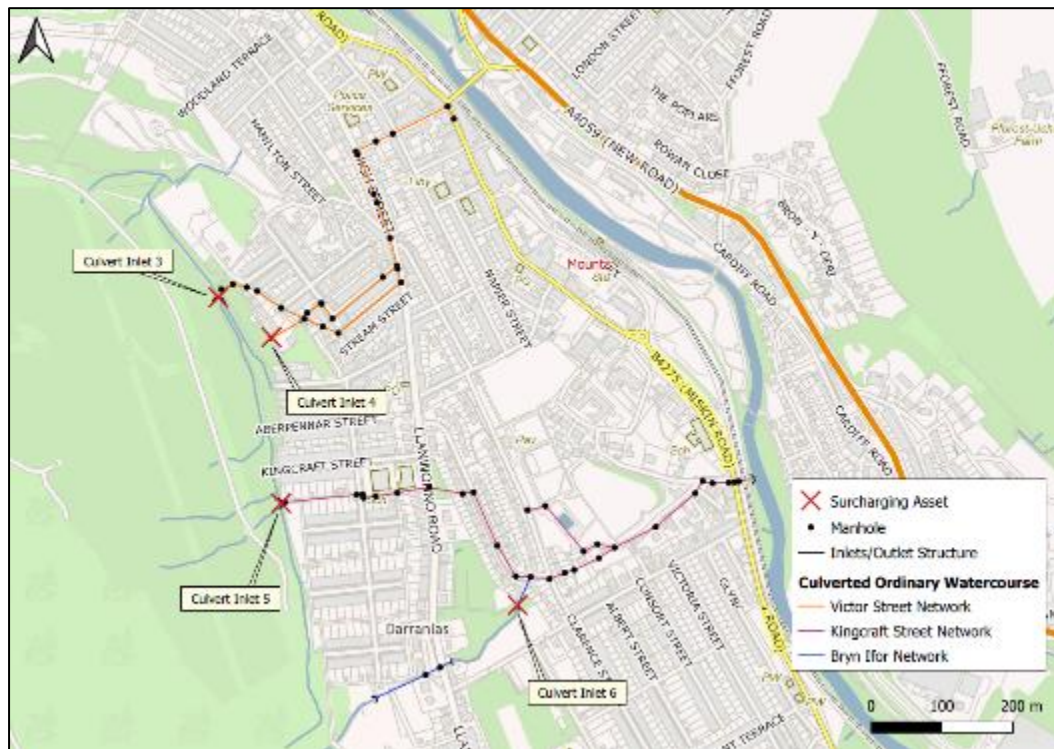
**Figure 21:** Surveyed culverted ordinary watercourse networks and the infrastructure identified as surcharging within the ‘Mountain Ash West’ catchment.

Figure 21 outlines the three culvert networks surveyed within the ‘Mountain Ash West’ catchment and highlights the culvert inlets known to have surcharged during the storm event.

‘Culvert Inlets 3, 4 and 5’ take inflow from the western hillsides of RCT06 via several unnamed ordinary watercourse and surface water runoff which is culverted beneath Mountain Ash West’s settlements and discharged into the River Cynon.

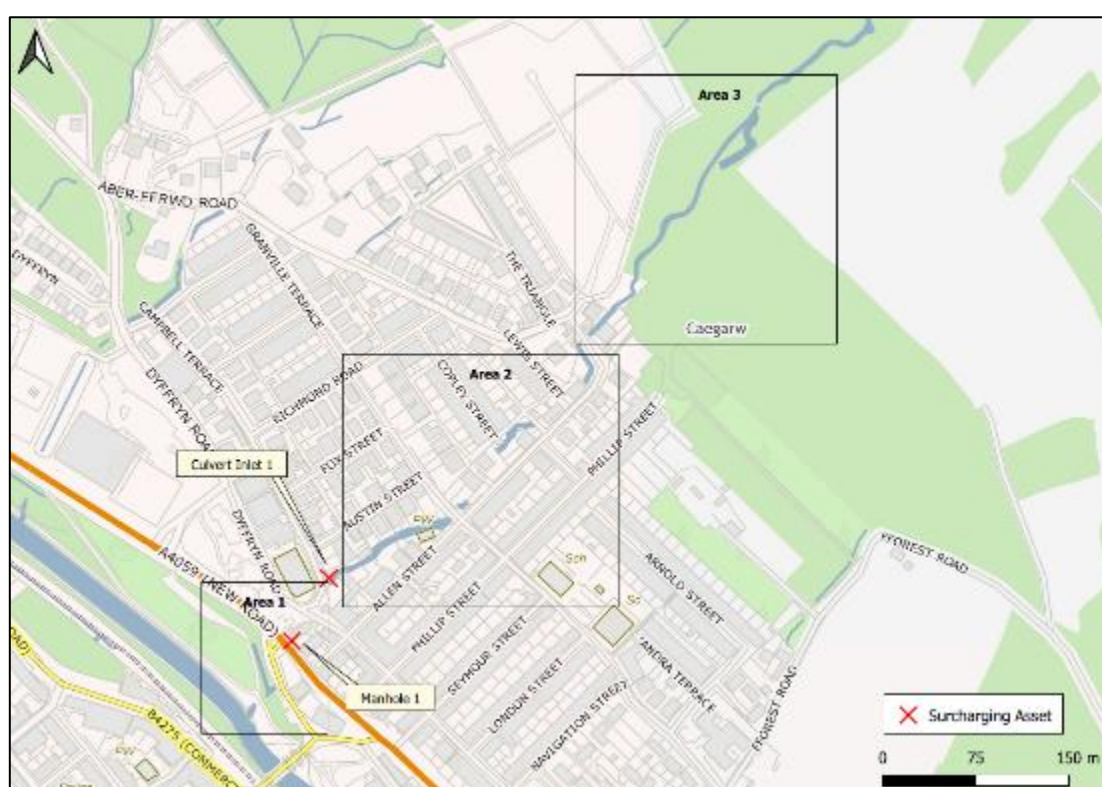
**Figure 26:** Nant y Ffrwd ordinary watercourse inspection location plan

Following the surcharging of ‘Culvert Inlet 1’ and ‘Culvert Section 1’ (Figures 6 and 7) caused by debris blockages during Storm Dennis, the Nant y Ffrwd ordinary watercourse was inspected by Flood Risk Management officers for signs of debris mobilisation. The watercourse was inspected at three areas, depicted in Figure 26.

The upstream sections of the Nant y Ffrwd ordinary watercourse (Area 1, Figure 26) showed evidence of significant embankment scour (Figure 27) and deposition of material consisting of large stonewash (Figure 28), within the upper channel. This material is assumed to have been mobilised from the upper reaches of the Nant y Ffrwd and carried downstream by the high flows during Storm Dennis.

Within Area 2, Figure 26, the Nant y Ffrwd ordinary watercourse is partially culverted beneath residential development and the sections of open channel are heavily modified. On review of the open channels in Area 2, further deposition of material was observed along with significant accumulation of material across the debris screens.

Downstream of 'Culvert Inlet 1' and 'Culvert Section 1' (Area 3, Figure 26), at the outfall of the Nant y Ffrwd, significant deposition of debris was observed. Figure 31 illustrates the condition of the outfall pre (Figure 31, left) and post (Figure 31, right) emergency clearance works, which were carried out by the Authority following Storm Dennis. The observed accumulation of debris provides further evidence of the substantial mobilisation of debris carried by the Nant y Ffrwd watercourse during Storm Dennis.

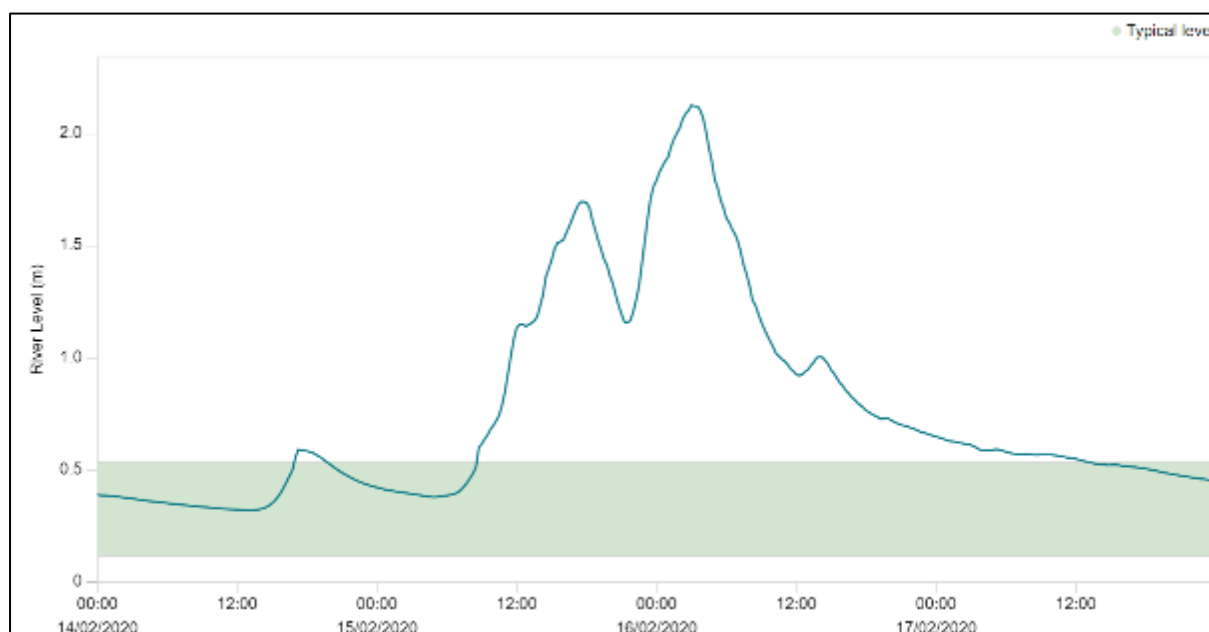
**Figure 35:** The River Cynon levels at Aberdare station between the 14<sup>th</sup> and 17<sup>th</sup> of February 2020 (Natural Resources Wales)

The closest river level gauge stations in operation along the River Cynon during Storm Dennis are approximately 5 kilometres both upstream and downstream of the investigation area; at Aberdare and Abercynon respectively. Figures 35 and 36 illustrate water levels within the River Cynon at both stations during Storm Dennis and provide an indication of the River Cynon’s response to rainfall during the storm event.

NRW issued a ‘Flood Alert’ (indicating possible flooding) for the River Cynon at 12:51 on the 15<sup>th</sup> of February, during that time the River Cynon at Aberdare and Abercynon had reached over a metre in depth. The River Cynon continued to rise during the early hours of Sunday 16<sup>th</sup> February morning before reaching a peak level of 2.125 metres (03:00 16<sup>th</sup> February) at Aberdare and 3.067 metres (07:00 16<sup>th</sup> February) at Abercynon; the highest levels recorded for the River Cynon at both stations.

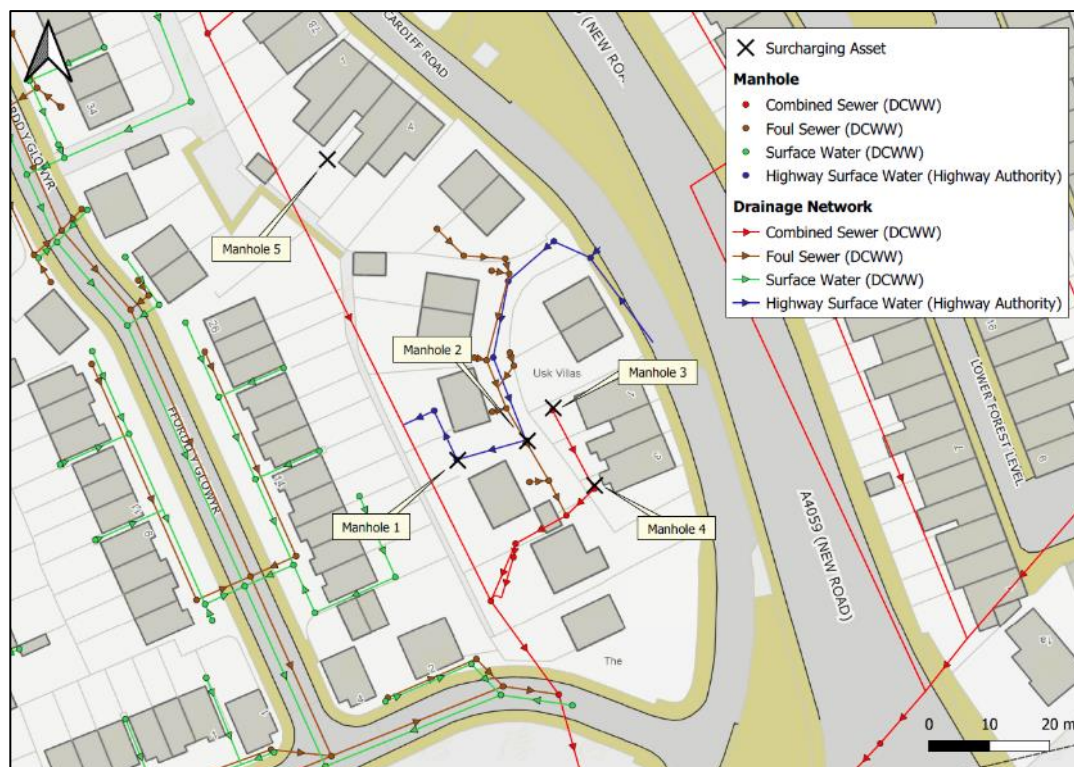
**Figure 39:** Map of the highway drainage network and DCWW operated sewer networks at Cardiff Road, Mountain Ash East. The surcharged assets during Storm Dennis are highlighted and labelled.

To the southwest of the investigation area at Cardiff Road and Usk Villas, the highway drainage infrastructure became overwhelmed during the storm event as a result of intense rainfall which caused two highway surface water drainage manholes to surcharge, labelled 'Manhole 1 and 2' in Figure 39. Both structures contributed to the internal flooding to three residential properties at Cardiff Road.

The impacted properties at Cardiff Road are situated lower than the highway, contributing to the accumulation of surface water at the low points and the conveyance of flood water into residential properties.

As depicted in Figure 39, the highway surface water drainage network connects into the combined sewer network, owned and operated by DCWW, which runs to the rear of the impacted properties and parallel to Cardiff Road.
