# Flood and Water Management Act 2010

## Section 19 Flood Investigation Report

### Storm Dennis – Flood Investigation Area RCT19 (Porth)

June 2022

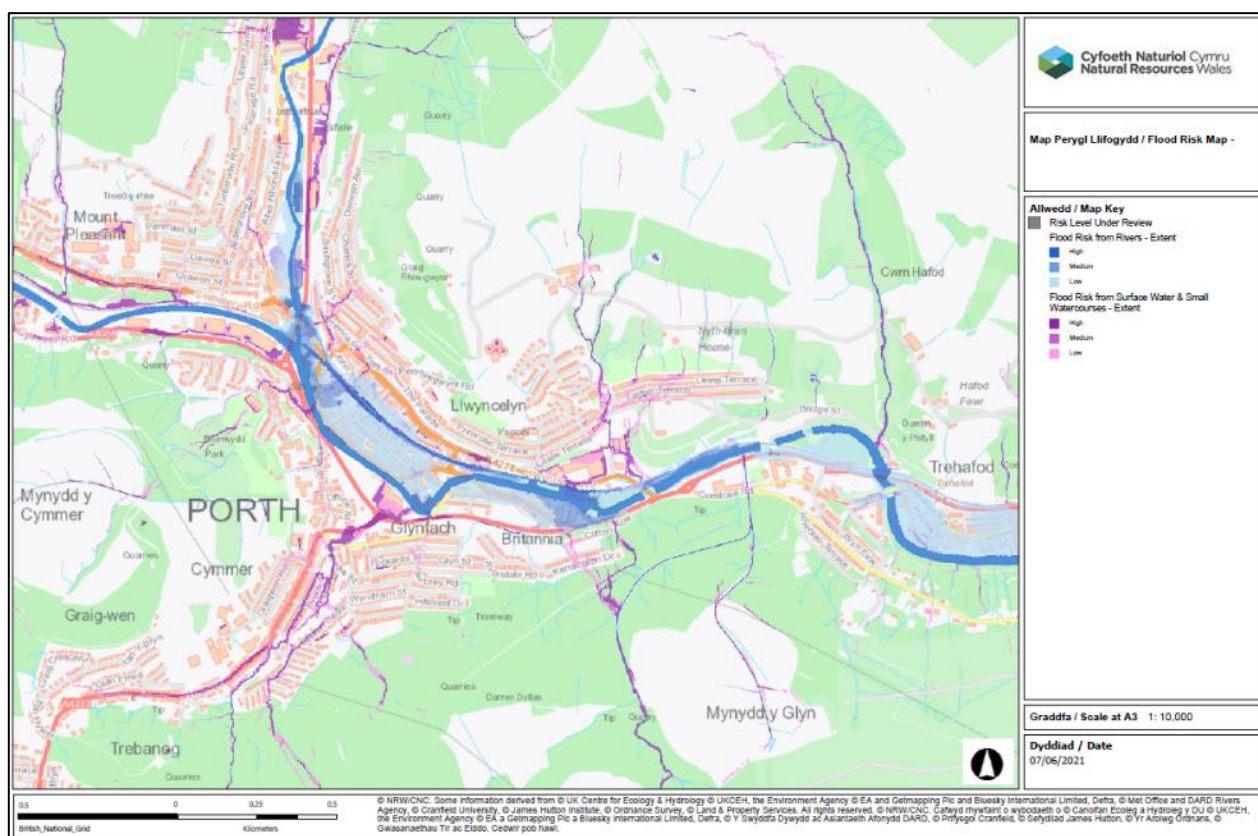
Flood risk is broadly associated with the River Rhondda and Rhondda Fach, particularly at the confluence. Natural Resources Wales' FRAW map (Figure 2) indicates a low to high fluvial flood risk present along the length of the River Rhondda. Figure 2 also depicts several localised areas of surface water and ordinary watercourse flood risk throughout RCT19, largely associated with the culvert inlets in the area. Flood risk throughout Porth is further described within RCT's Flood Risk Management Plan (FRMP)<sup>3</sup>.

**Figure 2:** Natural Resources Wales' Flood Risk Assessment Wales (FRAW) map for rivers and ordinary watercourse and surface water flood risk at investigation area RCT19. Contains Natural Resources Wales information © Natural Resources Wales and database right. All rights reserved.

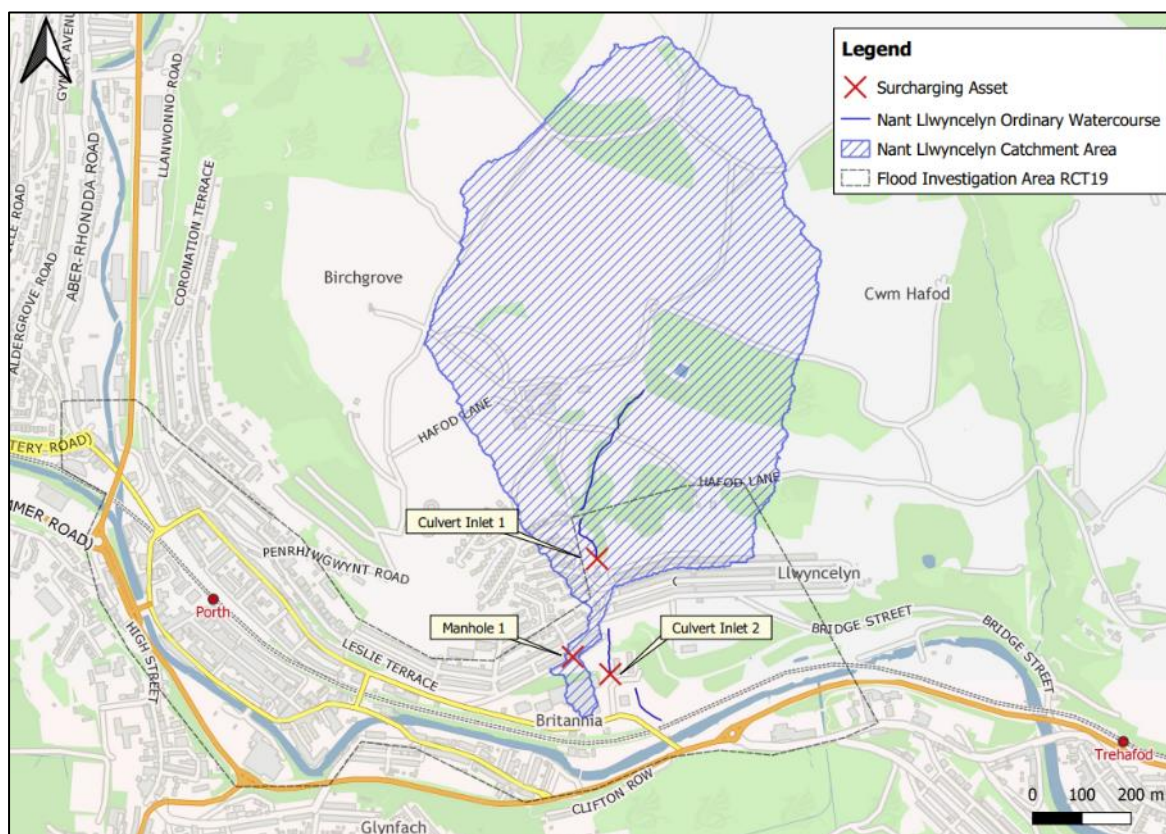
To the northwest of the investigation area, two culvert inlets associated to the Nant Llwyncelyn watercourse were identified as sources of flooding to 2 residential and 7 commercial properties during Storm Dennis. Both inlets are highlighted in Figure 7 which also illustrates the large catchment area associated to the Nant Llwyncelyn watercourse.

**Figure 7:** Nant Llwyncelyn ordinary watercourse catchment area and associated infrastructure identified as sources of flooding during Storm Dennis

The Nant Llwyncelyn ordinary watercourse drains the northern hillsides above Porth and is culverted beneath residential development at 'Culvert Inlet 1', adjacent to St Luke's Road. The ordinary watercourse continues to convey as an open channel toward Llwyncelyn Industrial Estate and is culverted again at 'Culvert Inlet 2' which conveys the industrial estate's access road. Beyond the access road, the culverted ordinary watercourse conveys south-easterly towards the River Rhondda.

In addition to flows originating from 'Culvert Inlet 1', a surcharging surface water manhole at Leslie Terrace (labelled 'Manhole 1', Figure 7) was also reported by property owners. Video footage provided by residents show evidence of 'Manhole 1' surcharging during the storm event and contributing surface water flows towards the rear of Llwynycelyn Industrial Estate (Figure 12).

A surface water manhole ('Manhole 1', Figure 7) was also observed as surcharging during the storm event and contributing to the surface water and ordinary watercourse flooding within Llwncelyn Industrial Estate. Upon an inspection of 'Manhole 1' during post event surveying operations, the surface water manhole was observed as free flowing with no blockages identified within the network. It is likely that some debris carried by the ordinary watercourse flows from 'Culvert Inlet 1' entered the surface water network during the storm event, impacting its capacity, however, the primary cause of surcharge at 'Manhole 1' has been attributed to hydraulic overload due to intense rainfall and exceedance flows from 'Culvert Inlet 1'.

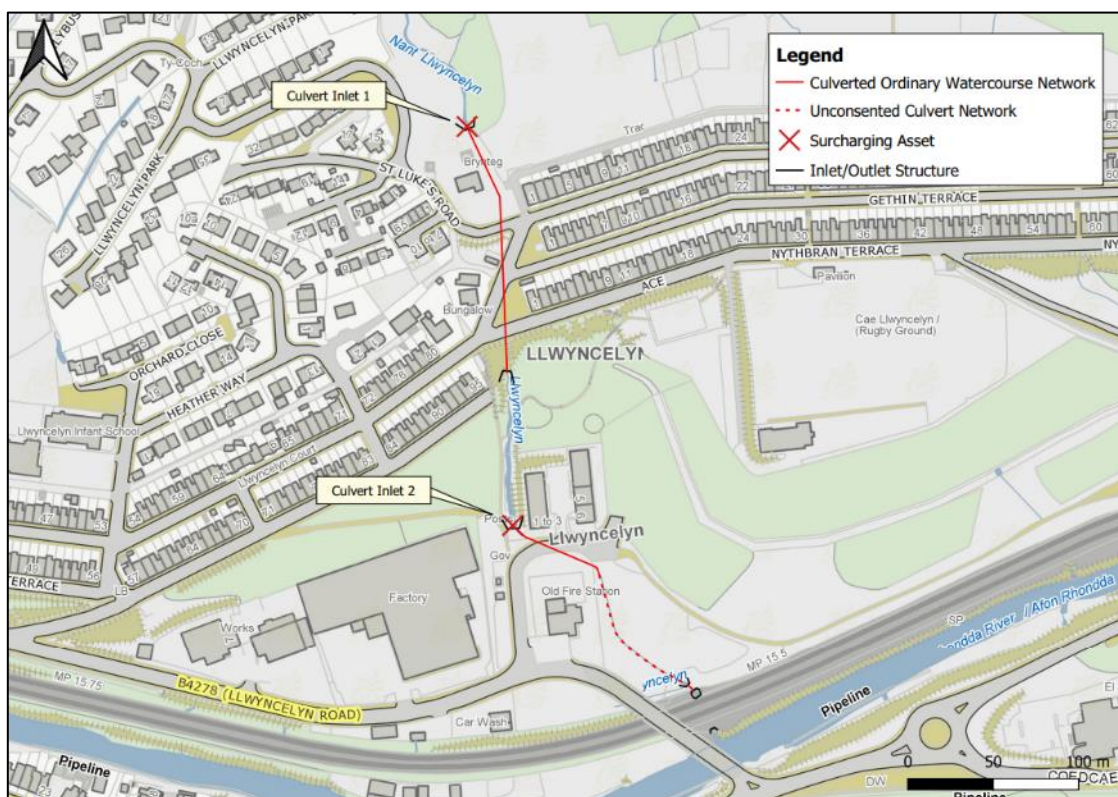
The Nant Llwyncelyn is culverted beneath residential properties at 'Culvert Inlet 1' before out falling into an open channel above Llwyncelyn Industrial Estate. The watercourse is culverted again at 'Culvert Inlet 2' which conveys beneath the railway line and discharges into the River Rhondda. Both culvert inlets were inspected by RCT's Flood Risk Management team and the Council's Highways and Streetcare Depot following the flood event to assess their condition. A CCTV survey inspection of the Nant Llwyncelyn culvert network was also undertaken to ascertain both the operational condition of the network, and its structural integrity along sections of the network. The surveyed Nant Llwyncelyn culvert network is depicted in Figure 15.

**Figure 15:** The Nant Llwyncelyn culverted ordinary watercourse network and culvert inlets identified as sources of flooding during Storm Dennis

In response to the identified reduction in culvert diameter, the Land Drainage Authority carried out further investigations of the culvert network. It was identified that the polyvinyl chloride culvert section had been installed without consent from the Land Drainage Authority under Section 23 of the Land Drainage Act 1991. The section of unconsented culvert network is illustrated by a dashed red line in Figure 15.

The Nant Llwynceilyn culvert networks associated to ‘Culvert Inlet 1 and 2’ (Figure 15) were surveyed post event to ascertain the internal condition of the networks, the results of which fed into a review of the hydraulic performance of the network to ascertain its current standard of protection. Causeway Flow modelling was used to assess the standard of protection of ‘Culvert Inlet 2’, while the online calculation tool from HR Wallingford, ‘Greenfield runoff rate estimation tool’<sup>5</sup>, was used to generate the runoff flow calculation for ‘Culvert Inlet 1’. The results of both culvert inlet capacity assessments are summarised in Table 5 and 6 below (refer to Figure 15 for culvert labels).

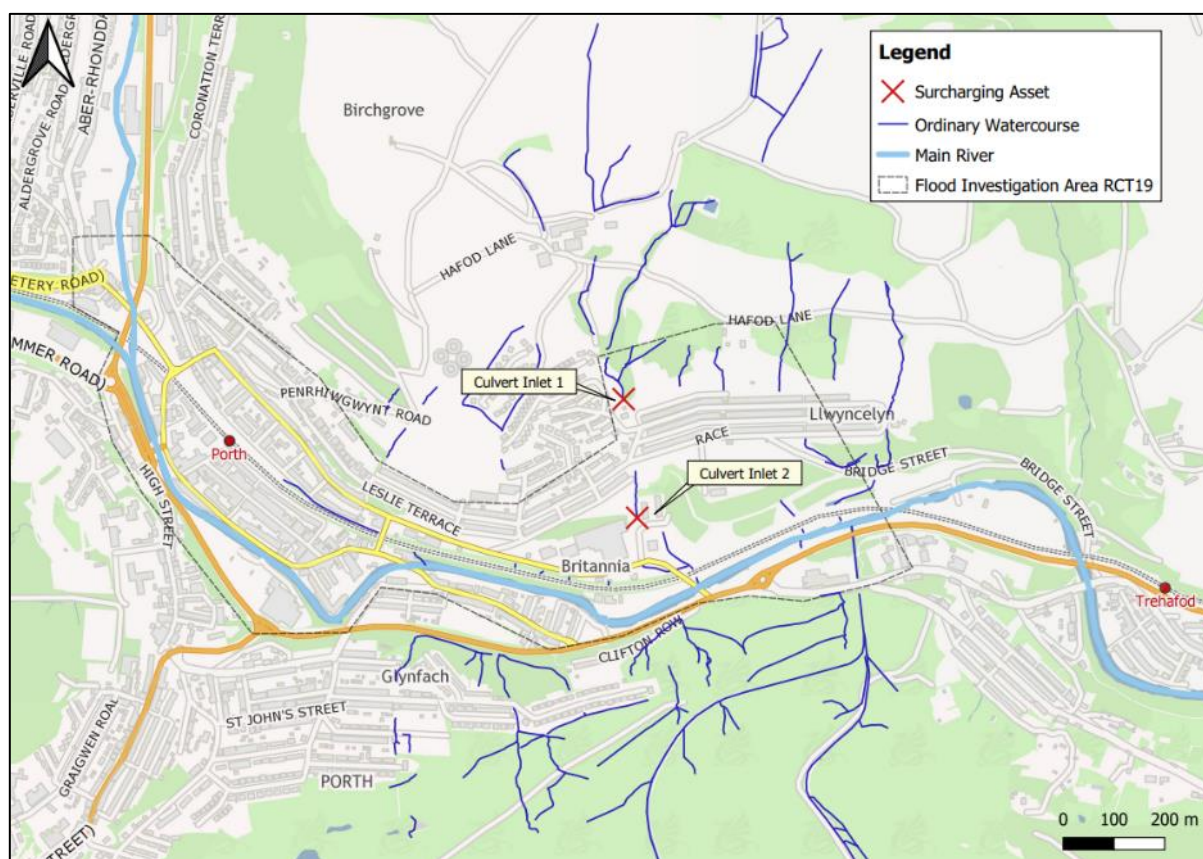
Several named and unnamed ordinary watercourses drain the hillsides above Porth and convey towards the Rhondda River through the investigation area via open channels and culverted networks. The ordinary watercourses have been illustrated in Figure 20.

**Figure 20:** Map of ordinary watercourses which feed into investigation area RCT19

With the exception of the Nant Llwynceilyn ordinary watercourse, there is no evidence to suggest that the network of ordinary watercourses illustrated in Figure 20 contributed to the flooding experienced during Storm Dennis.

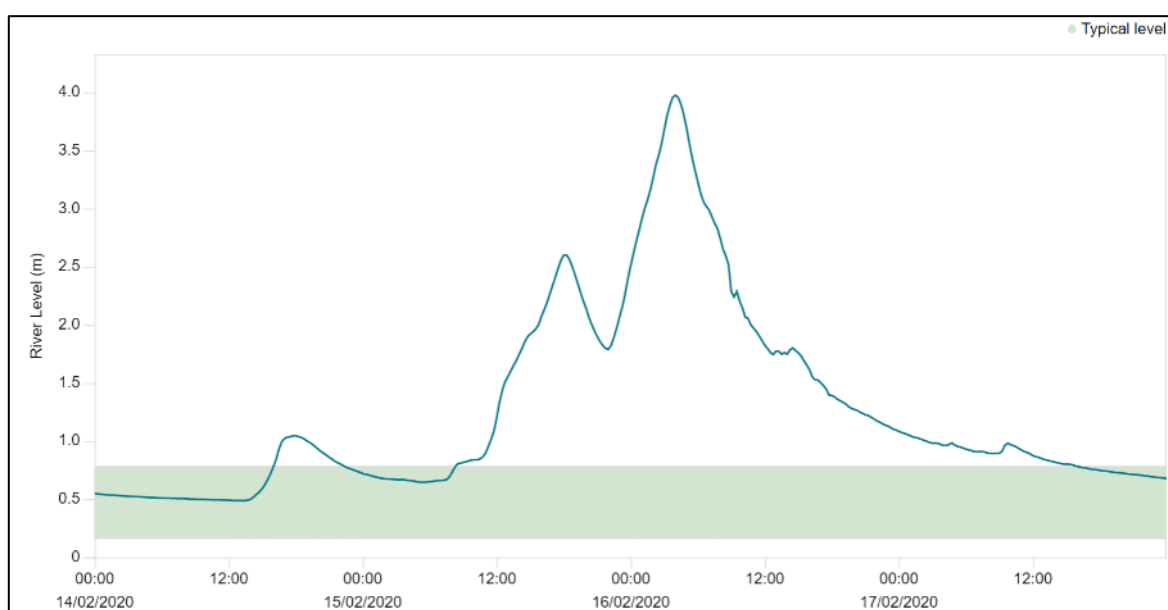
The hydrograph in Figure 23 illustrates the rapid rise in levels of the River Rhondda in response to rainfall between the 14 – 17<sup>th</sup> February 2020. River level data was captured at NRW's Trehafod station, located approximately 1.25 kilometres southeast of the investigation area's eastern boundary.

NRW issued a 'Flood Alert' (indicating possible flooding) for the entirety of the River Rhondda at 14:43 on 15<sup>th</sup> February; at which point the main river was almost 2 metres in depth and continuing to rise at Trehafod station. At approximately 23:00 on 15<sup>th</sup> February the River Rhondda began to rise again, reaching a peak river level of 3.977 metres at 04:00 on 16<sup>th</sup> February; the highest level recorded for the River Rhondda at Trehafod since 2001.

**Figure 23:** The River Rhondda levels at Trehafod station between the 14<sup>th</sup> and 17<sup>th</sup> February 2020 (Natural Resources Wales)

The green bar displayed on the hydrograph shows the typical level of the River Rhondda at Trehafod, ranging between approximately 0.2 and 0.8 metres. At its peak, the Rhondda River was over 3 metres higher than its average level, stressing the extreme and unprecedented levels that RCT's rivers rose to during the storm's peak intensity.

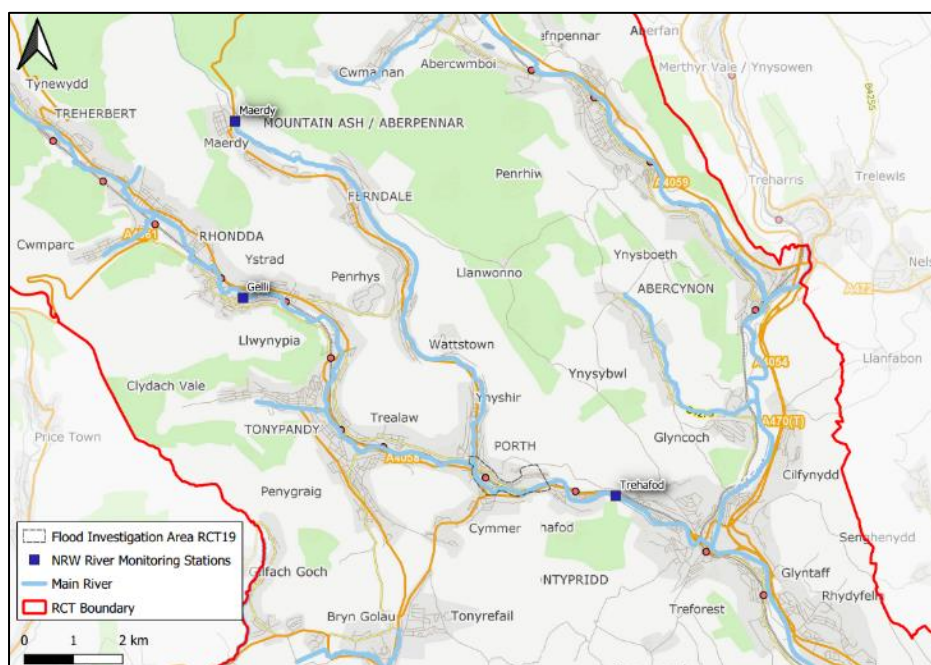
The Rhondda Fach and Fawr Rivers also reached unprecedentedly high levels at both the Maerdy and Gelli monitoring stations (both operated by NRW), highlighting that both the Rhondda Fach and Fawr catchment experienced significant rainfall and subsequent record-breaking river levels during Storm Dennis (Table 3). The location of NRW's monitoring stations in relation to the investigation area are illustrated in Figure 24.

**Figure 24:** NRW River Level Monitoring Stations along the Rhondda Fawr and Fach Rivers

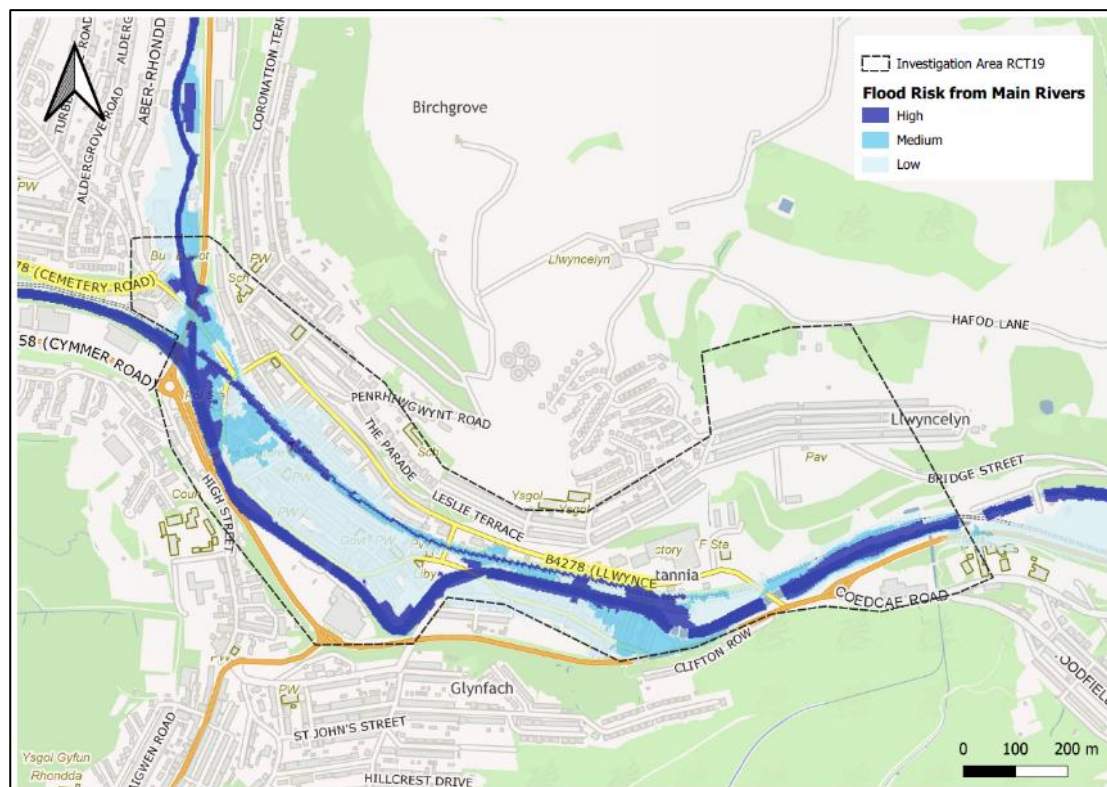
Figure 25 is an excerpt from NRW's Flood Risk Assessment Wales (FRAW) mapping exercise which depicts the main river flood risk extents for the 'Defended' scenario, i.e., with the presence of flood defence infrastructure. The darker shading identifies areas at higher risk of flooding (more frequent/less extreme rainfall events) and lighter shading showing the lower risk areas (less frequent/more extreme rainfall events).

The flooding that occurred within RCT19 during Storm Dennis is largely consistent with the modelled outputs of NRW's FRAW map (Figure 25), with the majority of the impacted properties falling within an area of high and medium risk of fluvial flooding. A high risk of flooding means that an area has a chance of flooding of greater than 1 in 30 (3.3%) each year; a medium risk of flooding signifies a yearly chance of flooding between 1 in 100 (1%) and 1 in 30 (3.3%); meanwhile a low risk of flooding means that an area has a chance of flooding between 1 in 1000 (0.1%) and 1 in 100 (1%) each year.

**Figure 25:** NRW's FRAW map for River sources at RCT19. Contains Natural Resources Wales information © Natural Resources Wales and database right. All rights reserved.

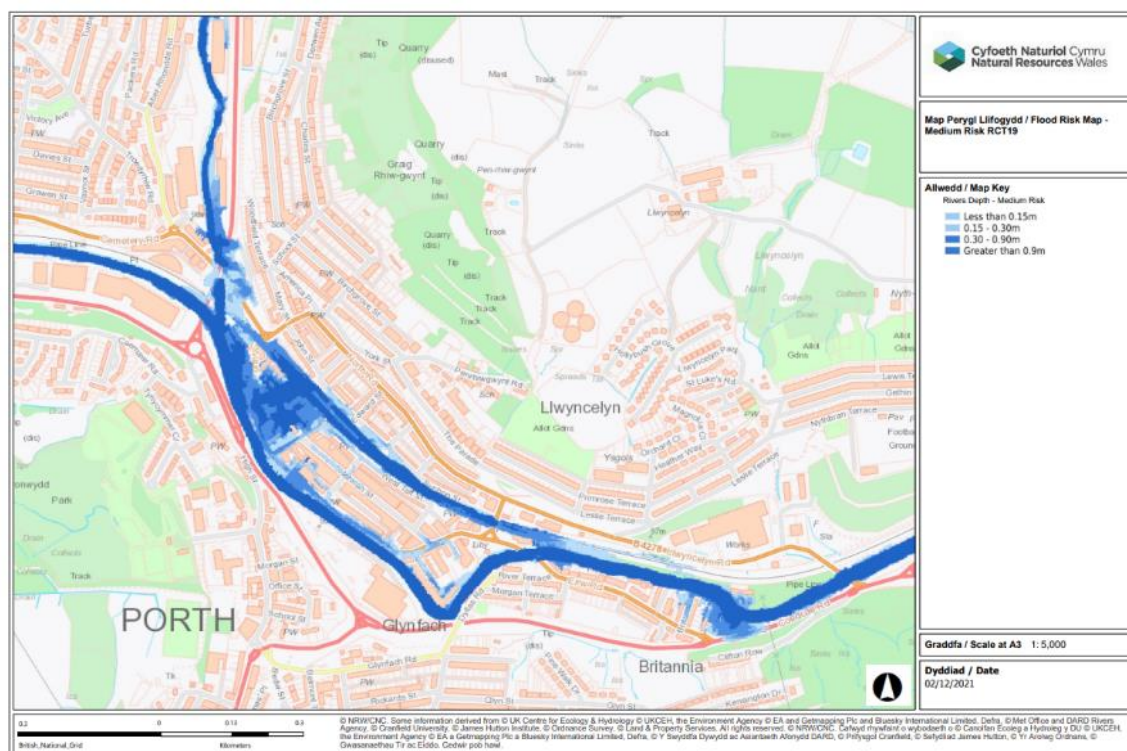
The worst affected areas of Porth, including Eirw Road, Brook Street and Britannia Street reported flood depths of up to 1.5 metres, which is also consistent with NRW's Flood Hazard maps which illustrate the modelled flood depth predictions for a medium risk flood event (Figure 26).

**Figure 26:** NRW's National Hazard map for Medium Risk River Flood Depth in RCT19. Contains Natural Resources Wales information © Natural Resources Wales and database right. All rights reserved.

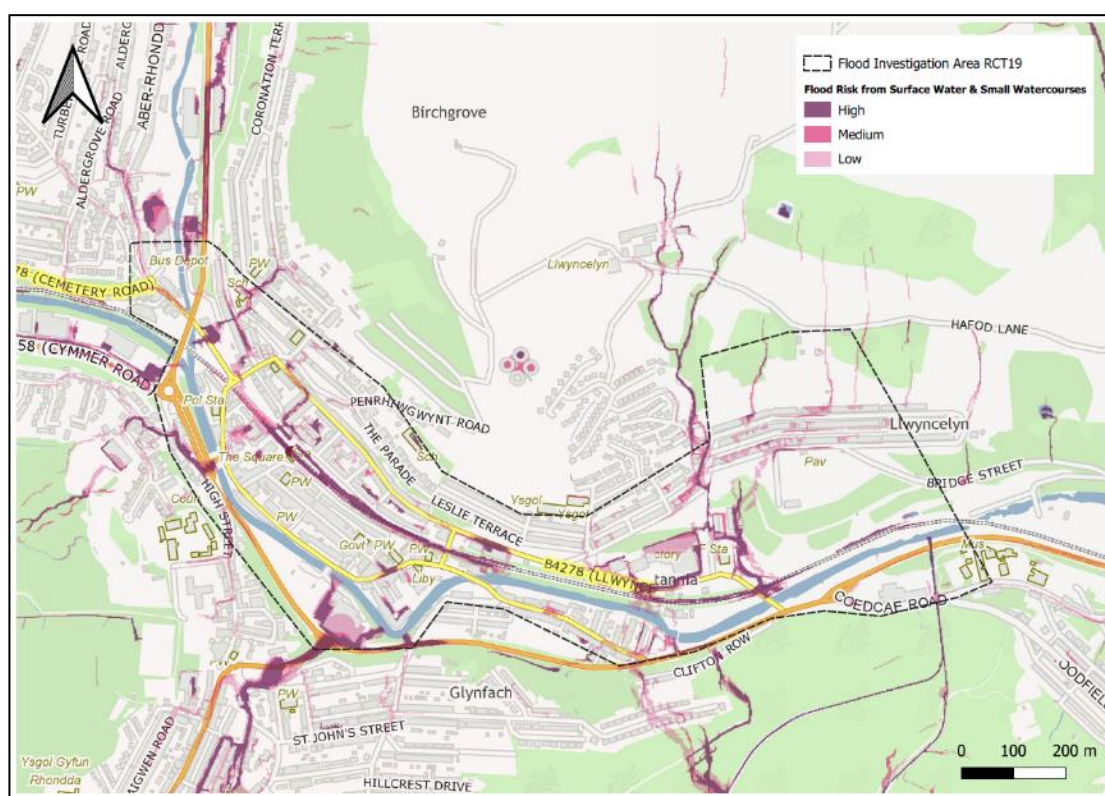
The pathways for surface water flooding during the storm event was observed primarily along the highway network. It should be noted that the exact flow routes have not been confirmed due to limited anecdotal evidence regarding the isolated incidences which occurred during the storm event however, NRW's national surface water and ordinary watercourse flood map (Figure 29) provides a reasonable indication of the pathways and areas of surface water flooding that would have occurred during Storm Dennis.

**Figure 29:** NRW's FRAW map for surface water and ordinary watercourse sources in RCT19. Contains Natural Resources Wales information © Natural Resources Wales and database right. All rights reserved.

Figure 29 identifies the impacted properties on Birchgrove Street, High Street, North Road and Coedcae Road to fall within areas of high to low surface water flood risk. In most cases, the surface water flooding at RCT19 was primarily caused by intense

Surface water is also considered to have contributed to the ordinary watercourse and main river flooding experienced within the lower reaches of Porth, particularly along Rheola Road, the B4278 (Llwncelyn Road) and Llwncelyn Industrial Estate, where water naturally accumulates, as depicted in Figure 29.
