Flood and Water Management Act 2010

Section 19 Flood Investigation Report

Storm Dennis –
Flood Investigation Area RCT20
(Ynyshir)

March 2022

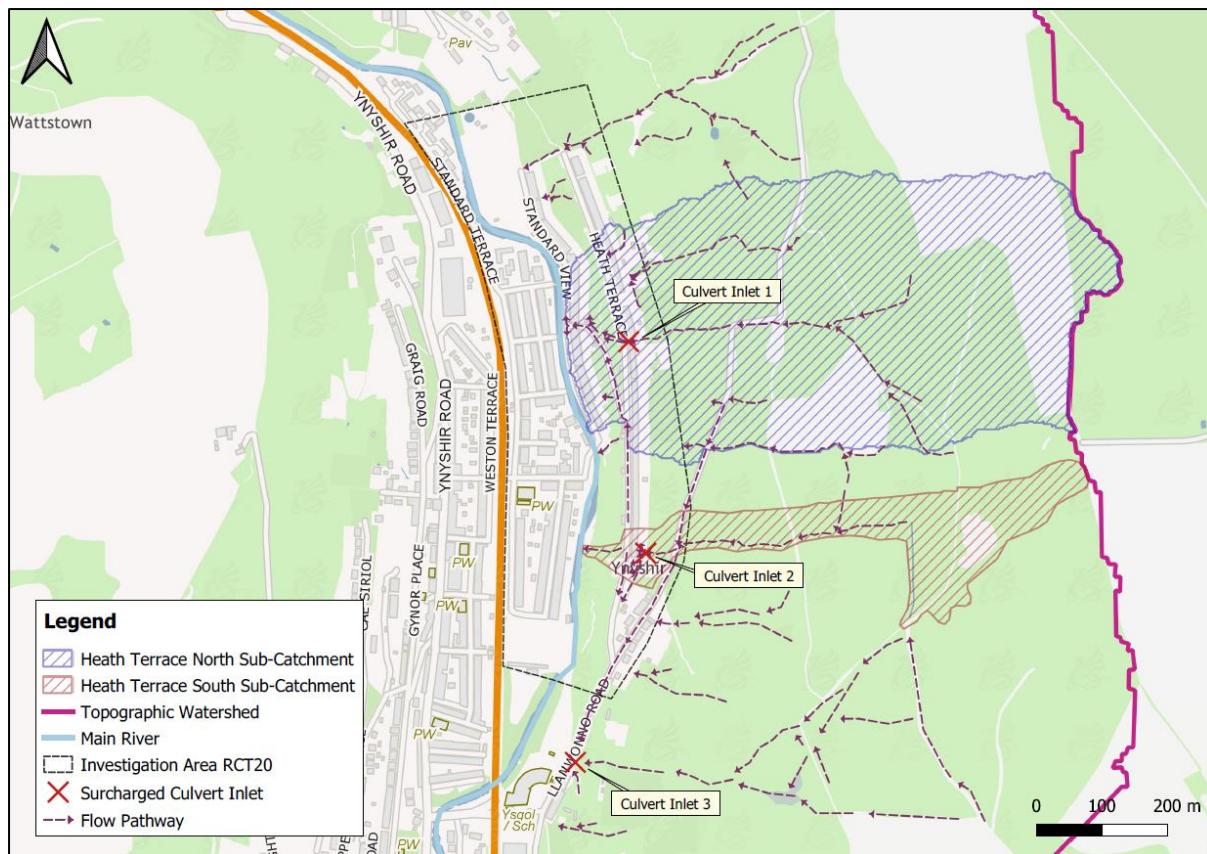
Figure 5: Flow pathways and surcharged culvert inlets within investigation area RCT20 during Storm Dennis

As depicted in Figure 5, surface water flows originating from the steep eastern hillsides and conveying via a series of unnamed ordinary watercourses contributed to the surcharging of two culvert inlets within RCT20, labelled 'Culvert Inlet 1' within the Heath Terrace North sub-catchment and 'Culvert Inlet 2' within the Heath Terrace South sub-catchment. A further culvert inlet to the south of the investigation area, labelled 'Culvert Inlet 3', also surcharged during the storm event however, no flooding to properties was reported as a result.

Pluvial flows from the wider valley catchment caused significant scour of the hillside, subsequently resulting in the transportation of debris within the hillside's ordinary watercourses. As the watercourses conveyed into the investigation area, debris was deposited at several culvert inlet trash screens, leading to blockage and the surcharging of two culvert inlets at Heath Terrace and a further culvert inlet at Llanwonno Road.

The surcharging of a 'Culvert Inlet 2' associated to the Heath Terrace South sub-catchment (Figure 5) was reported by residents on the 16th February 2020. Figure 6,

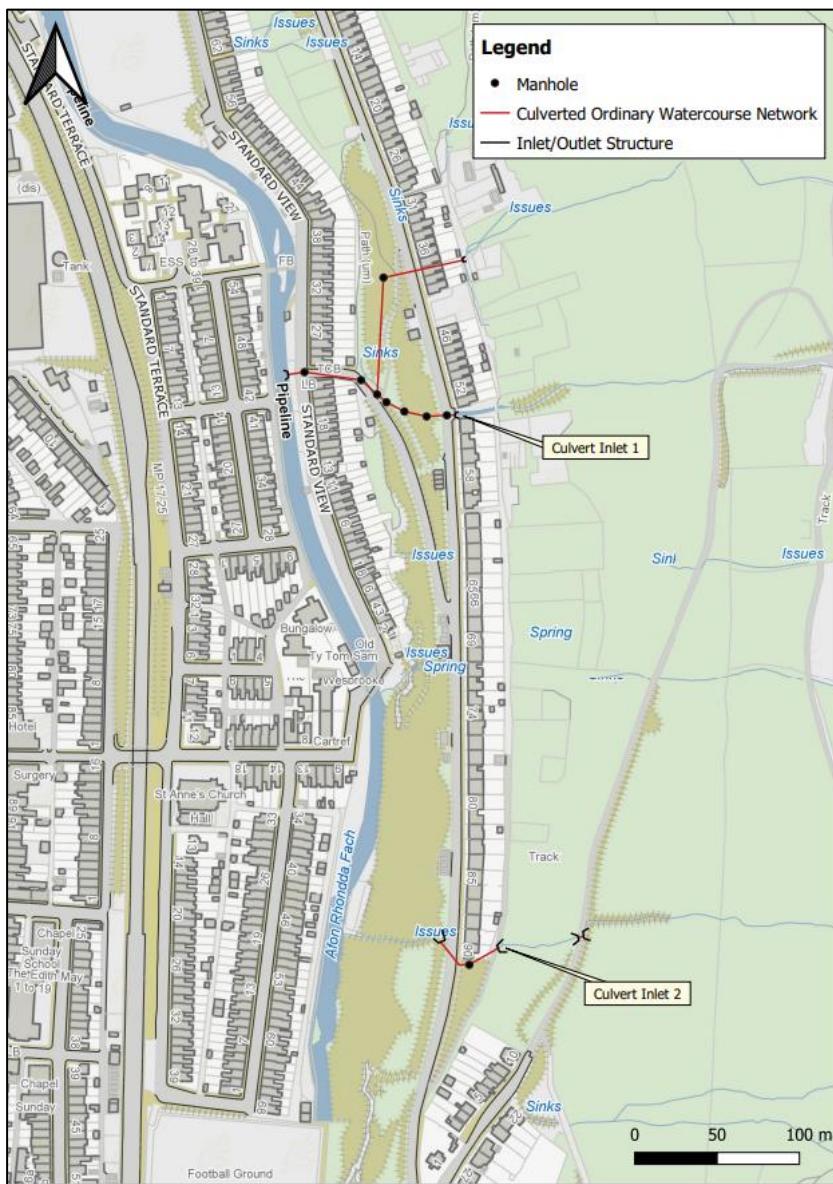
Figure 10: Surveyed culverted ordinary watercourse networks within investigation area RCT20

Two culverted ordinary watercourse networks associated to the two culvert inlets identified as sources of flooding within RCT20, 'Culvert Inlet 1 and 2', were inspected by RCT's Flood Risk Management team and the Council's Highways and Streetcare Depot following the flood event to assess their condition. CCTV survey inspections of both culvert network were also undertaken to ascertain both the operational condition of the network, and its structural integrity along sections of network. Both networks are depicted in Figure 10.

The culvert networks downstream of 'Culvert Inlet 1 and 2' were surveyed in July 2020 following Storm Dennis. Both networks were identified as being in acceptable condition with limited structural defects and settled deposits, indicating that blockages to both inlet structures caused by debris was the primary cause of surcharge during Storm Dennis.

Based on the above, the culvert conditions are not considered to have significantly contributed to the recorded flooding of properties in RCT20 during Storm Dennis as the present obstruction was associated with the culvert inlet, rather than the culvert network itself.

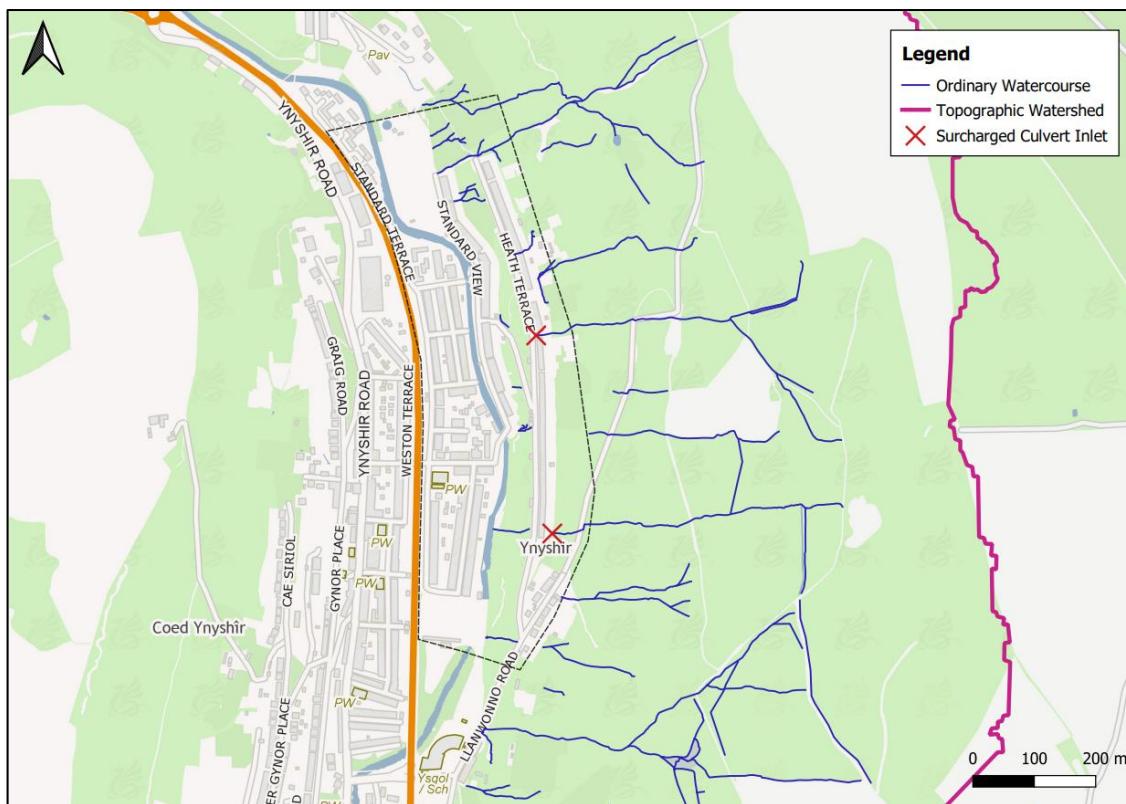
Figure 12: Map of Ordinary Watercourses which feed into investigation area RCT20

Several sections of natural ditches and unnamed ordinary watercourses which drain the steep catchment above Ynyshir are identified to flow through the investigation area and into the culvert networks discussed in Section 3.1. The unnamed ordinary watercourses have been illustrated in Figure 12.

On review of the unnamed ordinary watercourses above the investigation area, several indications of scour across the hillside were observed. The evidence suggests that intense rainfall and resultant surface water and ordinary watercourse flows caused severe erosion of the natural channels, leading to a significant displacement of debris, and sediment transportation within the watercourse itself, which conveyed towards 'Culvert Inlet 1 and 2' during the storm event.

The ordinary watercourses upstream of 'Culvert 1 and 2' are partially culverted beneath the track that runs up the hillside above RCT20 (Llanwonno Road). It was observed upon inspection that the culverted sections had become overwhelmed during the storm event, resulting in ordinary watercourse flows flowing overland and leading to increased erosive forces along the track and hillside. The figures below show evidence of debris deposition across the track, out-of-bank flows and eroded embankments, indicative of the significant flows travelling down the hillside towards the investigation area during the storm event.

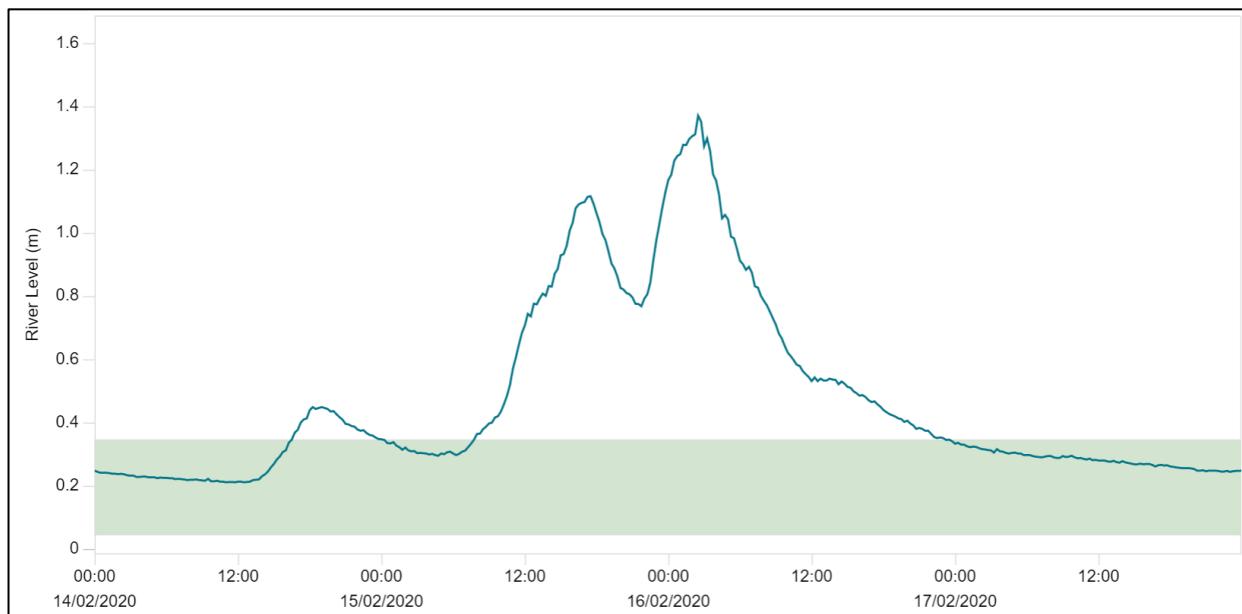
Figure 17: The Rhondda Fach River levels at Maerdy station between the 14th and 17th February 2020 (Natural Resources Wales)

The hydrograph in Figure 17 illustrates the rapid rise in levels of the Rhondda Fach River in response to rainfall, with the Rhondda Fach River at NRW's Maerdy station reaching its second highest recorded peak of 1.371 metres at 02:30am (16th February).

The green bar displayed on the hydrograph (Figure 17) shows the typical level of the Rhondda Fach River at Maerdy station, ranging between 0.05 and 0.35 meters. At its peak, the Rhondda Fach River was over a meter higher than its average level, stressing the extreme and unprecedented levels that RCT's rivers rose to during the storm's peak intensity.

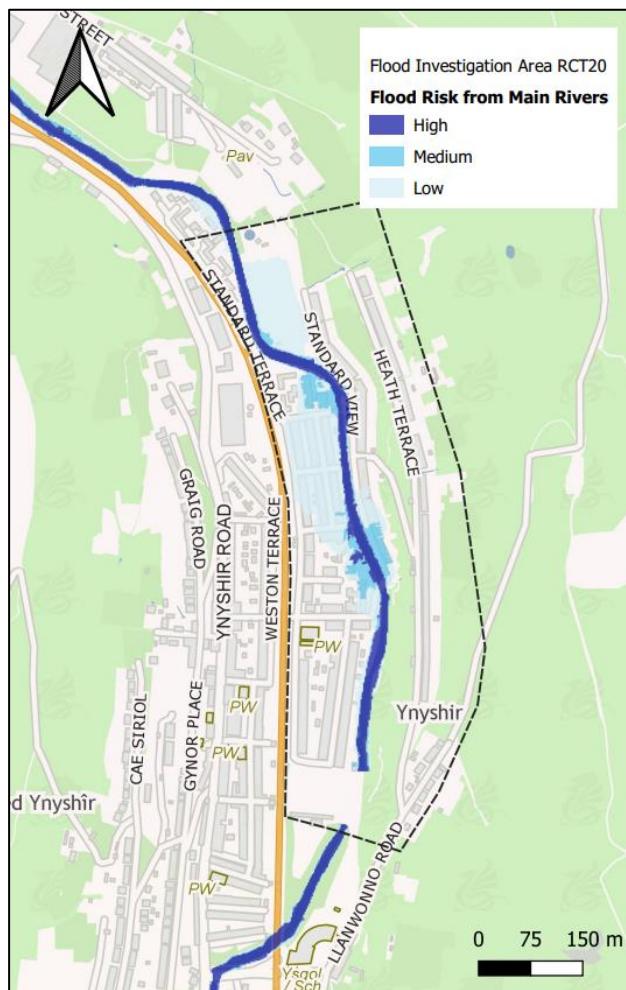
Figure 19: NRW's FRAW map for River sources in RCT20. Contains Natural Resources Wales information © Natural Resources Wales and database right. All rights reserved.

The flooding that occurred within RCT20 during Storm Dennis is largely consistent with the modelled outputs of NRW's FRAW map (Figure 19), with the majority of the impacted areas within RCT20 falling within an area of medium and low risk of fluvial flooding. A small area of high main river flood risk is also present along the western embankment at Riverside Close.

A high risk of flooding means that an area has a chance of flooding of greater than 1 in 30 (3.3%) each year; a medium risk of flooding signifies a yearly chance of flooding between 1 in 100 (1%) and 1 in 30 (3.3%); meanwhile a low risk of flooding means that an area has a chance of flooding of between 1 in 1000 (0.1%) and 1 in 100 (1%) each year. Considering Storm Dennis has been estimated as a 1 in 200 annual probability (Q200) flood event, the area of flooding aligns with those depicted by the medium main river flood risk extent (Figure 19).

Flooding up to 1 metre was observed across the worst affected streets at RCT20, including at Riverside Close and Avon Terrace. It is however notable that areas of medium main river flood risk upstream of the worst affected streets did not experience internal flooding during Storm Dennis, such as adjacent to the footbridge between Standard View and Springfield Estate.

This suggests that, whilst unprecedented river levels were recorded in the Rhondda Fach River during Storm Dennis, the primary cause of the overtopping at RCT20 was the obstruction of the river flow caused by woody debris at the highway bridge connecting Avon Terrace and Station Road. This obstruction created a damming effect which resulted in the River Rhondda Fach overtopping its bank upstream.

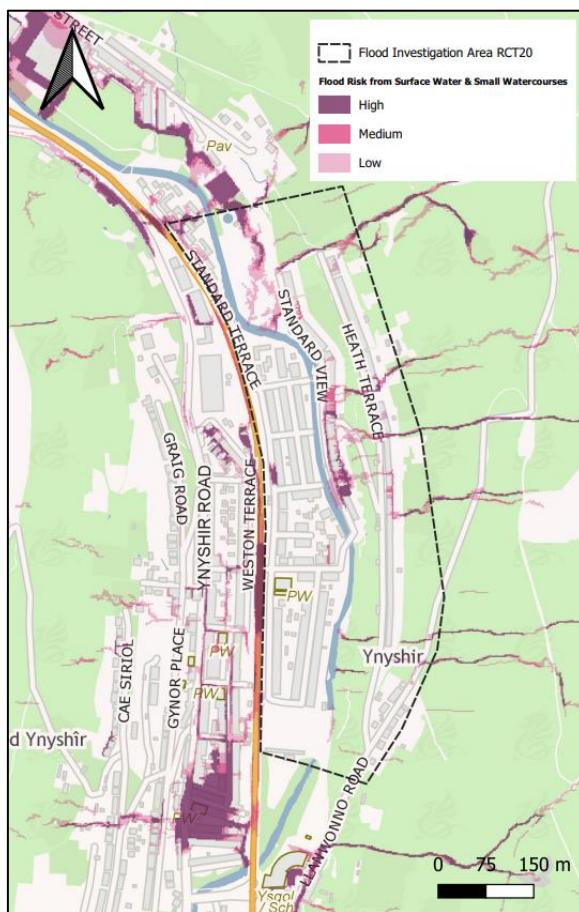
Figure 23: NRW's FRAW map for surface water and ordinary watercourse sources within RCT20.
Contains Natural Resources Wales information © Natural Resources Wales and database right. All rights reserved.

Surface water flows generated by intense rainfall across the hillside to the east of the investigation area and conveying via local topography and the highway network is considered to be a contributing source of flooding to properties within the lower reaches of Ynyshir, particularly along Standard View and Avon Terrace, where water naturally accumulates.

NRW's surface water and ordinary watercourse flood map (Figure 23) depicts the higher risk of flooding from pluvial sources within those lower reaches. Despite main river flooding being identified as the primary cause of flooding to properties within the lower reaches of RCT20, surcharging flows from 'Culvert Inlet 1 and 2' above Heath Terrace are considered to have contributed to the surface water accumulation along these streets, which was unable to drain away via surface water drainage systems during the storm event.
