Section 19 Flood Investigation Report

Flood Investigation Area RCT21
(Blaenllechau & Ferndale)

October 2022

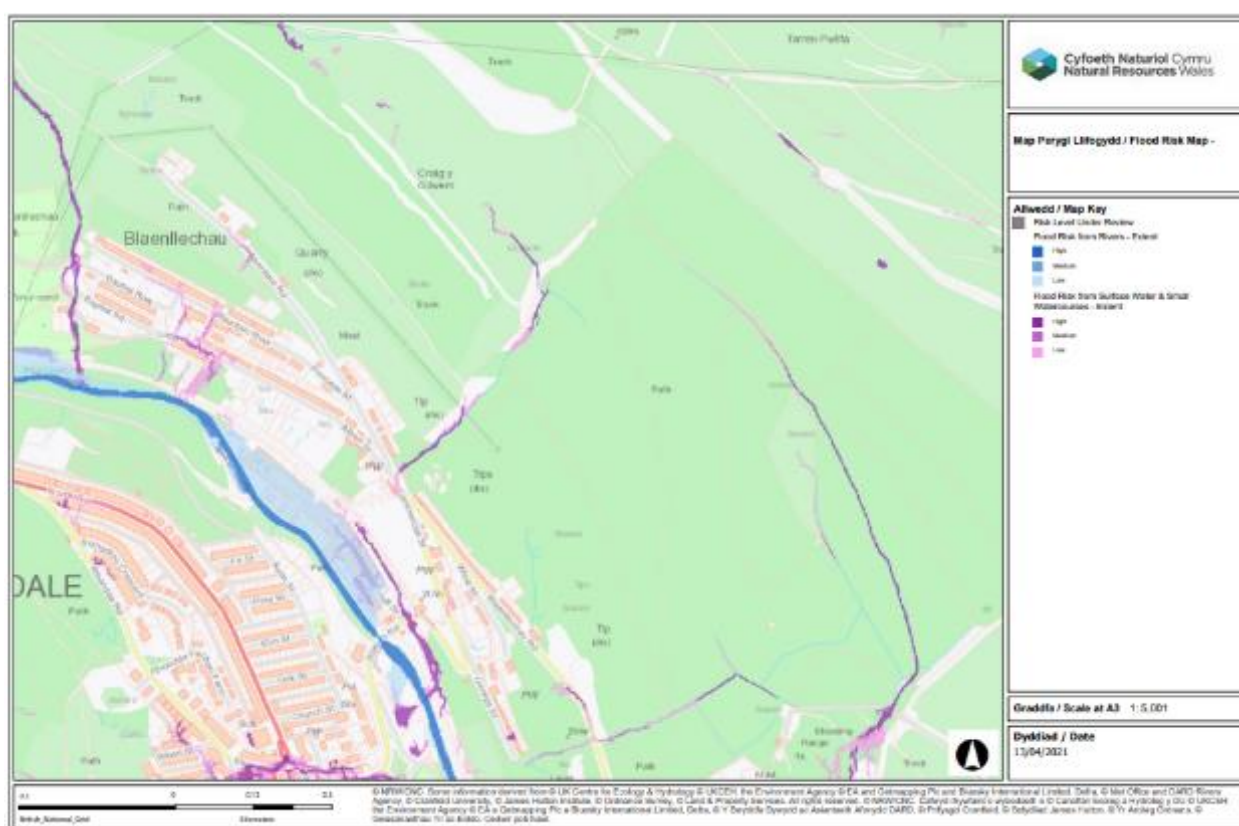
Figure 2: Natural Resources Wales' Flood Risk Assessment Wales (FRAW) map for rivers and ordinary watercourse and surface water flood risk at investigation area RCT21. Contains Natural Resources Wales information © Natural Resources Wales and database right. All rights reserved.

Based on NRW's Flood Risk Assessment Wales (FRAW) map presented in Figure 2, the investigation area is identified as an area of relatively low to medium flood risk sourced from the potential surcharge of culvert inlets but primarily flood risk is associated with breached banks of the Rhondda Fach River to the south of Blaenllechau.

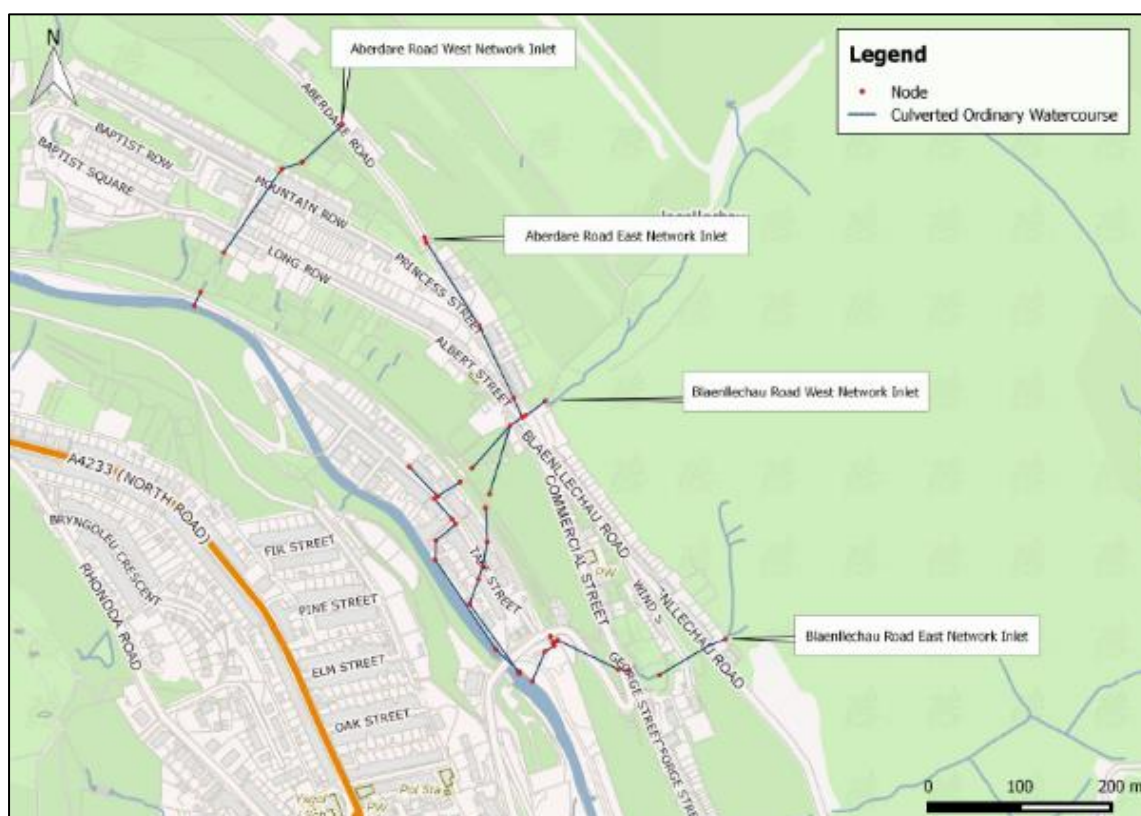
Figure 5: Surveyed culverted ordinary watercourse networks within flood investigation area RCT21

Four culverted ordinary watercourse networks were identified within the investigation area. Figure 5 depicts the location of these four networks. Aberdare Road West and East inlets are identified as the responsibility of Natural Resources Wales on behalf of Welsh Government as the landowner of the Welsh Government Woodland Estate (WGWE), whilst the Blaenllechau Road East and West inlets are identified as the responsibility of two private individual landowners.

All four culvert networks were inspected and surveyed by a Council appointed contractor following Storm Dennis, to ascertain both the operational condition of the network, and its structural integrity along sections of the network. The culvert inspections highlighted several sections of the culvert drainage systems in RCT21 that are in poor condition, however it is not possible to say whether its poor condition was as a result of the storm event. In response, a cleansing operation of the four culvert networks was carried out post flood event to remove the settled deposits identified within the networks, particularly within the downstream sections. Approximately 46 tonnes of material was removed during these operations.

The FIR notes that the culvert inlets however were not significantly affected by Storm Dennis, with no evidence of significant blockage or damages to the structures identified during post event inspections. This result correlates with the anecdotal evidence supplied by RCT's Flood Risk Management inspectors, as well as residents accounts and photo evidence showing very clearly that the dominant flood mechanism during Storm Dennis was groundwater and overland flow entering properties from the hillside above Blaenllechau.

Based on the location of the flooded properties and the flow paths, the culvert conditions of the four identified networks are not considered to have significantly contributed to the recorded flooding of properties in investigation area RCT21 during Storm Dennis.

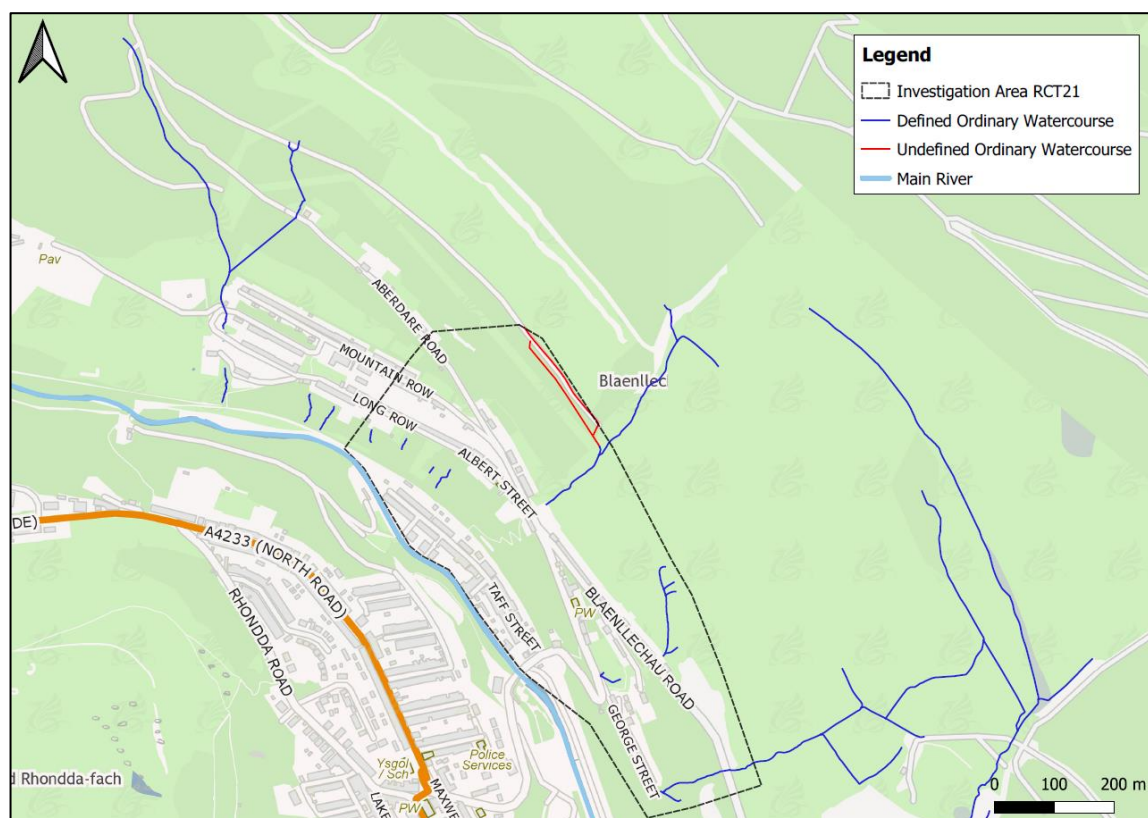
Figure 6: Map of defined and undefined ordinary watercourses which flow through Investigation Area RCT21

Several unnamed ordinary watercourses which drain the steep catchment above Blaenllechau are identified to flow through the investigation area, as illustrated in Figure 6. A number of these watercourses are undefined due to the steepness of the catchment being drained.

On review of the available information there is a limited amount of dedicated and defined ordinary watercourse channels identified within the investigation area. This is considered to result in a large proportion of the catchment above RCT21 draining overland during heavy rainfall and following natural and manmade contours as opposed to draining via defined ordinary watercourse channels.

The assessment identified undefined ordinary watercourse channels / land drainage channels across parts of the forestry track (highlighted red in Figure 6) which are considered to manage the overland flows from the hillside and covey into the defined ordinary watercourse which is culverted beneath Commercial Street (highlighted blue in Figure 6).

Upon engagement with NRW as land estate manager of the WGWE, it was confirmed that remedial works were undertaken to improve the capacity of the undefined ordinary watercourse / land drainage channel on the topside of the forestry track following Storm Dennis, in August 2020. Figure 7 illustrates the condition of the drainage channel post excavations works.

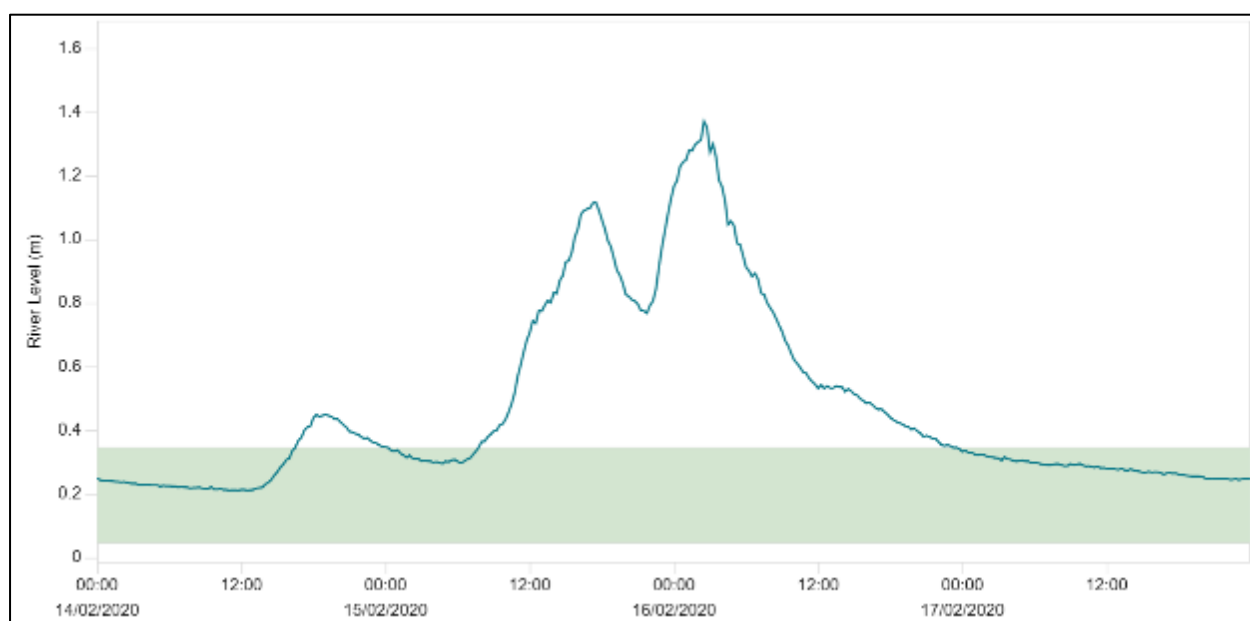
Figure 10: The Rhondda Fach River levels at Maerdy station between the 14th and 17th February 2020 (Natural Resources Wales)

The hydrograph in Figure 10 illustrates the rapid rise in levels of the Rhondda Fach River in response to rainfall, captured at NRW's Maerdy station. The Rhondda Fach River at Maerdy reached its second highest peak ever recorded at 02:30am (16th February), reaching 1.371 meters.

The green bar displayed on the hydrograph shows the typical level of the Rhondda Fach River at Maerdy station, ranging between 0.05 and 0.35 meters. At its peak, the Rhondda Fach River was over a meter higher than its average level, stressing the extreme and unprecedented levels that RCT's rivers rose to during the storm's peak intensity.

There is no evidence from this investigation to suggest that the Rhondda Fach River contributed to the recorded flooding of properties in investigation area RCT21 during Storm Dennis.

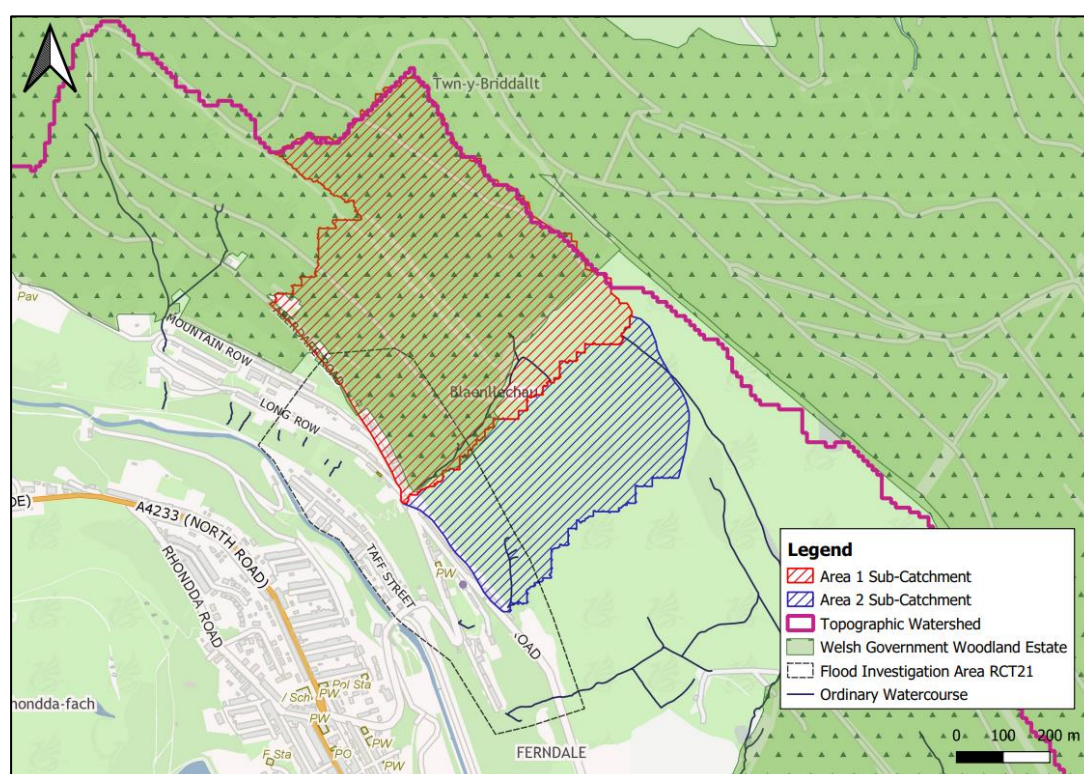
Figure 13: Welsh Government Woodland Estate boundary within the upper catchment above investigation area RCT21. Sub-catchment areas 1 and 2 have been highlighted.

The area of land that drains towards investigation area RCT21 can be divided into two sub-catchment areas as shown in Figure 13. Both areas of hillside are separated by an unnamed ordinary watercourse which is culverted beneath Commercial Street.

The majority of 'Area 1' forms part of the Welsh Government Woodland Estate (WGWE) which is owned by the Welsh Government and managed by NRW. This area of hillside drains towards the rear of Aberdare Road, to the northwest of RCT21, where 3 properties were impacted by flooding. 'Area 2', to the northeast of RCT21, drains towards Blaenllechau Road and is owned and maintained by a private landowner. 17 residential properties were impacted during Storm Dennis at Blaenllechau Road.

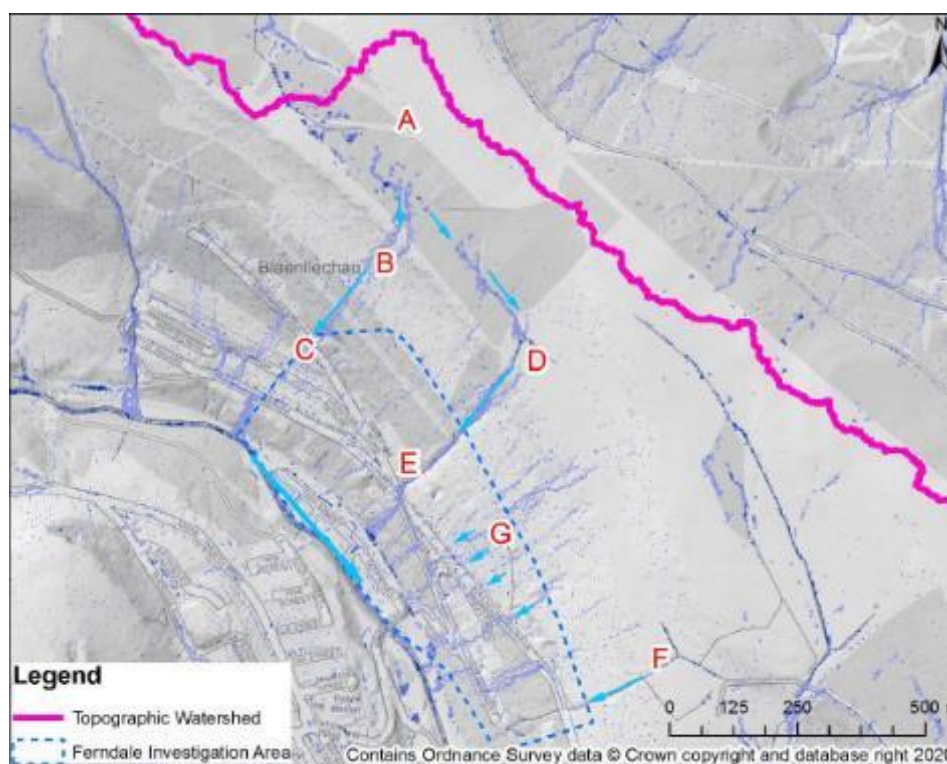
Figure 14: Detailed flow route of the catchment. Flow path 1 (A-B-C) and flow path 2 (A-D-E).
Produced by Redstart's FIR.

On review of the area of land that would expect to drain towards Aberdare Road, there is potential for complex flow routing. LIDAR based hydrodynamic assessments produced by Redstart's FIR identify two significant pathways which are outlined below and illustrated within Figure 14:

The analysis shows that both flow routes are valid for this part of the catchment and the route taken is dependent on the rate of flow. Lower flows were shown to be intercepted by the ridge and follow flow path 2 (A-D-E), with larger exceedance flows routing over the ridge following flow path 1 (A-B-C).

Based on the intensity of rainfall during Storm Dennis, and in review of the observed flow paths described by residents, it is inferred that flow path 1 was the primary pathway at 'Area 1', i.e., surface water runoff travelling overland down the hillside rather than atypically via the ordinary watercourses. The increase in overland runoff is also considered to have saturated the hillside, contributing to the observed groundwater flooding.

Overland flow from the steeper sections of the valley side (area G on Figure 14) is also identified as a pathway of flooding during the storm event, resulting in surface water flows towards Blaenllechau Road. These flows are sourced by the area of hillside to the east of the investigation area, labelled 'Area 2' in Figure 13, which falls under private ownership.

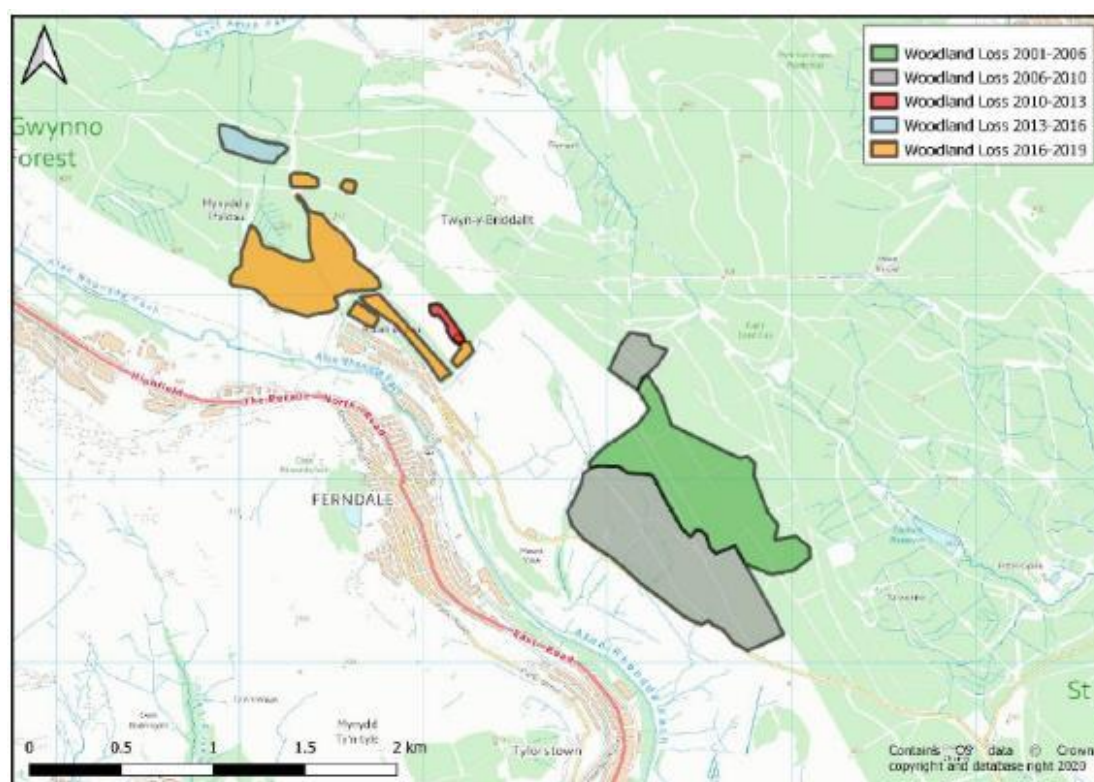
Figure 16: Digitised woodland loss between 2001 and 2018 based on Google earth data

The area of land to the northwest of the investigation area forms part of the Welsh Government Woodland Estate (WGWE) which is owned by the Welsh Government and managed by NRW. Areas of woodland within NRW's Forestry estate to the north and east of Ferndale have been felled since 2001 based on evidence presented by Redstart's FIR. The woodland loss has been digitised based upon the observed woodland loss in Google Earth and tree cover loss with greater than 10% canopy based upon data analysed from global forest watch⁵. The combination of datasets is depicted within Figure 16 and confirms that areas of woodland above the investigation area has been felled during the last five years.

Forests and woodlands can have an impact on flooding in multiple ways; trees reduce sediment runoff and forests and woodlands typically produce less runoff than other land uses such as farms and grasslands; the removal of canopy cover increases the rate and volume of runoff of surface water due to the reduction in rainfall interception; and furthermore, felling activity can involve large mechanical plant to fell and transport the material causing disturbances and alterations to local landscape. The choice of
