Flood and Water Management Act 2010

Section 19 Flood Investigation Report

Storm Dennis –
Flood Investigation Area RCT14

January 2022

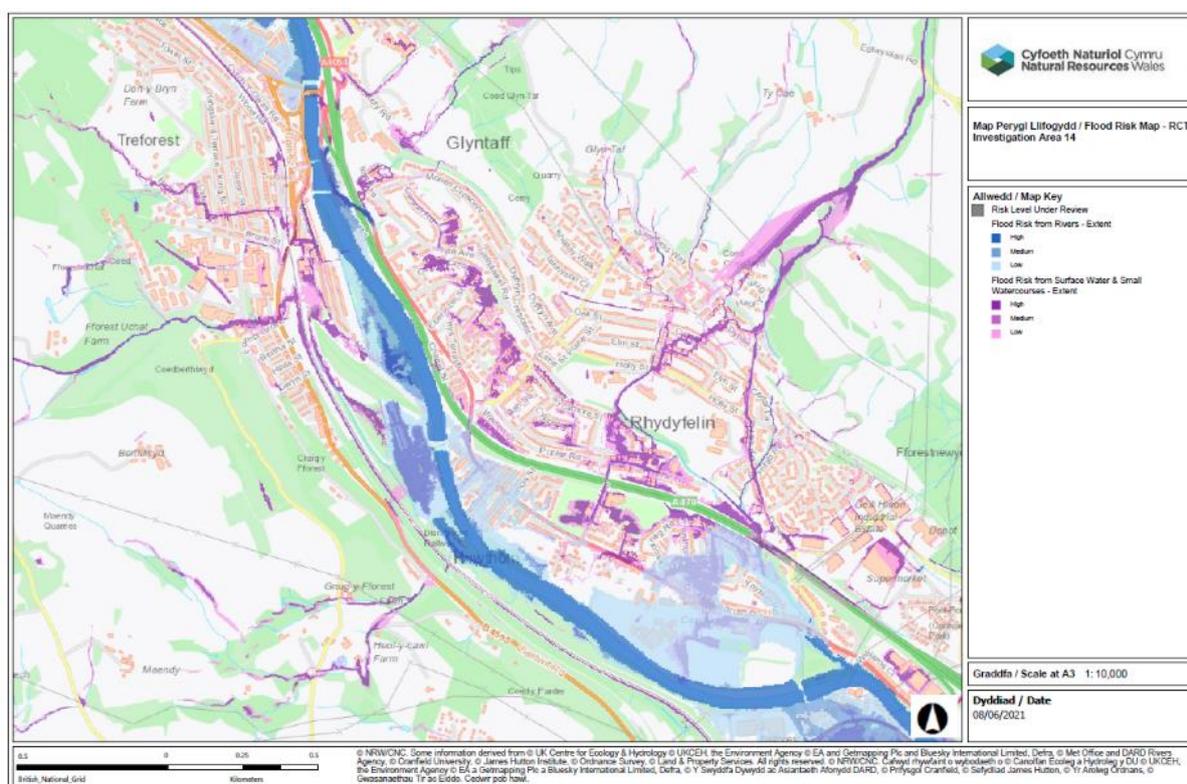
Figure 2: Natural Resources Wales' Flood Risk Assessment Water (FRAW) map for rivers and ordinary watercourse and surface water flood risk at investigation area RCT14. Contains Natural Resources Wales information © Natural Resources Wales and database right. All rights reserved.

RCT14 sits primarily on the eastern floodplains of the River Taf, with low to high fluvial flood risk sourced by the main river present across much of the investigation area. Flood risk from surface water and ordinary watercourse sources is also noted within parts of the investigation area, as illustrated in Figure 2. This is broadly associated with bank breaches of the unnamed watercourses which drain the north of the site, as outlined within RCT's FRMP³. Within some areas adjacent to the main river, it is considered that people may be at risk from both surface water flooding and main river flooding.

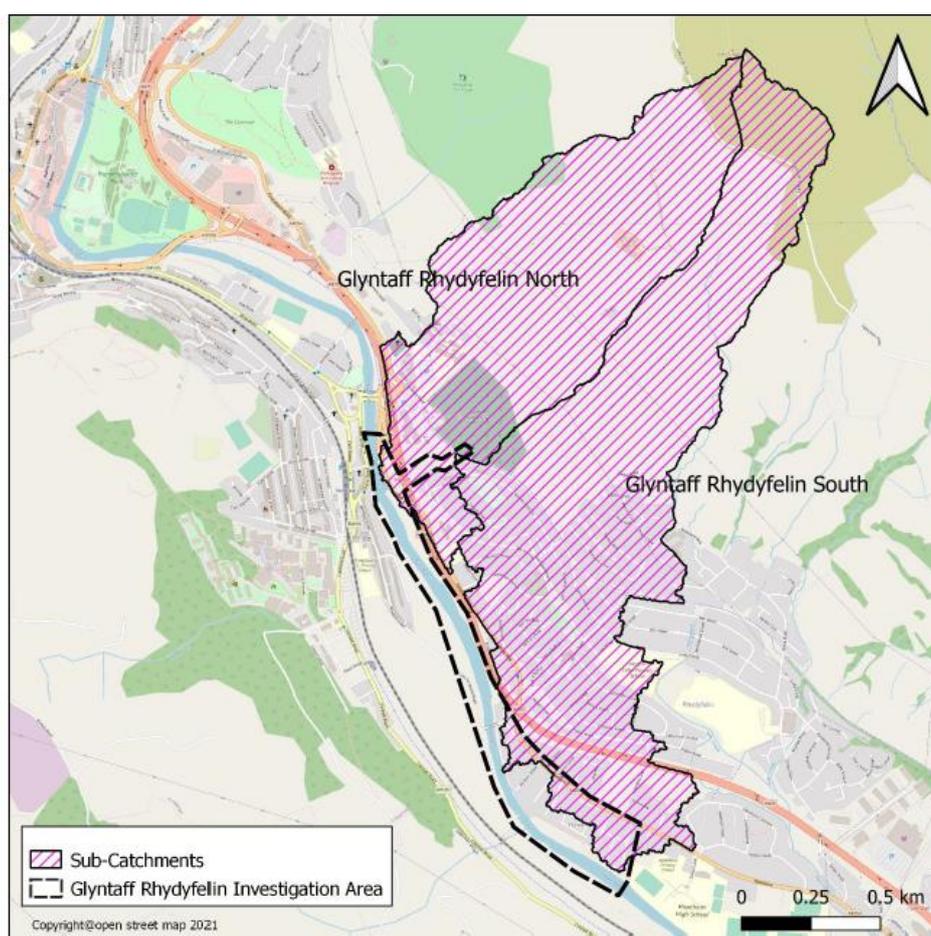
Figure 3: Flood Investigation Area RCT14 Sub-Catchments

For the purpose of this investigation, the flood incident at investigation area RCT14 will be described in three parts: the flood incident at ‘Glyn-taf Rhydyfelin North’ (sub-catchment 1), the flood incident at ‘Glyn-taf Rhydyfelin South’ (sub-catchment 2) and the flood incident on the western bank of the River Taf.

Glyn-taf Rhydyfelin North is an area of approximately 97 hectares that originates at the River Taf and extends northeastwards (Figure 3). All areas of the surrounding hillside that form the northern sub-catchment drain towards the main river.

Glyn-taf Rhydyfelin South sub-catchment covers an area of approximately 140 hectares across the east and southeast of the study area and also includes areas of the surrounding hillside that drain towards the River Taf (Figure 3).

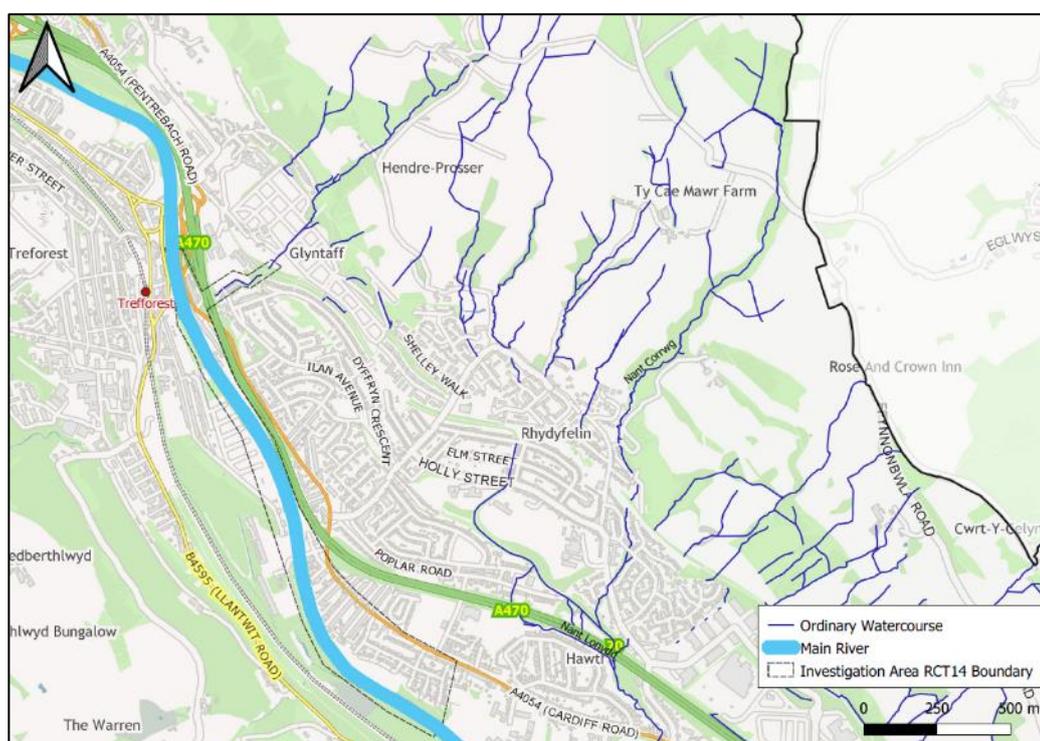
Figure 11: Map outlining main river and ordinary watercourse locations throughout RCT14 and the surrounding region.

Whilst there are several unnamed watercourses within the upper catchment of the investigation area, many of these watercourses convey into the Nant Corrwg and Nant Lonydd before discharging into the River Taf (highlighted in Figure 11). These watercourses and their tributaries fall outside of the investigation area.

There is no evidence to suggest that the ordinary watercourses outlined in Figure 11 contributed to the flooding experienced in RCT14 during Storm Dennis.

The designated main River Taf flows in a southeasterly direction through Glyn-taf, Rhydyfelin and Hawthorn (Figure 11). Areas on both the western and eastern embankments of the River Taf were impacted during Storm Dennis.

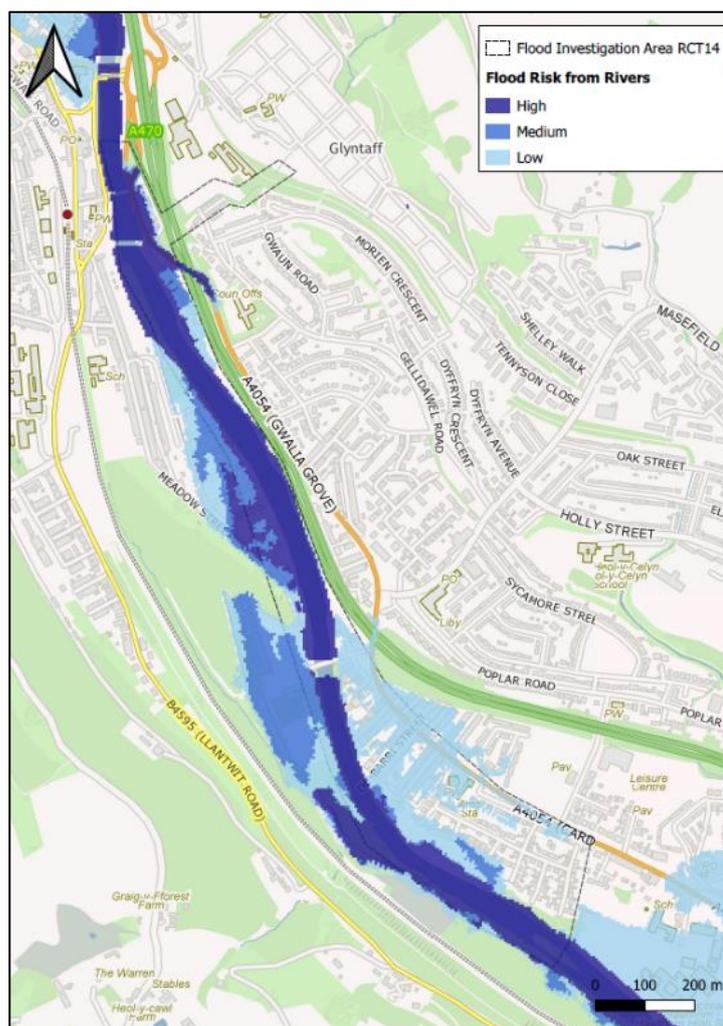
Figure 13: Natural Resources Wales' Flood Risk Assessment Wales (FRAW) map for River sources. Contains Natural Resources Wales information © Natural Resources Wales and database right. All rights reserved.

Figure 13 is an excerpt from NRW's Flood Risk Assessment Wales (FRAW) mapping exercise which depicts the main river flood extents for the 'Defended' scenario, i.e., with the presence of flood defence infrastructure. The darker shading identifies areas at higher risk of flooding (more frequent/less extreme rainfall events) and lighter shading showing the lower risk areas (less frequent/more extreme rainfall events).

The flooding that occurred within RCT14 during Storm Dennis is largely consistent with the modelled outputs of NRW's FRAW map (Figure 13), with the majority of investigation area RCT14 identified at high and medium risk of fluvial flooding.

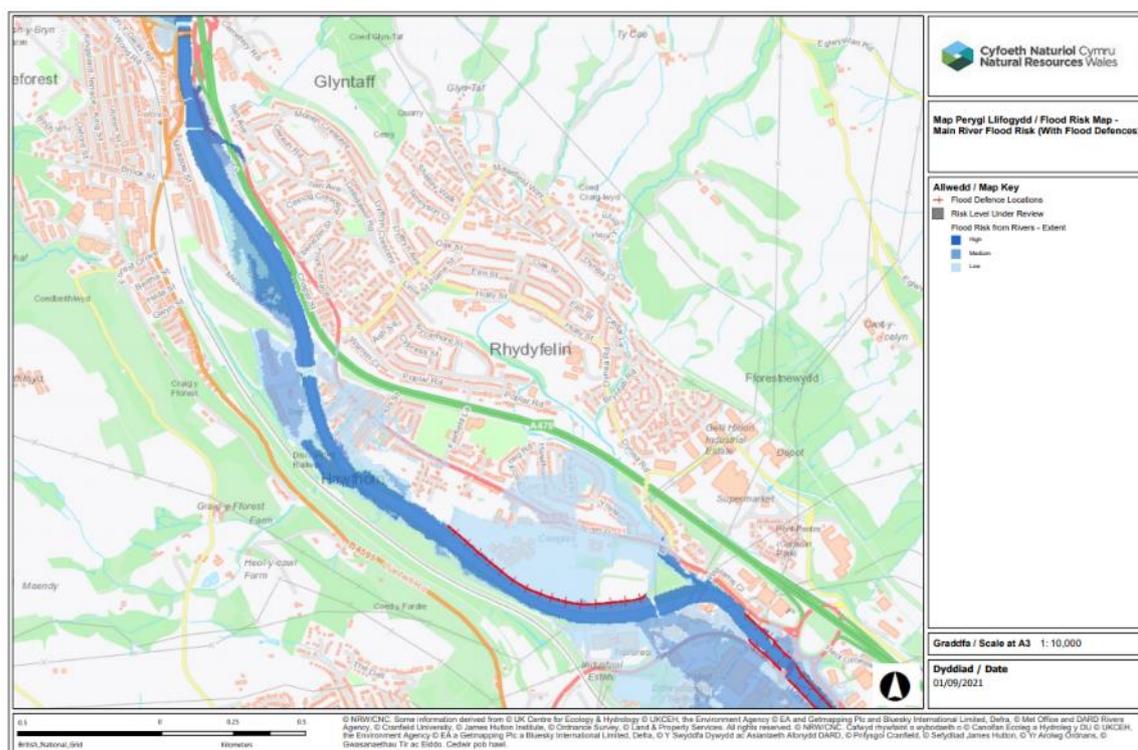
Figure 16: Natural Resources Wales' Flood Risk Assessment Wales (FRAW) map for River sources, including flood defence locations at investigation area RCT14. Contains Natural Resources Wales information © Natural Resources Wales and database right. All rights reserved.

There are no formally designated flood defences along the River Taf at investigation area RCT14, i.e., there are no flood defences operated or maintained by NRW. The closest flood defence, demarcated on Figure 16 by a bold red line, is immediately downstream of Alexon Way at the southern extent of the investigation area boundary.

Figure 16 illustrates the reduction in flood risk that derives from the presence of a flood defence structure, with the defended area of Hawthorn identified at low risk of main river flooding in comparison to areas of Glyn-taf and Rhydyfelin upstream that are identified at high and medium risk of fluvial flooding.

NRW's 'Flood Incidence Response Review'⁴ does in fact outline that no flood defences failed in the lower Taf region and that the flooding was the result of river flows exceeding the construction design standard.
