Flood and Water Management Act 2010

Section 19 Flood Investigation Report

Storm Dennis – Flood Investigation Area RCT27

November 2021

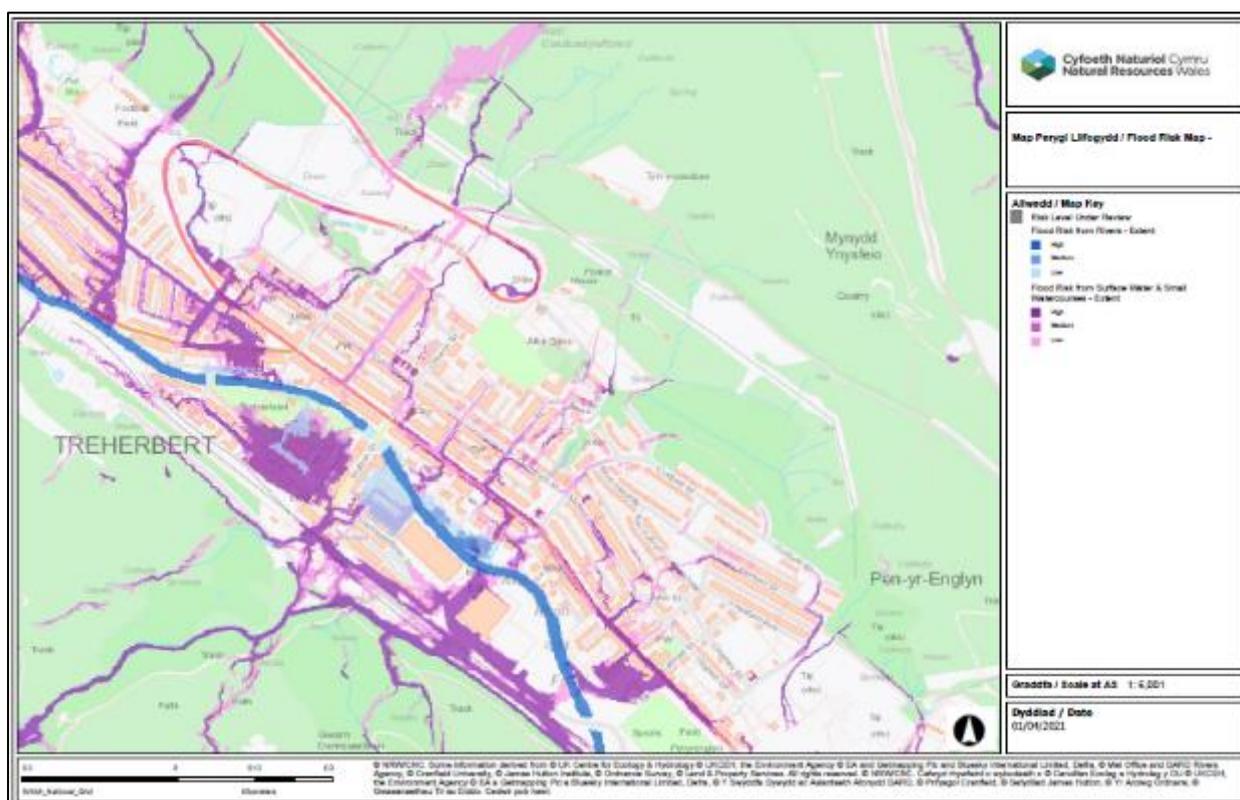
Figure 2: Natural Resources Wales’ Flood Risk Assessment Wales (FRAW) map for rivers and ordinary watercourse and surface water flood risk at investigation area RCT27. Contains Natural Resources Wales information © Natural Resources Wales and database right. All rights reserved.

The highest risk posed to people and properties according to the FRMP is broadly associated with culvert inlets located to the north of investigation area RCT27³. The risk of flooding from pluvial sources (surface water and ordinary watercourse) is illustrated within Natural Resources Wales’ Flood Risk Assessment Wales (FRAW) mapping (Figure 2). A low risk of flooding from the Main River is noted within the floodplains adjacent to the River Rhondda Fawr.

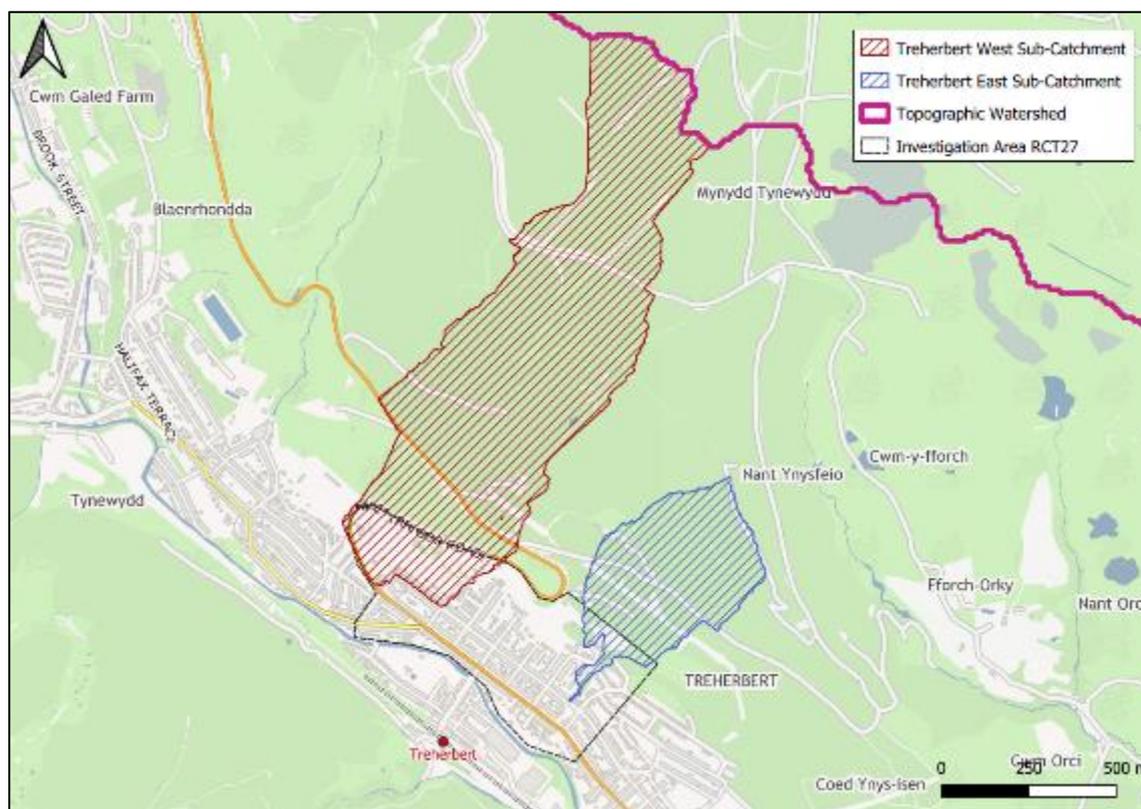
Figure 3: Rainfall Topographic Watershed and Sub-catchments above investigation area RCT27

On review of Table 2, the principal source of flooding in this incident originated from intense rainfall generating significant surface water runoff from the steep hillsides to the north and east of Treherbert draining to lower ground. This runoff was routed towards the investigation area via several ordinary watercourses, many of which became overwhelmed during Storm Dennis and caused flooding associated to blocked culvert inlets.

Figure 3 depicts the topographic watershed of the Rhondda Fawr and Fach valleys (bold pink line), with rainfall to the south east of the watershed draining to the Rhondda Fawr catchment. The catchment above investigation area RCT27 can be sub-divided into further sub-catchments to illustrate the area of land that would expect to drain towards the investigation area (hatched areas in Figure 3). The flood incident at investigation area RCT27 will be further described in two parts: the incident at 'Treherbert West' sub-catchment (red hatched area, Figure 3) and the incident at 'Treherbert East' sub-catchment (blue hatched area, Figure 3).

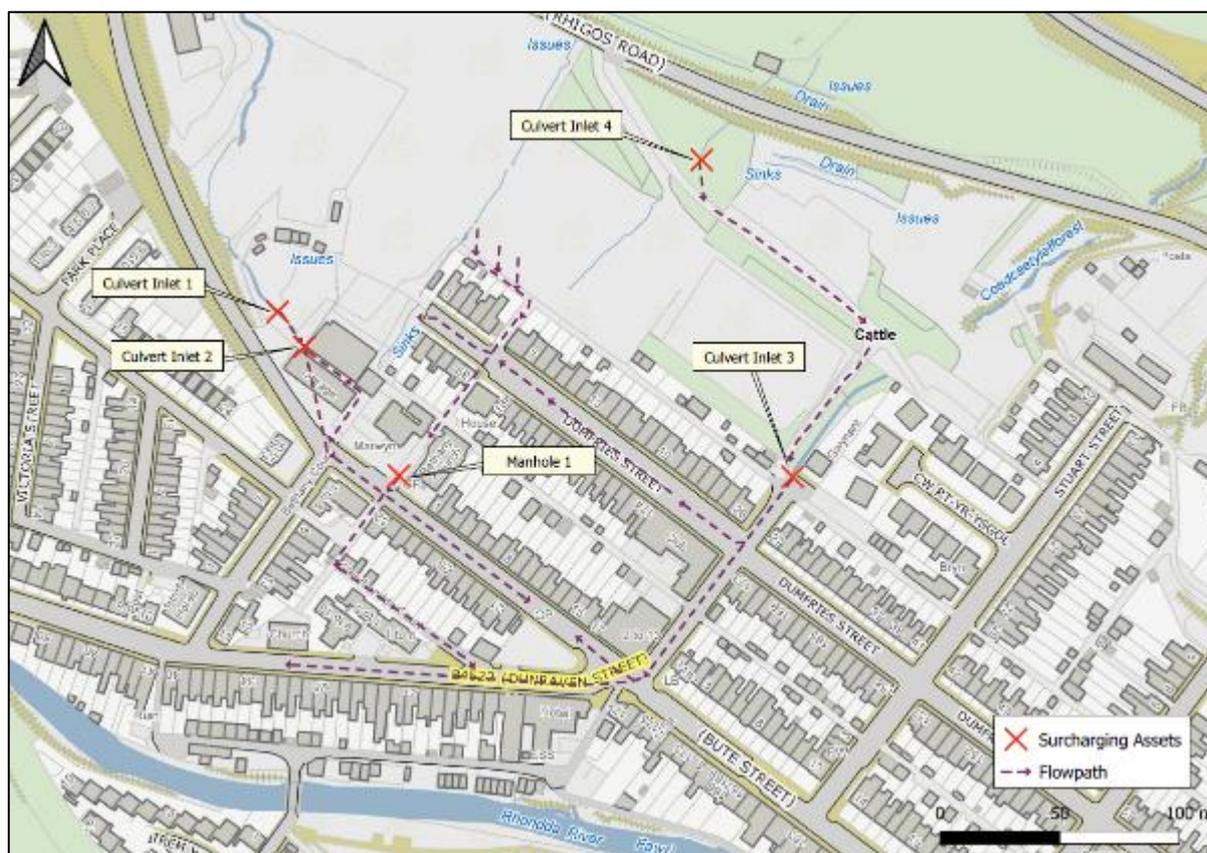
Figure 4: Observed flow paths within 'Treherbert West' sub-catchment during Storm Dennis (16th February 2020)

Figure 4 depicts the observed pathways of flooding within the ‘Treherbert West’ sub-catchment during Storm Dennis. The infrastructure known to have surcharged and contributed to the flooding are also illustrated in Figure 4.

Several calls were received from residents at Abertonllwyd Street and Dunraven Street on the 16th February 2020 to report water ingress into multiple residential properties. Upon a site inspection undertaken by RCT's Flood Risk Management team on the 18th February 2020, a culvert inlet adjacent to New Park Garage on Abertonllwyd Street (labelled 'Culvert Inlet 1' in Figure 4) was identified as half-submerged (Figure 5), indicating that the inlet was operating at a limited capacity post storm event.

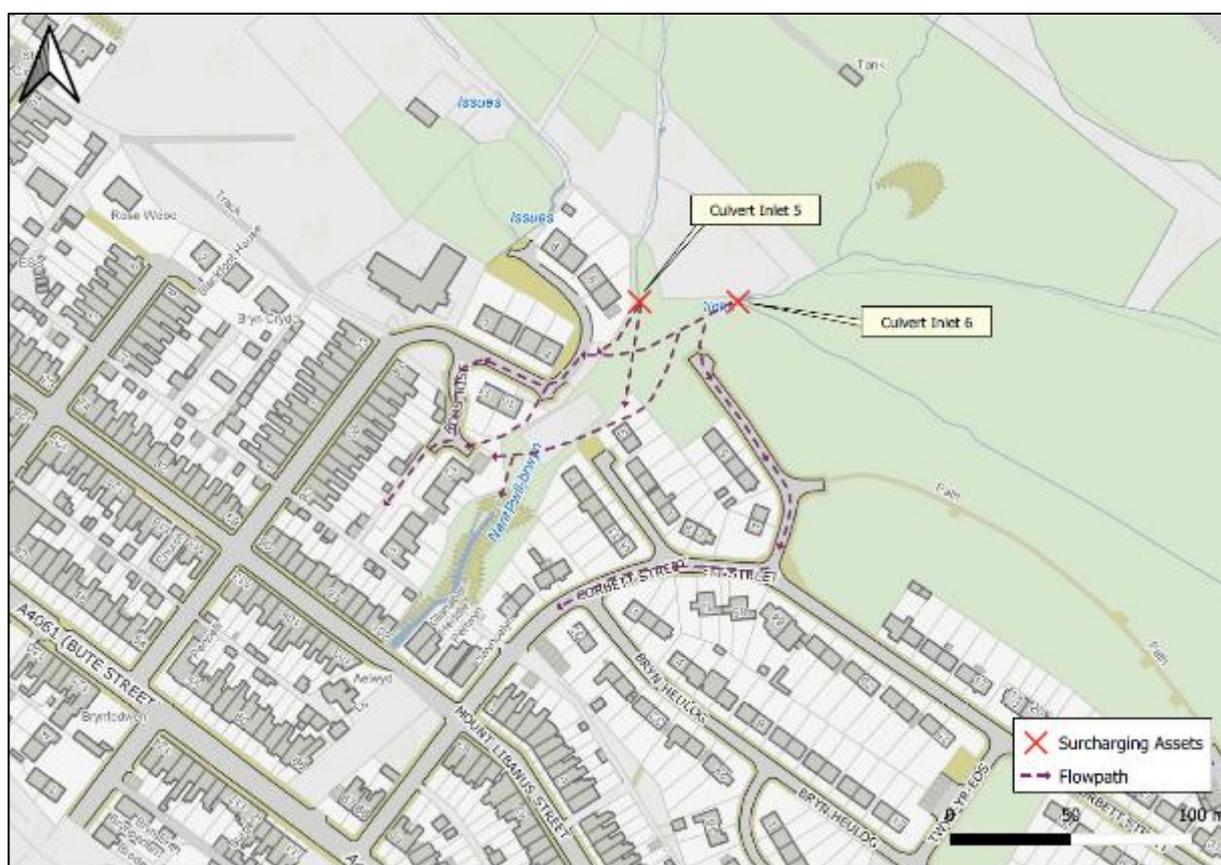
Figure 9: Observed flow paths within 'Treherbert East' sub-catchment during Storm Dennis (16th February 2020)

Figure 9 shows the observed pathways of flooding within the 'Treherbert East sub-catchment during Storm Dennis. The infrastructure known to have surcharged and contributed to the flooding are also illustrated in Figure 9.

Calls were received by residents at Tyle Fforest on the 16th February 2020 to report water emanating from a culvert inlet situated to the rear of Tyn-y-coedcae. Upon wider inspection of the area, undertaken by RCT's Flood Risk Management team on 19th

February 2020, two culvert inlets, labelled 'Culvert Inlet 5' and 'Culvert Inlet 6' in Figure 9, located to the north of Ross Rise and Tyn-y-coedcae, showed evidence of surcharge (Figure 10).

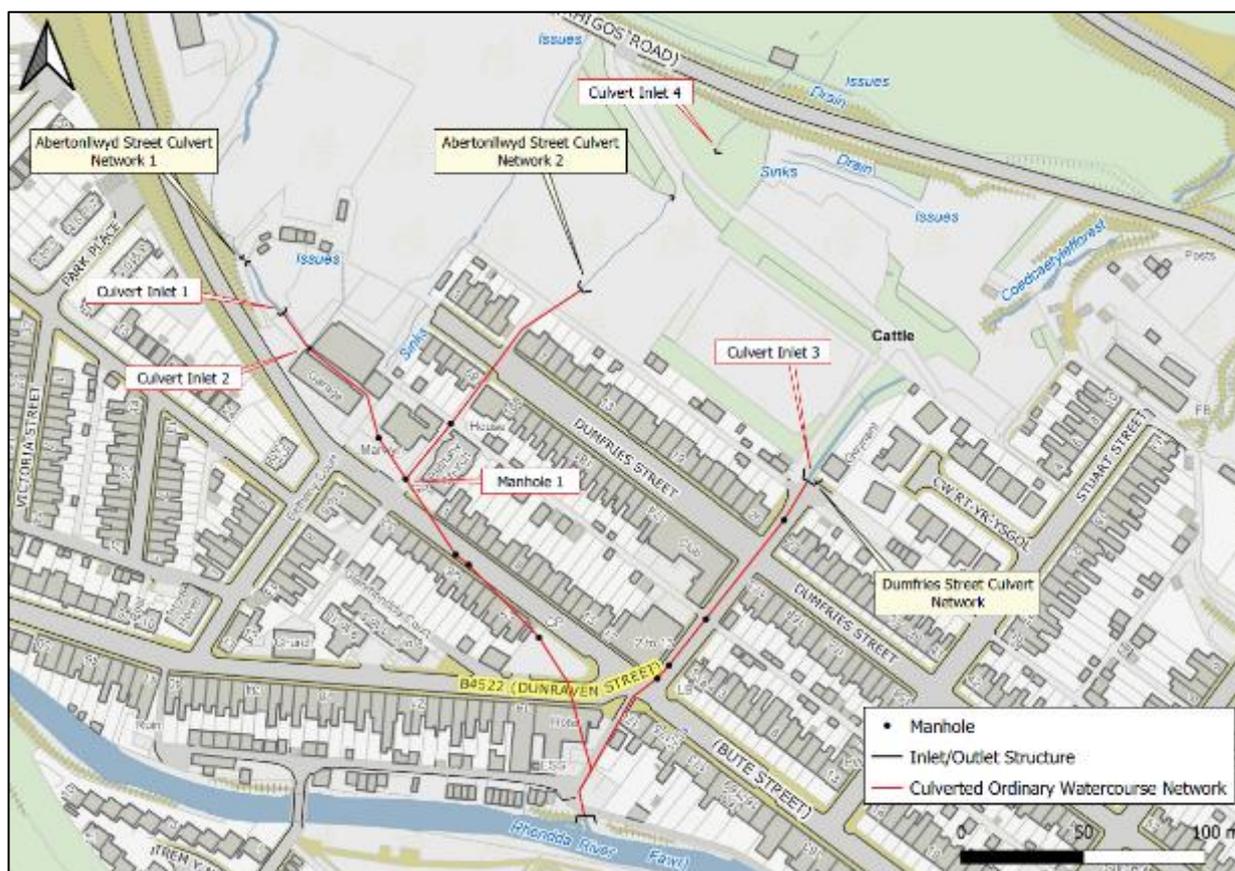
Figure 11: Surveyed culverted ordinary watercourse network within the 'Treherbert West' sub-catchment

Figure 11 outlines the three networks surveyed within the 'Treherbert West' sub-catchment and highlights the culvert inlets and manhole known to have surcharged.

According to on-site officers, several sections of open watercourse upstream of the 'Abertonllwyd Street Culvert Network 1' (Figure 11) had significant build-up of debris within the channels, indicating significant mobilisation of debris occurred during the storm event (depicted in Figure 20). The conveyance of sediment, silt and stone downstream is considered to have contributed to the surcharging of 'Culvert Inlet 1' and 'Culvert Inlet 2' during Storm Dennis. This debris is also considered to have entered the culvert network, contributing to the surcharge of 'Manhole 1' during the event.

The unnamed ordinary watercourses located above 'Abertonllwyd Street Culvert Network 2' (Figure 11) did not show evidence of significant debris mobilisation, however, it was apparent during post event inspections that significant overland flows had occurred along the hillside upon identifying evidence of flattened vegetation and saturated ground. The ordinary watercourse channel upstream of 'Culvert Inlet 4' (Figure 11), which surcharged during the storm event, was largely undefined and is considered to have contributed to the inlet becoming submerged, resulting in out-of-bank flows (Figure 8)

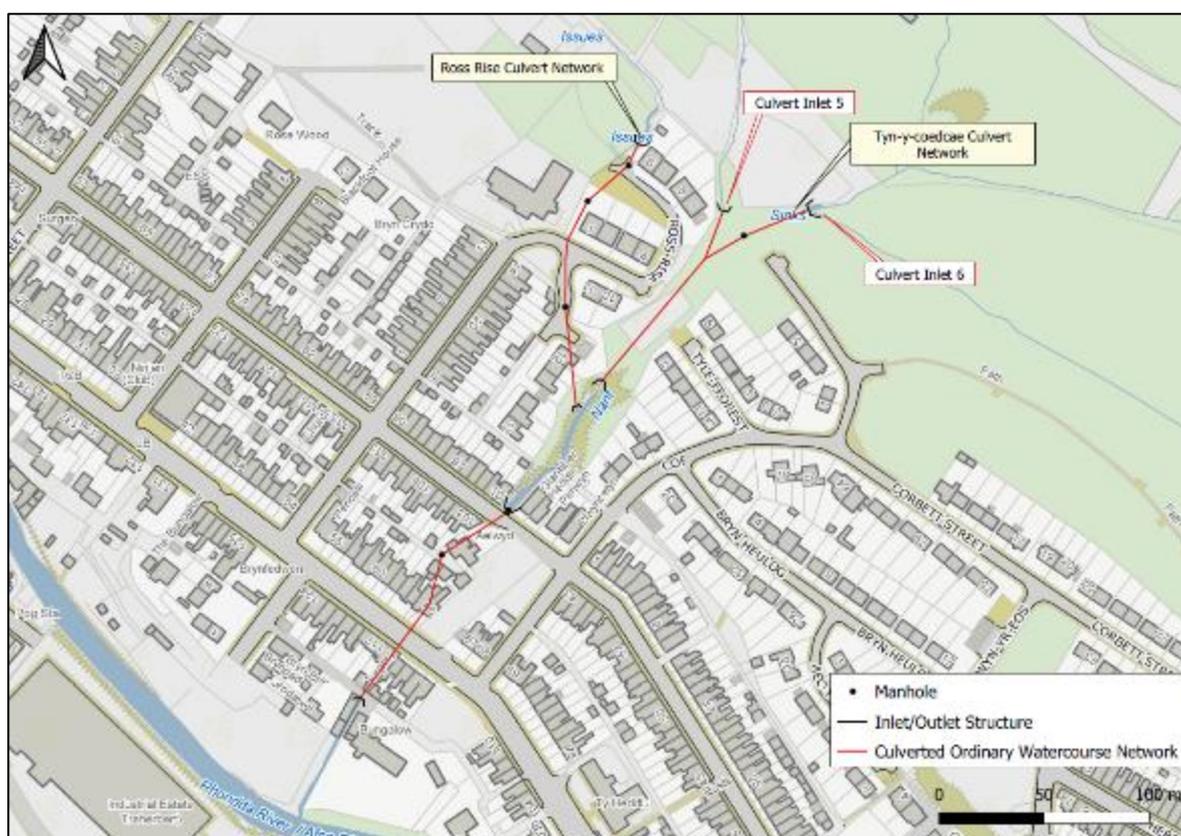
Figure 17: Surveyed culverted ordinary watercourses within the 'Treherbert East' sub-catchment

Figure 17 outlines both networks surveyed within the 'Treherbert East' sub-catchment and highlights the culvert inlets known to have surcharged.

The source of flooding to three properties at Ross Rise and Tyle Fforest was identified as originating from two surcharged culvert inlets located to the north of Tyn-y-coedcae, labelled 'Culvert Inlet 5 and 6' in Figure 17.

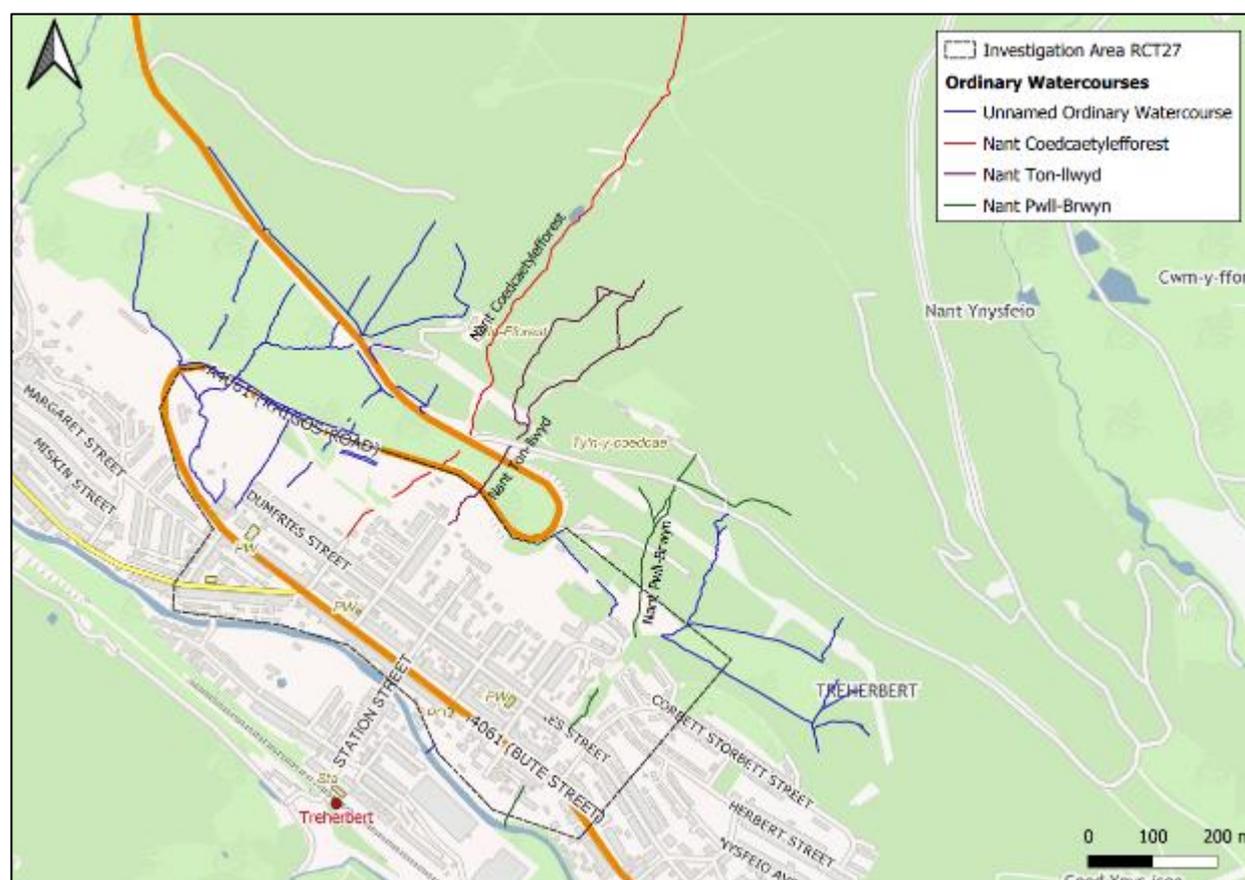
Figure 19: Map of Ordinary Watercourses which feed into investigation area RCT27

Several sections of natural ditches and open watercourses which drain the steep catchment above Treherbert are identified to flow through the investigation area, as illustrated in Figure 19. The most notable watercourses include the Nant Coedcaetylefforest, the Nant Ton-llwyd and Nant Pwll-brwyn.

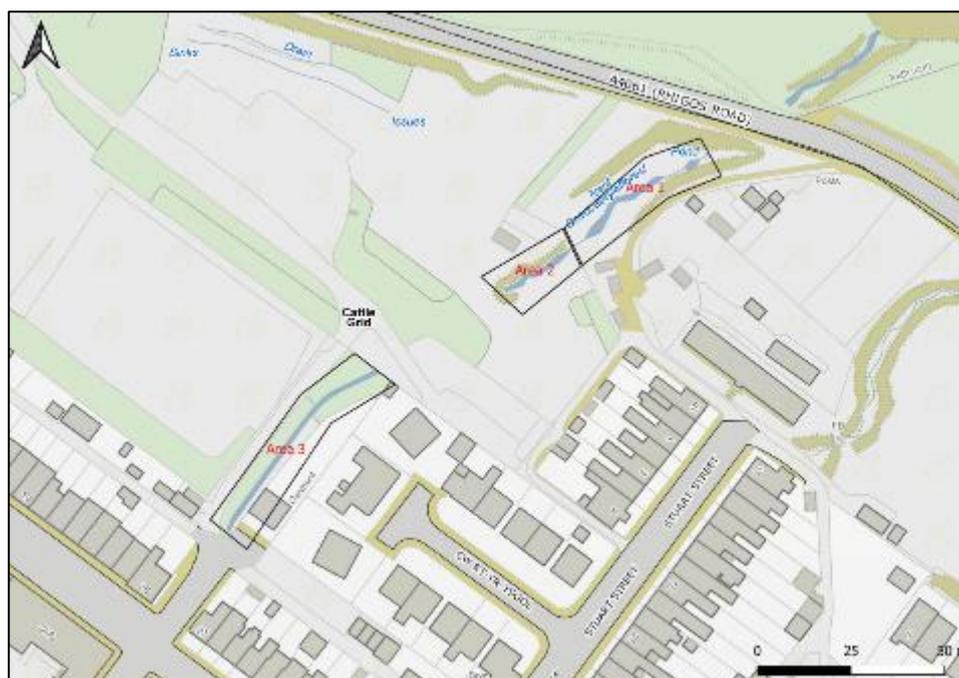
Figure 21: Nant Coedcaetylefforest ordinary watercourse inspection location plan

Following the surcharging of 'Culvert Inlet 3' (Figure 4) caused by debris blockage during Storm Dennis, the Nant Coedcaetylefforest ordinary watercourse was inspected by Flood Risk Management officers for signs of debris mobilisation. The watercourse was inspected at three areas, depicted in Figure 21.

The upstream sections of the Nant Coedcaetylefforest ordinary watercourse (Area 1, Figure 21) showed evidence of debris deposition within the man-made channel, along with significant accumulation of material across the upper debris screens and headwall structure. Figure 22 and 23 depicts the material, which consists of coarse stone, silt and woody debris, within the upper channel. This material is assumed to have been mobilised from the upper reaches above the A4061 (Rhigos Road) and carried downstream by the high flows during Storm Dennis.

Below the headwall structure, the channel and culvert inlet (Area 2, Figure 21) did not show evidence of debris conveyance or blockage to the inlet, as shown in Figure 24. It is considered that the upstream debris screens at Area 1 succeeded in minimising the volume of debris travelling downstream.

The channel immediately upstream of 'Culvert Inlet 3' (Area 3, Figure 21) is identified as man-made and therefore showed no signs of bank erosion. Upon an inspection of the surrounding area post Storm Dennis however, material on the banking area was evident (Figure 7). This material is not considered to have originated from Area 1.

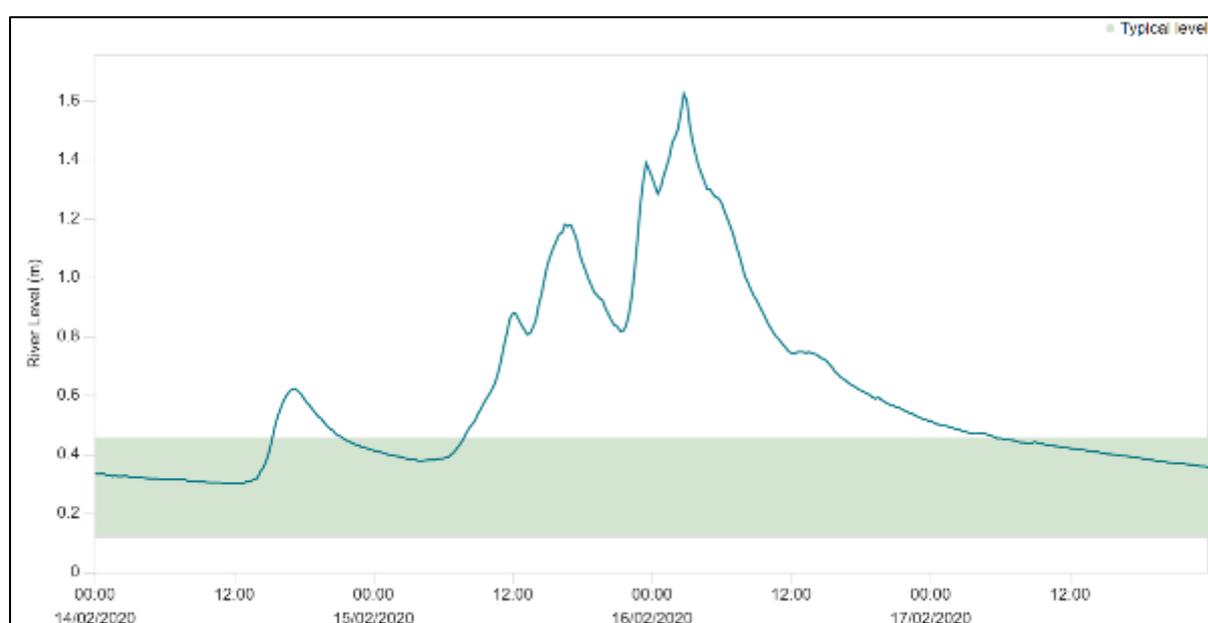
Figure 25: The Rhondda Fawr River levels at Tynewydd station between the 14th and 17th February 2020 (Natural Resources Wales)

The hydrograph in Figure 25 illustrates the rapid rise in levels of the River Rhondda Fawr in response to rainfall, captured at NRW's Tynewydd station. The River Rhondda Fawr at Tynewydd reached its highest peak ever recorded at 02:45 on 16th February 2020, reaching 1.62 meters.

The green bar displayed on the hydrograph shows the typical level of the River Rhondda Fawr at Tynewydd station, ranging between 0.1 and 0.5 meters. At its peak, the River Rhondda Fawr was over twice its average level, stressing the extreme and unprecedented levels that RCT's rivers rose to during the storm's peak intensity.
