Flood and Water Management Act 2010

Section 19 Flood Investigation Report

Storm Dennis – Flood Investigation Area RCT25

July 2021

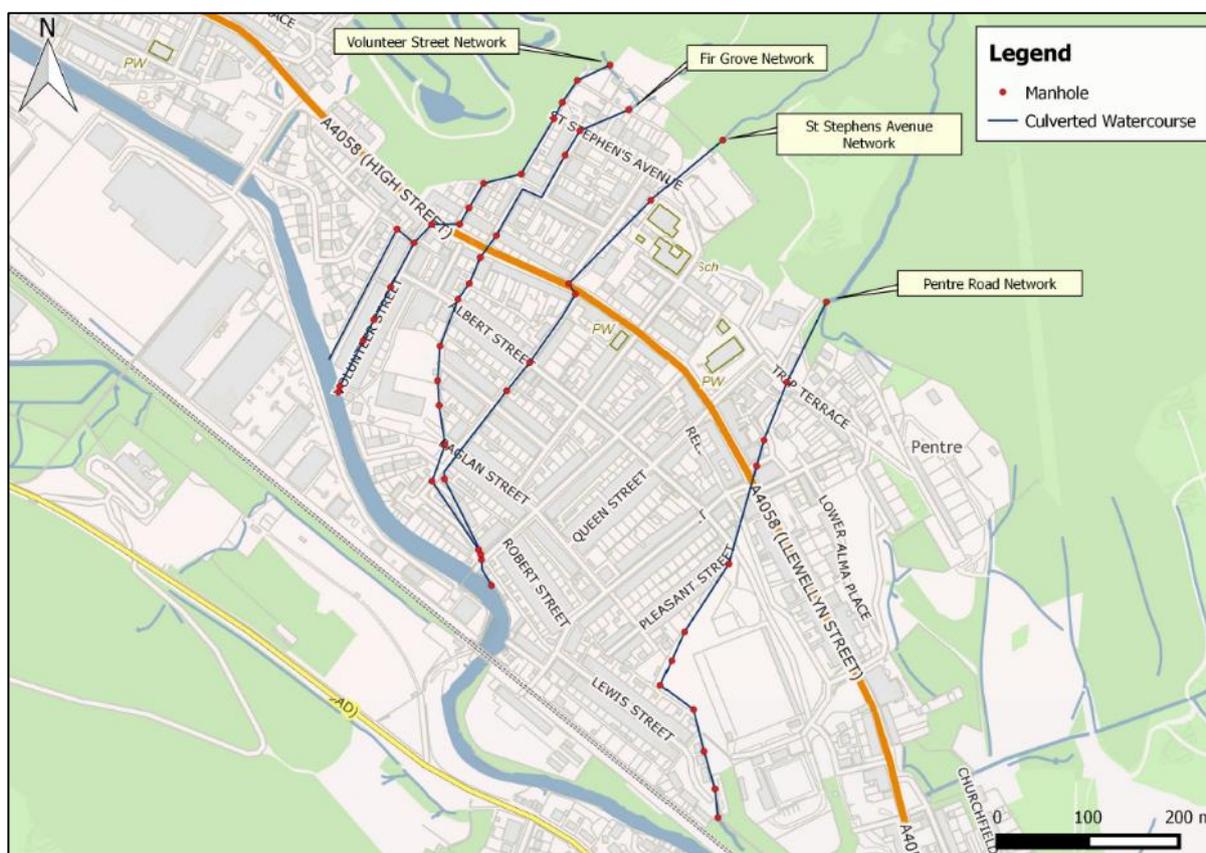
Figure 13: Four culverted watercourse networks in investigation area RCT25

Within investigation area RCT25 there are four main culverted Ordinary Watercourse networks that originate to the north of the village, which flow in a south-westerly direction towards the Rhondda Fawr River depicted within Figure 13. Pentre Road and St Stephen's Avenue inlets are identified as the responsibility of Natural Resources Wales on behalf of Welsh Government as the landowner, whilst the Volunteer Street and Fir Grove inlets are identified as the responsibility of two private individual landowners.

Following the first flood event of 2020 that occurred on 16th February (Storm Dennis), the four culvert inlets were inspected by RCT's Flood Risk Management team. The results of which identified that only Pentre Road inlet was found to have been overcome with debris, reportedly having been washed down from the upper catchment, as shown below in Figures 14 - 17.

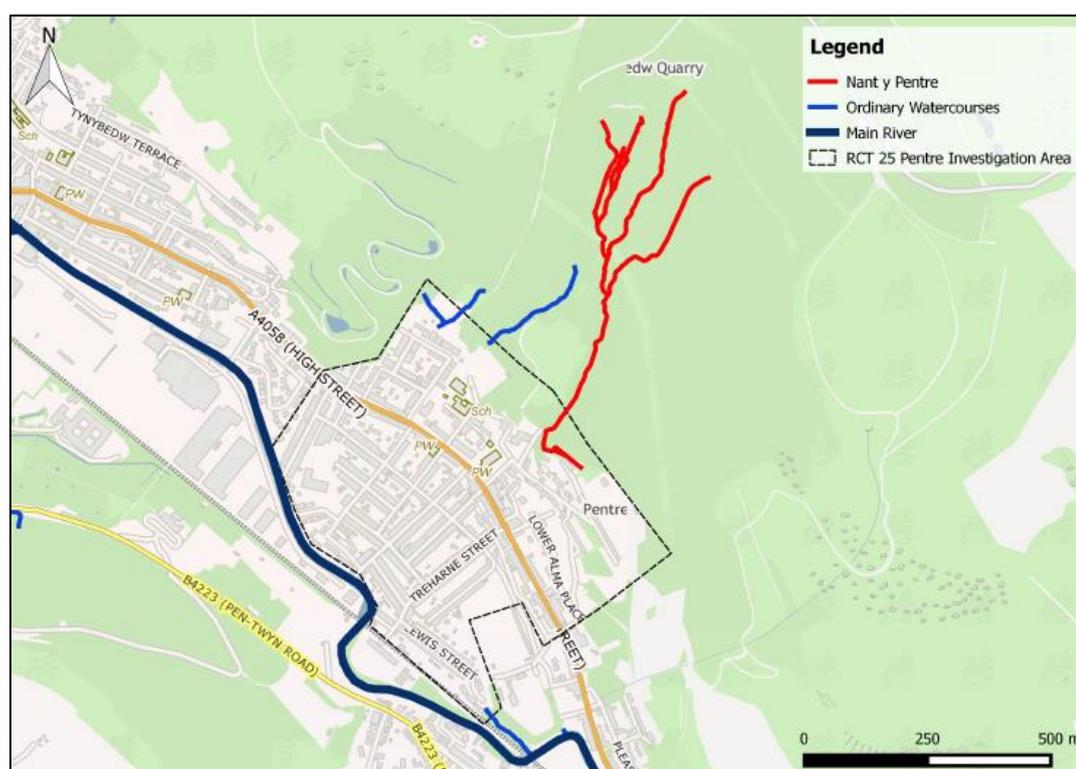
Figure 21: Ordinary watercourses flowing into Pentre investigation area. Nant y Pentre watercourse is highlighted red.

On review of the open watercourse sections identified within investigation area RCT25, four distinct networks were identified. The Nant y Pentre watercourse and its tributaries (highlighted red in Figure 21) was reviewed following the mobilisation of debris washed from the hillside which blocked the Pentre Road culvert inlet.

The Nant y Pentre rises steeply from the town situated at the base of the hillslope. Bed incision has created a deeply confined valley with steep, forested sides that rise sharply from the channel. Due to the steepness of the channel and the confined valley, the delivery of overland or sub-surface flow routes to the channel are accelerated, meaning the catchment will respond rapidly to rainfall.

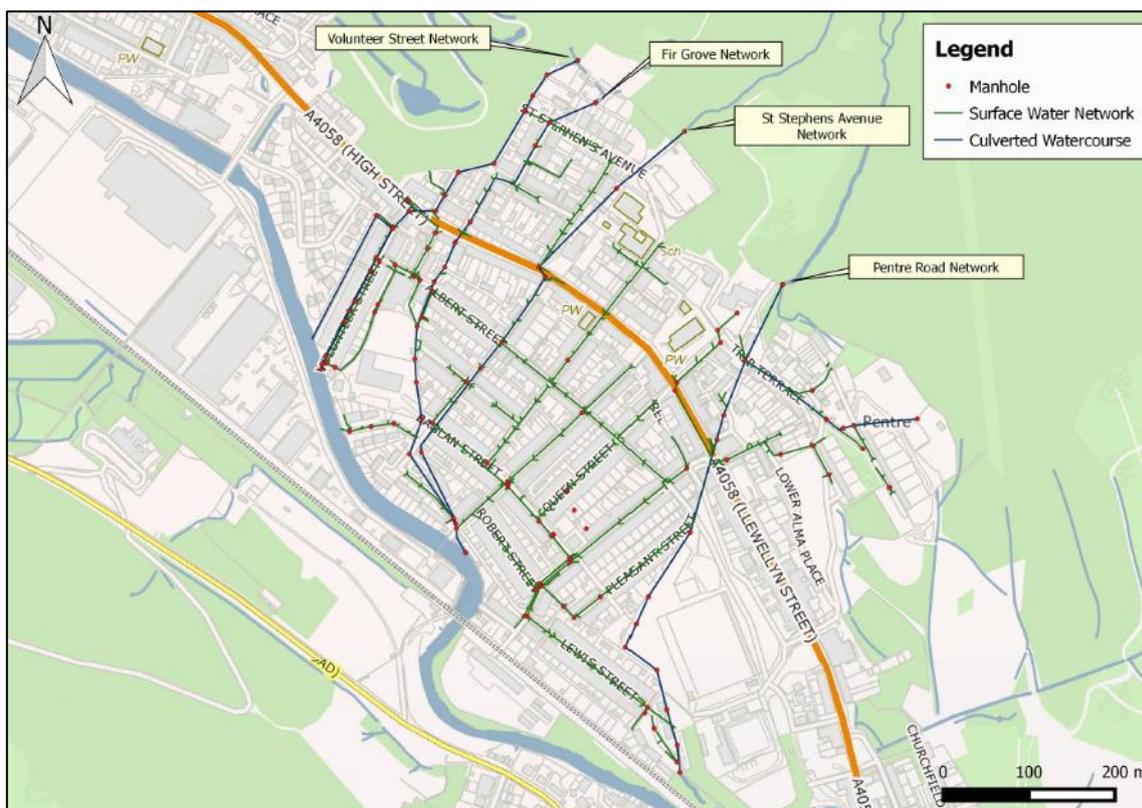
Figure 25: The extent of the surface water drainage and culverted watercourse systems within investigation area RCT25

Figure 25 depicts the surface water drainage systems in Pentre, of which there is approximately 5.5 km of highway drainage infrastructure identified. This infrastructure was surveyed and mapped following extensive jetting and cleansing of the network by the Council Highways and Streetcare Depot. CCTV surveys of the highway drainage conditions in Pentre following the February and June storms confirm significant blockages were present, particularly at the Lewis Street storm water network where

the survey had to be abandoned due to two large obstacles blocking the pipe (between manholes SS96957851 and SS96959750, shown in Figure 26).

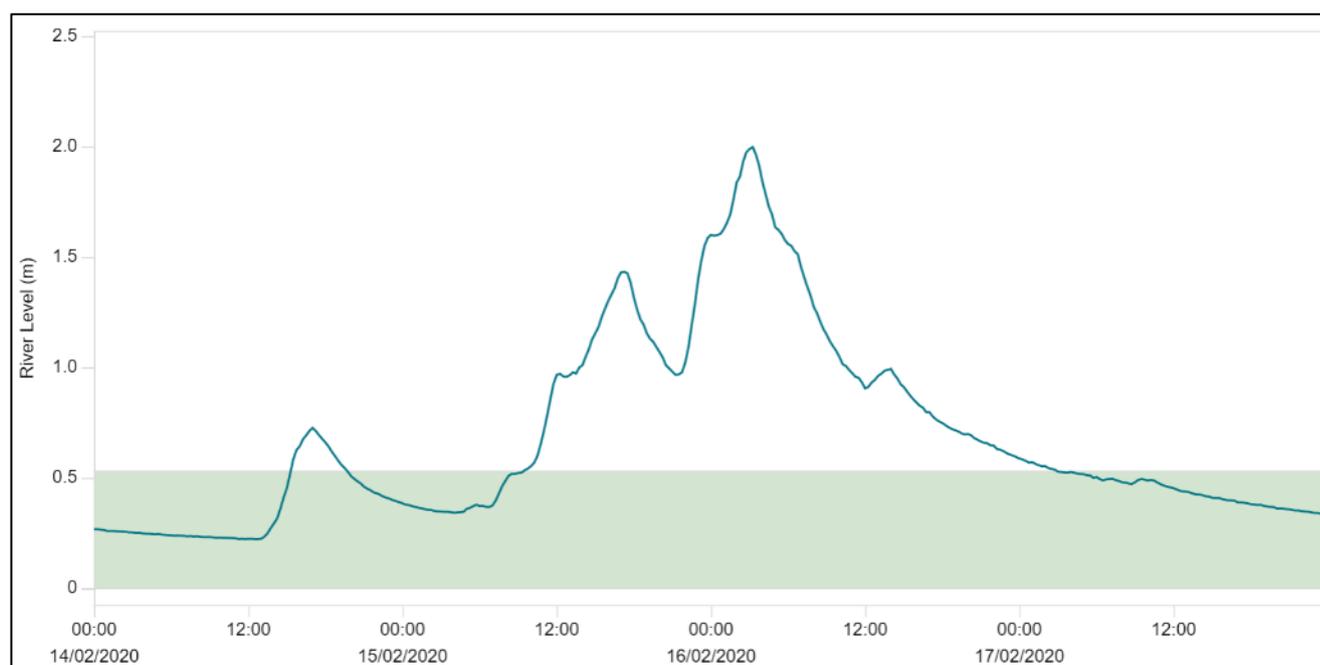
Figure 27: The Rhondda Fawr River levels at Gelli station between the 14th and 17th February 2020 (Natural Resources Wales)

The hydrograph in Figure 27 illustrates the rapid rise in levels of the Rhondda Fawr River in response to rainfall, captured at NRW's Gelli station near Pentre. The Rhondda Fawr River at Gelli reached a peak level of 1.998 meters at 03:30am (16th February); only 0.3 meters lower than its highest level ever recorded.

The green bar displayed on the hydrograph shows the typical level of the Rhondda Fawr River at Gelli station, ranging between 0 and 0.5 meters. At its peak, the Rhondda Fawr River at Gelli was almost a meter and a half higher than its average level, stressing the extreme and unprecedented levels that RCT's rivers rose to during the storm's peak intensity.

There is no evidence from this investigation that the main river Rhondda Fawr significantly contributed to the recorded flooding of properties in Pentre during the 2020 flood events.

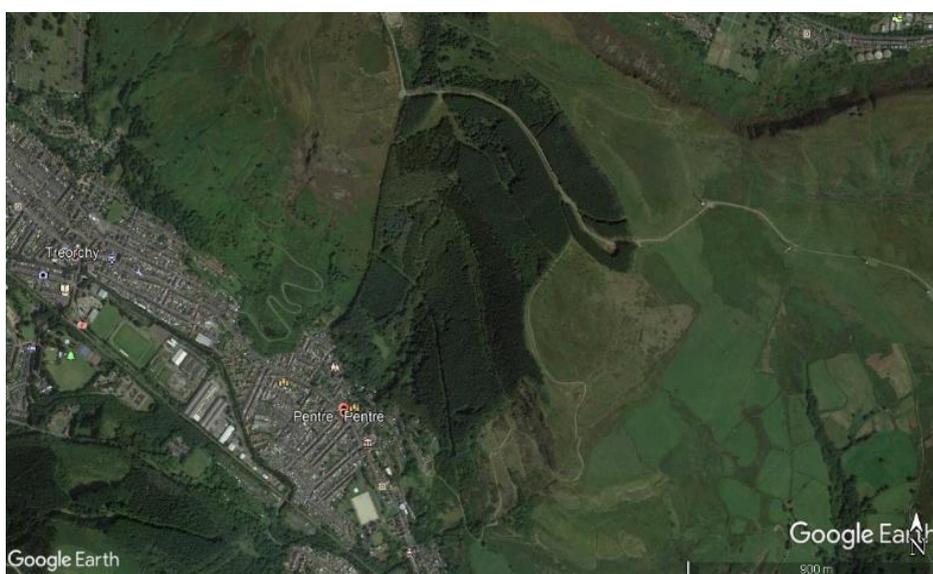
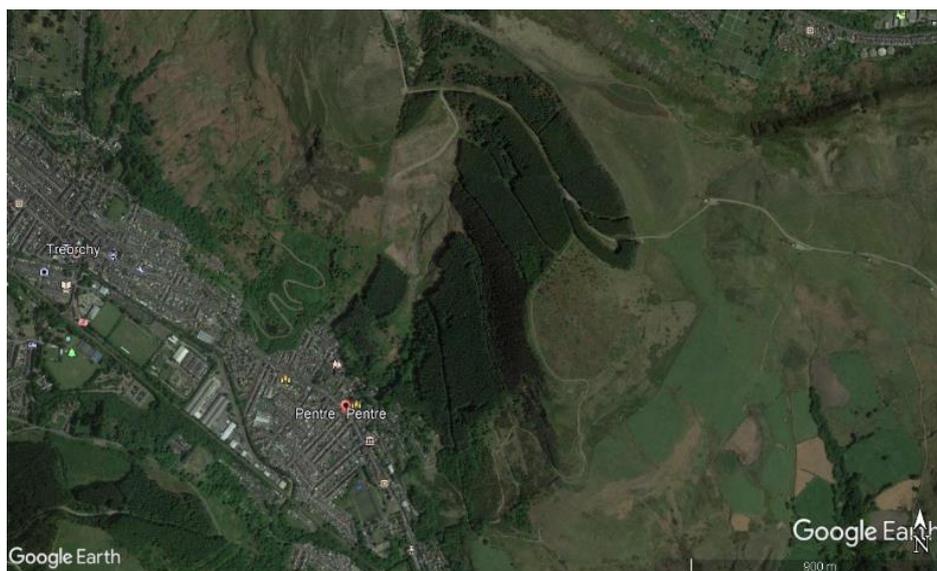
Figure 28: Google Earth imagery of area above Pentre showing change in tree cover between 2016 and 2020

Large areas of woodland to the north of Pentre have been felled during the last 2 years. The area in which tree felling has occurred forms part of the Welsh Government's Woodland Estate (WGWE) which is owned by the Welsh Government and managed by NRW. Figure 28 illustrates the woodland loss observed between 2016 and 2020 in parts of Pentre's upper catchment using historic aerial imagery from Google Earth.

Woodland is currently felled following routine harvesting or removal of Larch infected with 'Phytophthora ramorum' and awaiting 'restocking'. According to NRW's Land Estate Management Review, harvesting was carried out in Pentre mainly over winter 2018/19, although dispatch of timber from the site proceeded until relatively recently⁵.

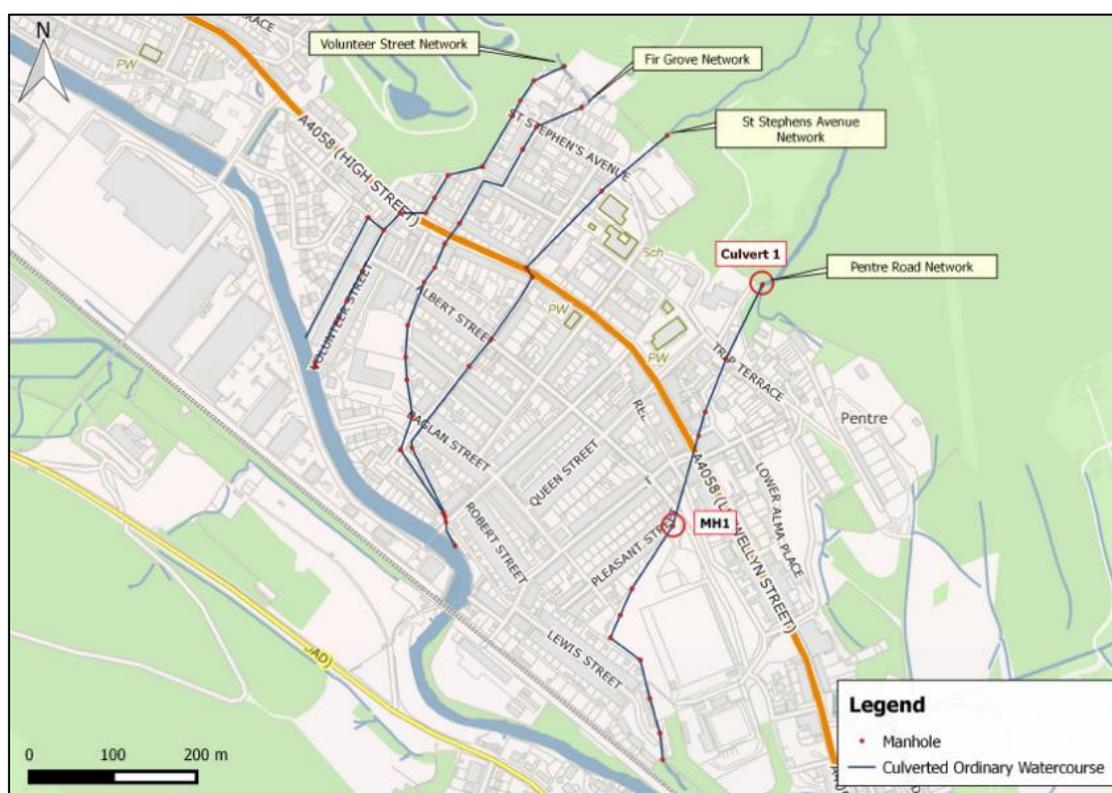
Figure 30: Ordinary watercourse structures identified as flood sources during the 2020 flood events in Pentre

The ordinary watercourse structures as depicted within Figure 30, further referred to as Culvert 1 and MH1, have been assessed to identify the capacity of the network at the point of flooding. The summary of the assessment is depicted within Table 3.

The second node associated to flooding several days following Storm Dennis was MH1 which is a manhole associated to the Nant Y Pentre ordinary watercourse network located within Pleasant Street Park (Figure 30). A review of the capacity of MH1 when free of blockage is identified as providing a SOP of Q25, which is below current design standards. As such the manhole would have been expected to surcharge during Storm Dennis with or without the identified full-bore blockage. It is likely that the initial blockage to the Pentre Road culvert inlet significantly reduced the volume of water entering the network and consequently reduced the likelihood of surcharge at MH1 during the initial flood event.

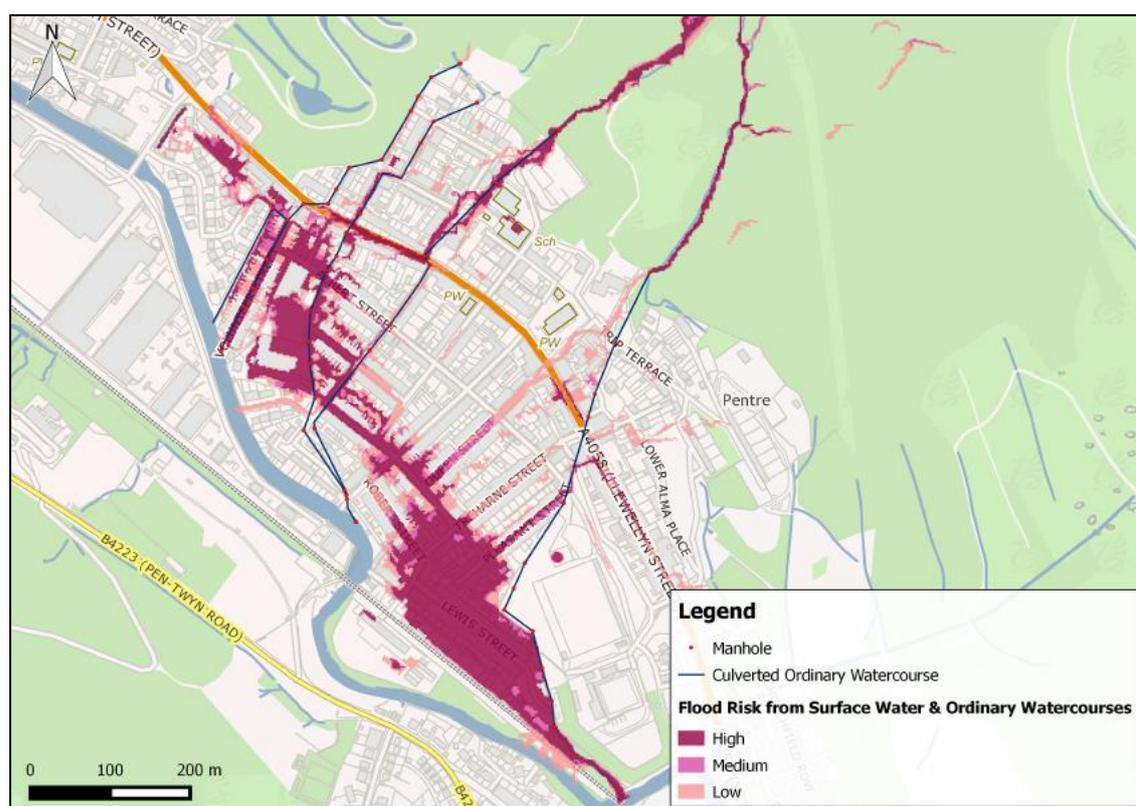
Figure 32: Natural Resources Wales' Flood Risk Assessment Wales (FRAW) map for surface water and ordinary watercourse sources. Contains Natural Resources Wales information © Natural Resources Wales and database right. All rights reserved.

To assess the likely impacts of surface water flooding within the community of Pentre, the National Flood Maps produced by NRW and published in October 2020, have been used i.e. 'Flood Risk Assessment Wales' (FRAW). The outputs of the FRAW mapping is depicted within Figure 32.

The extent of the high risk (Q30) flooding event, depicted within Figure 32, is comparable to the extent of flooding experienced during Storm Dennis and the June 17th flood event. This comparison provides evidence that surface water flooding has a significant impact on the community of Pentre, particularly towards the lower streets at the base of the catchment.
