Section 19 Flood Investigation Report

Storm Dennis – Flood Investigation Area RCT26 (Treorchy)

February 2022

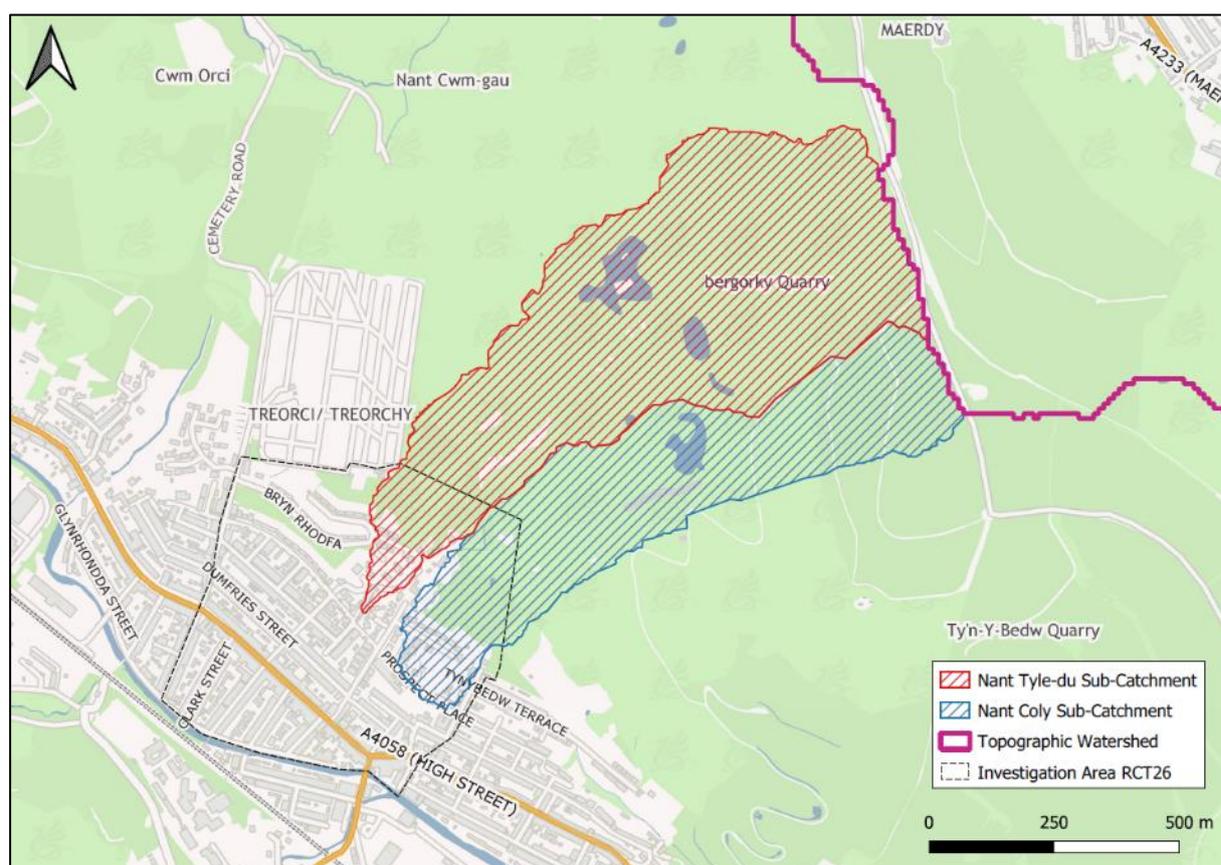
Figure 3: Rainfall Topographic Watershed and sub-catchments above investigation area RCT26

Figure 3 depicts the topographic watershed of the Rhondda Fawr and Fach valleys (bold pink line), with rainfall to the south west of the watershed draining to the Rhondda Fawr catchment. The catchment above investigation area RCT26 can be sub-divided into further sub-catchment to illustrate the area of land that would expect to drain towards the investigation area (hatched areas in Figure 3). The flood incident at investigation area RCT26 will be further described in two parts: the incident at 'Nant Tyle-du' sub-catchment (red hatched area, Figure 3) and the incident at 'Nant Coly' sub-catchment (blue hatched area, Figure 3).

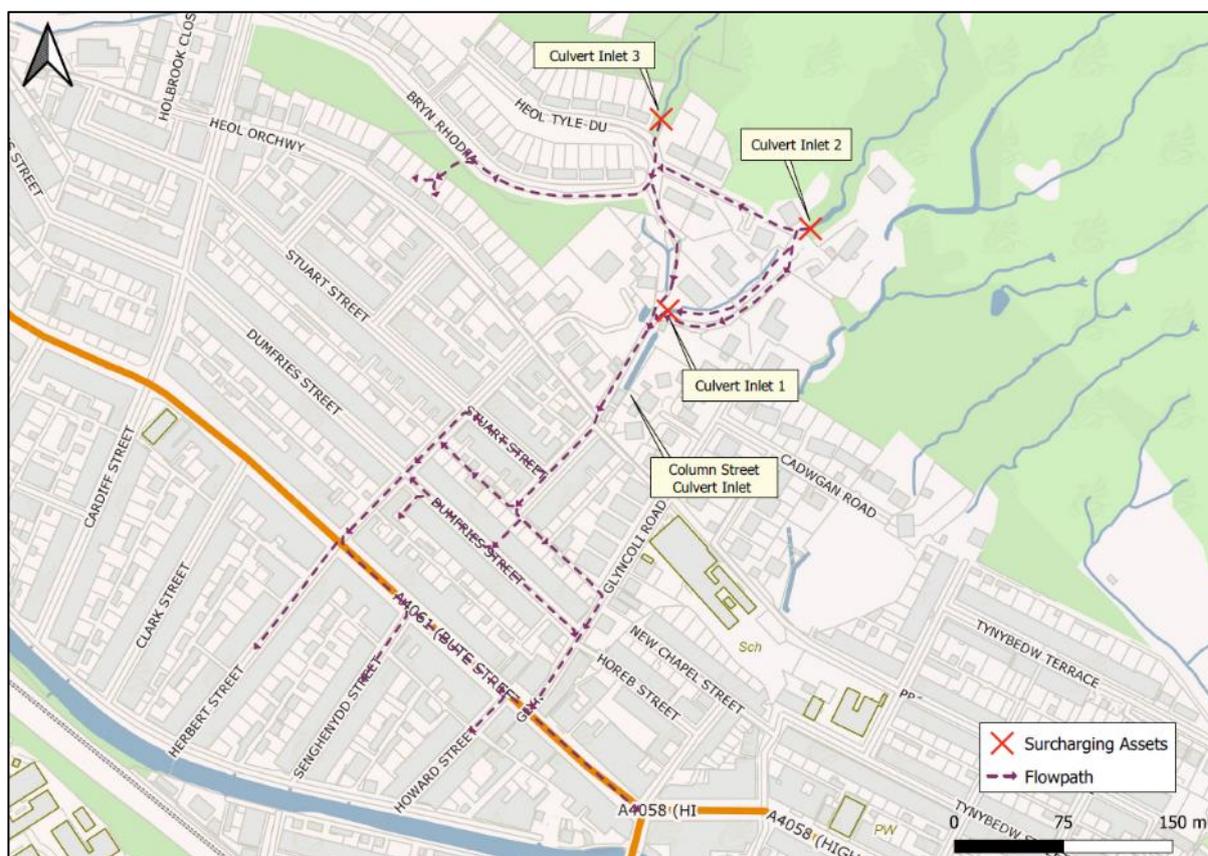
Figure 4: Observed flow paths within 'Nant Tyle-du' sub-catchment during Storm Dennis (16th February 2020)

Figure 4 depicts the observed pathways of flooding within the 'Nant Tyle-du' sub-catchment during Storm Dennis. The infrastructure known to have surcharged and contributed to the flooding are also illustrated in Figure 4.

Several calls were received from residents at Column Street and Dumfries Street on the 16th February 2020 to report water ingress into multiple residential properties associated to culvert blockages upstream of Column Street. Upon a site inspection undertaken by RCT's Flood Risk Management team on the 17th February 2020, three culvert inlets associated to the Nant Tye-du ordinary watercourse and its tributaries were identified as sources of flooding during the storm event. The location of the culvert inlets are illustrated in Figure 4.

The site inspection also identified evidence of a third surcharged culvert inlet located at Heol Tyle-Du (labelled 'Culvert Inlet 3' in Figure 4). This inlet conveys flows from the Nant Tyle-du ordinary watercourse towards the 'Column Street Culvert Inlet'. 'Culvert Inlet 3' was observed as surcharging by residents during the event, resulting in water conveying down Heol Tyle Du towards Bryn Rhodfa. At a low point along Bryn Rhodfa, water overtopped the kerb line before cascading down the hillside towards the rear of properties at Heol Orchwy. Four residential properties along Heol Orchwy were confirmed as internally flooded as a result of this flow path.

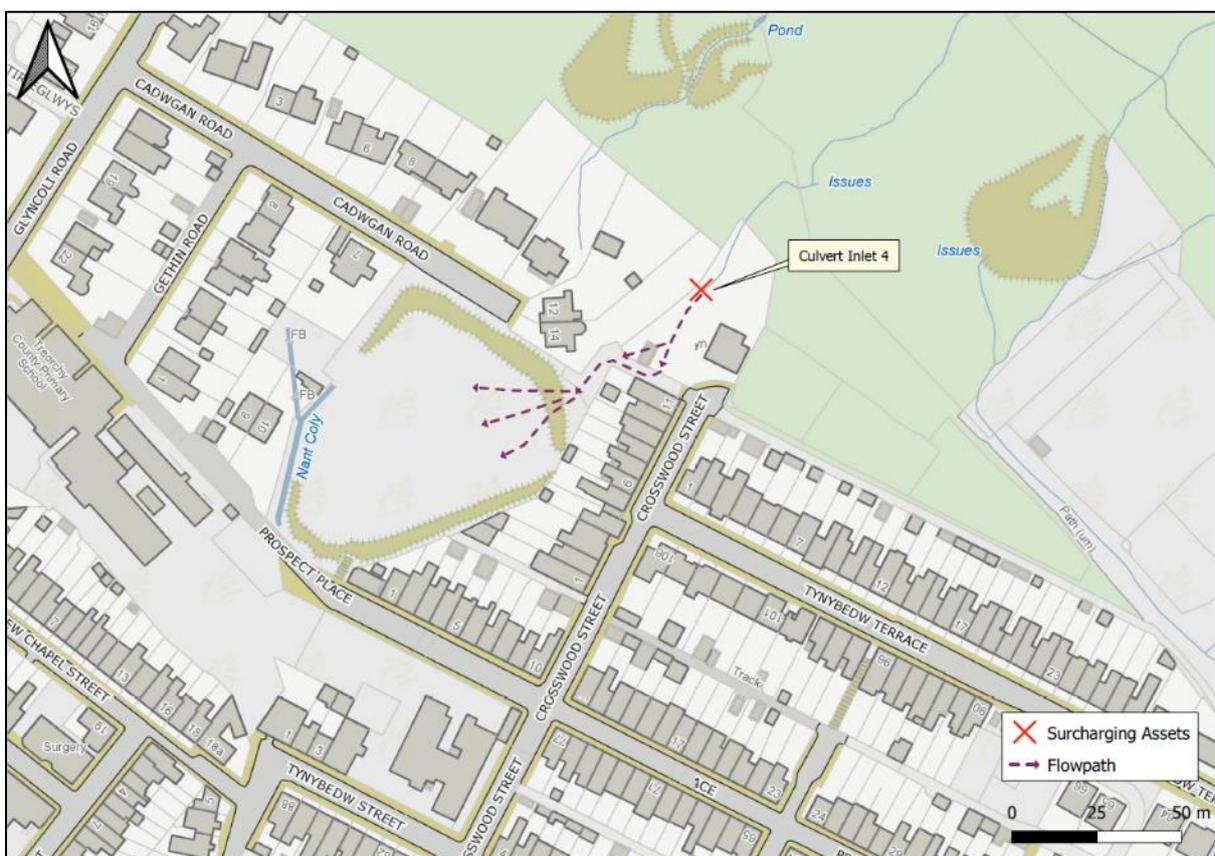
Figure 9: Observed flow paths within the 'Nant Coly' sub-catchment during Storm Dennis (16th February 2020)

Figure 9 depicts the observed pathways of flooding within the 'Nant Coly' sub-catchment during Storm Dennis. The infrastructure known to have surcharged and contributed to the flooding is illustrated in Figure 9.

Calls were received by residents at Crosswood Street to report water emanating from a culvert inlet situated north of Crosswood Street. Upon wider inspection of the area and discussions with residents, undertaken by RCT's Flood Risk Management team on 21st February 2020, one culvert inlet, labelled 'Culvert Inlet 4' in Figure 9, showed evidence of surcharge.

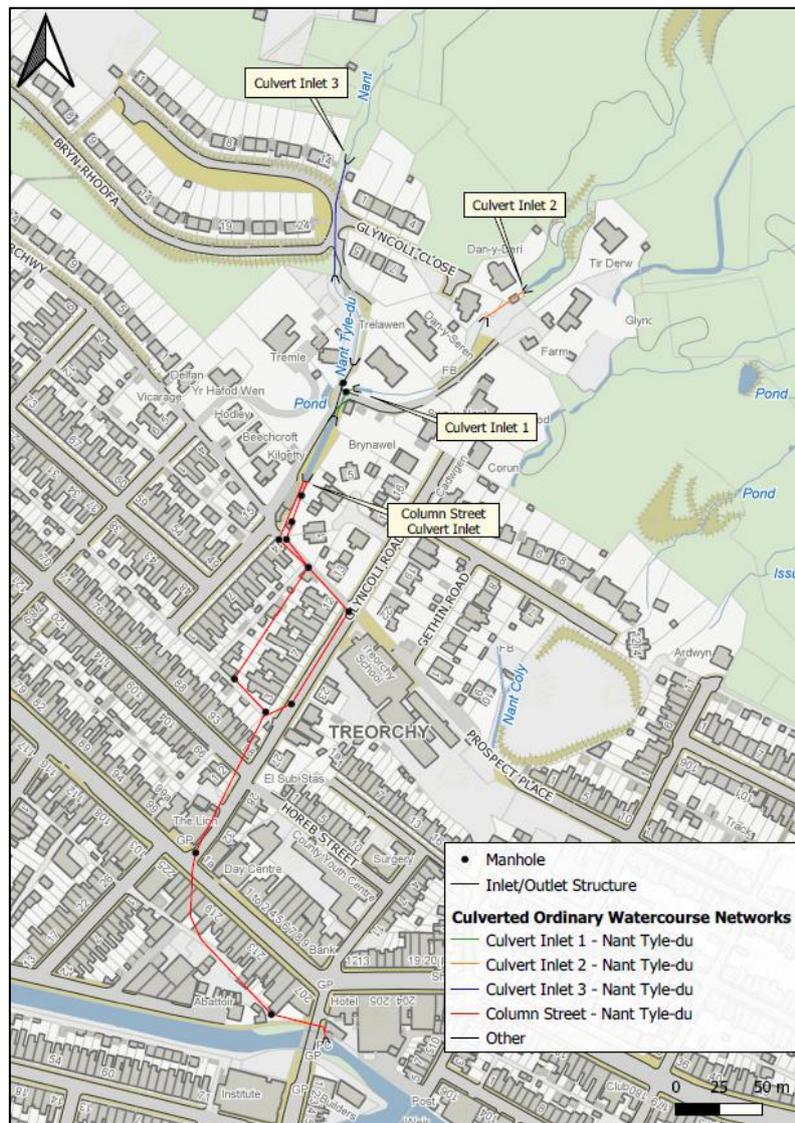
Figure 11: Surveyed culverted ordinary watercourse networks within the 'Nant Tyle-du' sub-catchment

Figure 11 outlines the four networks surveyed within the 'Nant Tyle-du' sub-catchment and highlights the culvert inlets known to have surcharged. All four culvert networks are associated to the Nant Tyle-du ordinary watercourse and its tributaries.

Culvert networks within the investigation area (Figures 11 and 17) were surveyed post event to ascertain the internal condition of the networks, the results of which fed into a review of the hydraulic performance of the network to ascertain its current standard of protection using Causeway Flow modelling. The results of the culvert inlet capacity assessments are summarised in the Table below (refer to Figure 11 for culvert labels).

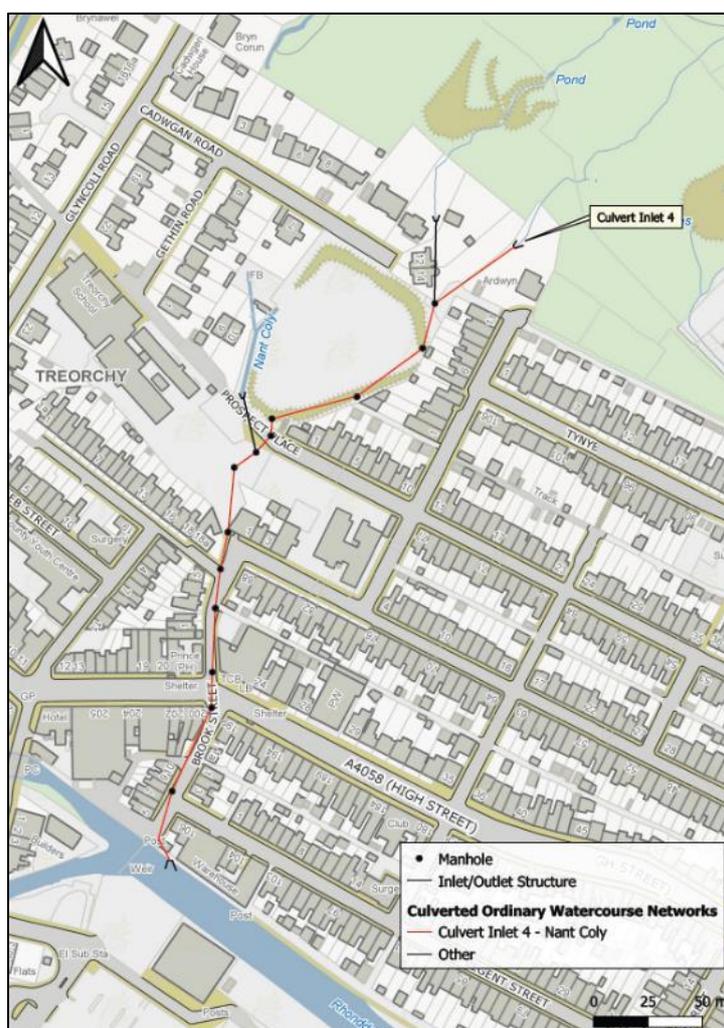
Figure 17: Surveyed culverted ordinary watercourse network within the 'Nant Coly' sub-catchment

Figure 17 depicts the 'Culvert Inlet 4' culverted ordinary watercourse network associated to the Nant Coly ordinary watercourse within the 'Nant Coly' sub-catchment.

'Culvert Inlet 4' was identified as the source of flooding to one residential property at Crosswood Street. The inlet was inspected by RCT's Flood Risk Management team in the days following the storm event and was found to be in poor condition (Figure 18).

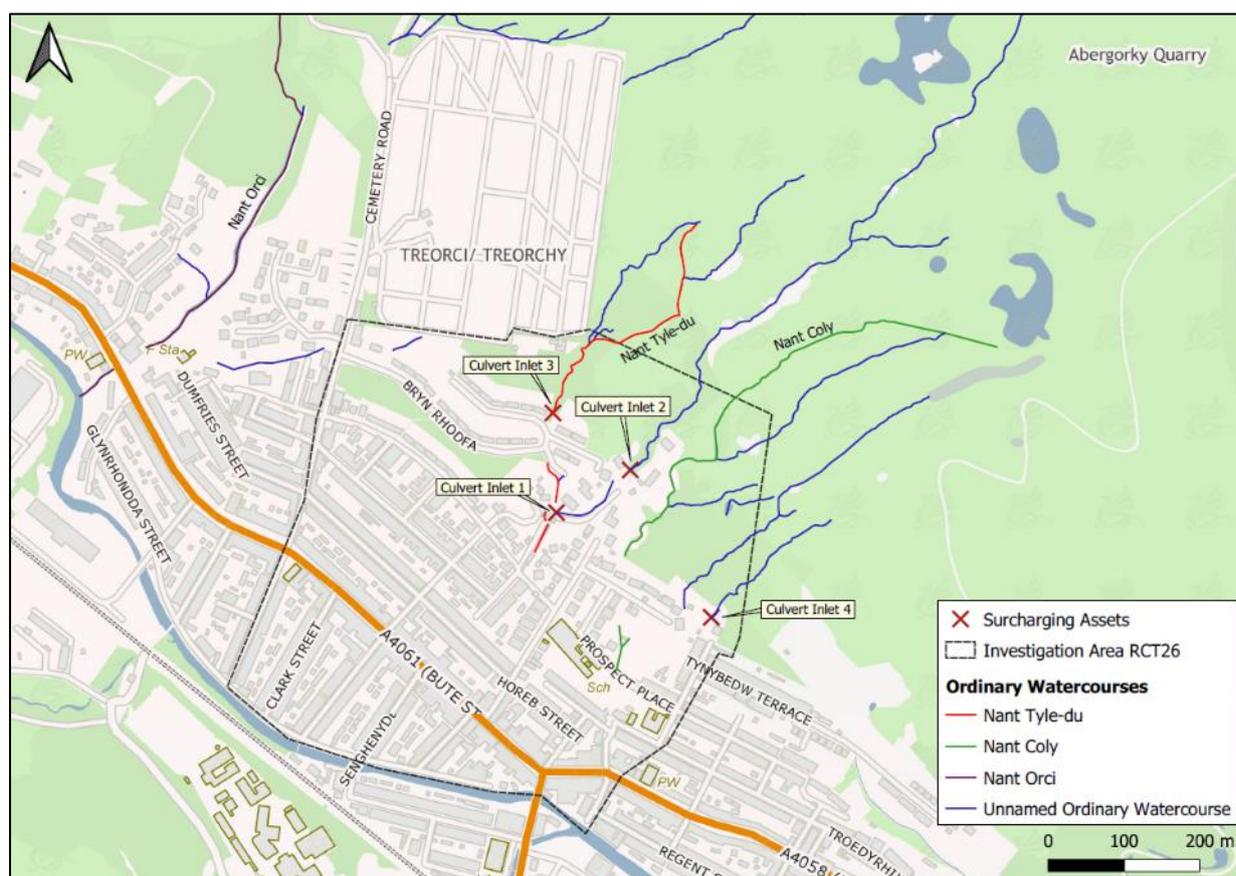
Figure 19: Map of Ordinary Watercourses which flow through investigation area RCT26

Several sections of natural ditches and open watercourses which drain the steep catchment above Treorchy are identified to flow through the investigation area, as illustrated in Figure 19. The most notable watercourses include the Nant Tyle-du and the Nant Coly. The Nant Orci drains the hillsides to the northwest of RCT26 and flows outside of the investigation area boundary.

Following the storm event, RCT Flood Risk Management officers carried out a site walk-over assessment of the ordinary watercourses upstream of the culvert inlets identified as sources of flooding (highlighted in Figure 19) to assess the condition of the watercourse for any signs of overtopping, evidence of scour and any land movement of the hillsides.

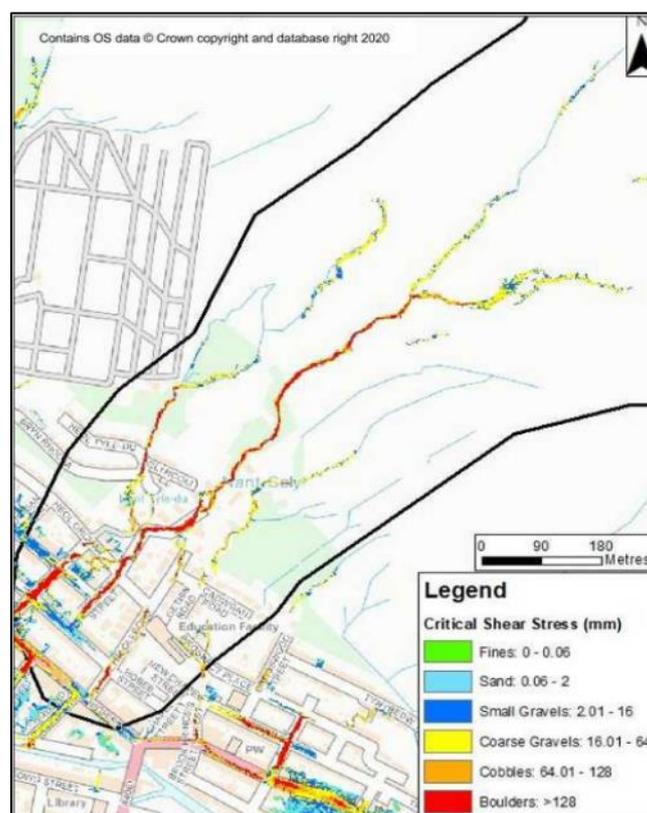
Figure 25: Critical shear street results in the Q100 flood event produced by JBA's hydraulic modelling

Hydraulic modelling was undertaken by JBA to calculate the shear stresses produced during a 1 in 100 annual probability event (Q100) (Figure 25). The model results show that during a Q100 flood event, akin to extreme storm events such as Storm Dennis, significant velocities in the ordinary watercourse channels generate shear stresses capable of entraining sediment up to cobble and boulder size through most of the channel lengths. This is particularly apparent along the Nant Tyle-du and its tributaries, where debris and sediment mobilisation has been attributed as the primary cause of surcharge at 'Culverts 1, 2 and 3'.

Shear stresses along the Nant Coly and its tributaries are less severe which also supports the conclusion that morphological processes had less impact on the surcharge of 'Culvert Inlet 4'. The surcharging at this inlet has been attributed to the watercourse and culvert inlet becoming hydraulically overwhelmed during the storm event.

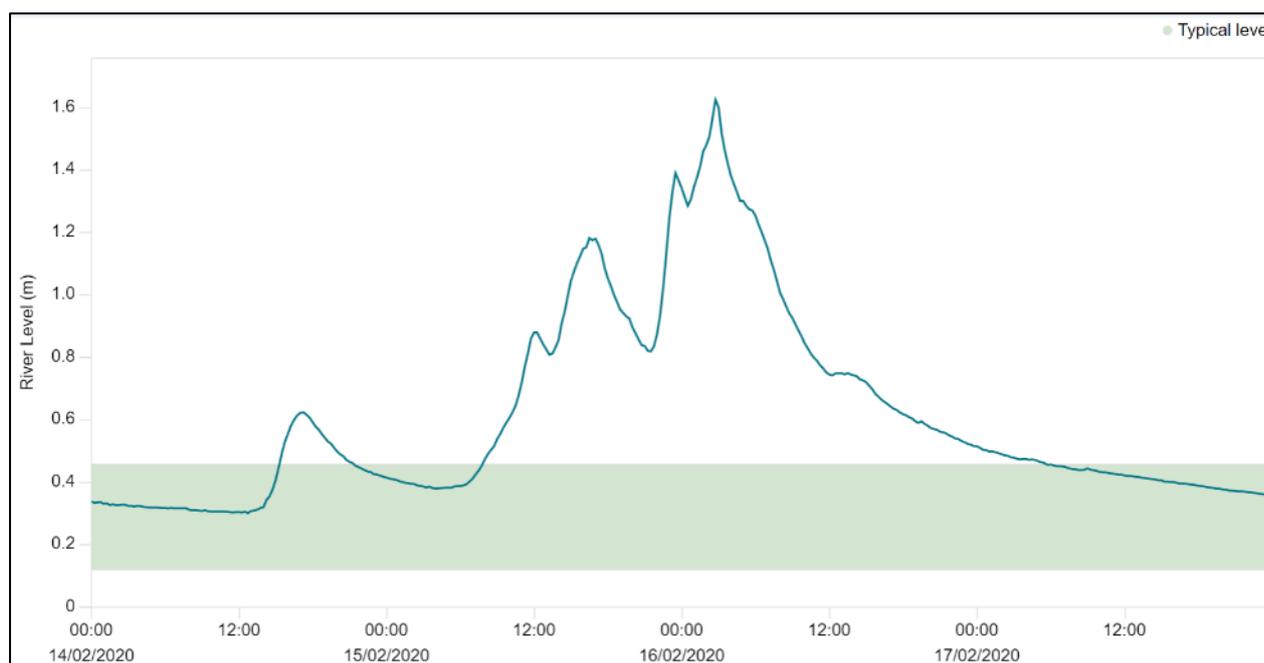
Figure 26: The Rhondda Fawr River levels at Tynewydd station between the 14th and 17th February 2020 (Natural Resources Wales)

The hydrograph in Figure 26 illustrates the rapid rise in levels of the River Rhondda Fawr in response to rainfall, captured NRW's Tynewydd station, located approximately 3 km upstream of RCT26. The River Rhondda Fawr at Tynewydd reached its highest peak recorded at 02:45 on 16th February 2020, reaching 1.62 metres.

The green bar displayed on the hydrograph shows the typical level of the River Rhondda Fawr at Tynewydd station, ranging between 0.1 and 0.5 meters. At its peak, the River Rhondda Fawr was over twice its average level, stressing the extreme and unprecedented levels that RCT's rivers rose to during the storm's peak intensity.
