Section 19 Flood Investigation Report

Storm Dennis – Flood Investigation Area RCT18 (Trehafod)

April 2022

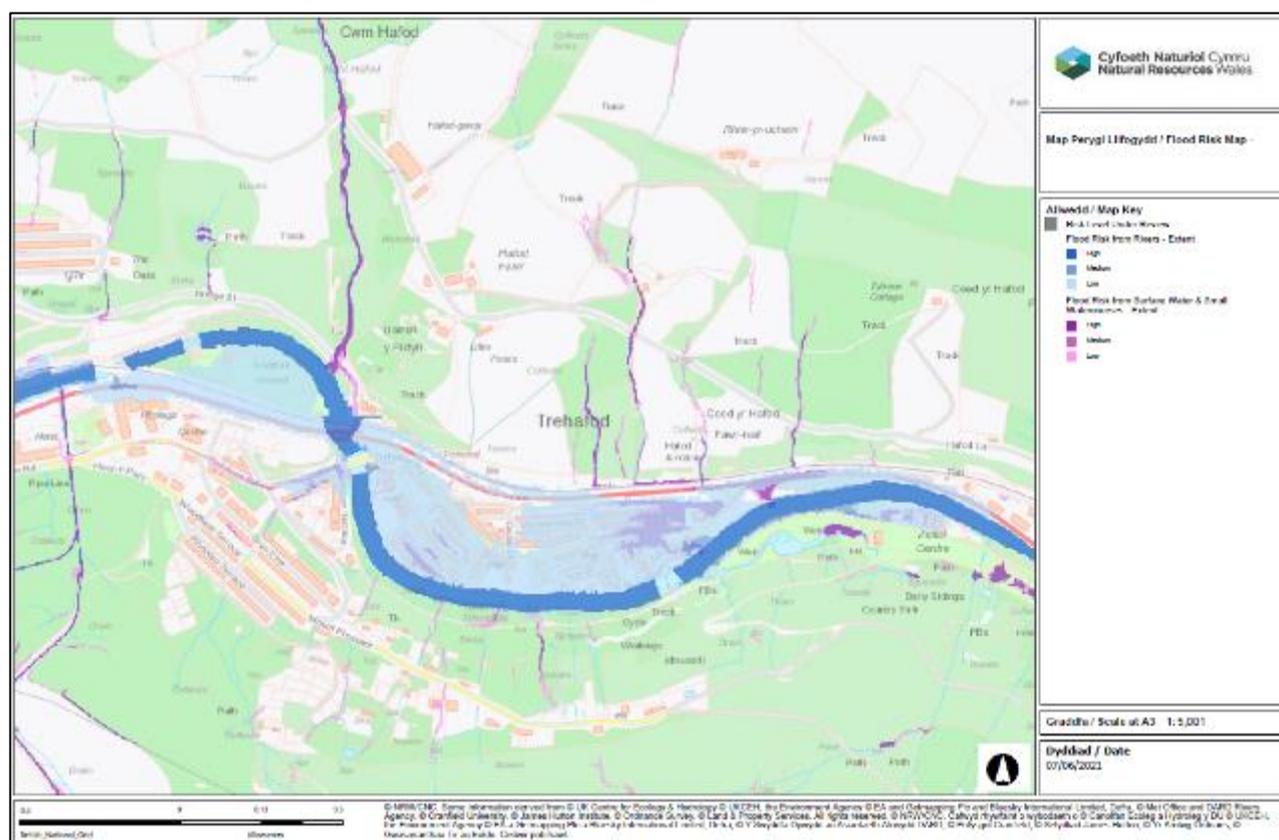
Figure 2: Natural Resources Wales' Flood Risk Assessment Wales (FRAW) map for rivers and ordinary watercourse and surface water flood risk at investigation area RCT18. Contains Natural Resources Wales information © Natural Resources Wales and database right. All rights reserved.

NRW's FRAW map (Figure 2) identifies a low to high risk of surface water and ordinary watercourse flooding along the western streets of investigation area RCT18, sourced

by blocked culvert inlets and potential bank breaches/overtopping related to the network of ordinary watercourse draining the northern hillsides. A low risk of river flooding is also noted at Trehafod, sourced by the Rhondda River breaching/overtopping its northern banks and affecting the majority of the investigation area. Flood risk throughout Trehafod is further described within RCT's FRMP³.

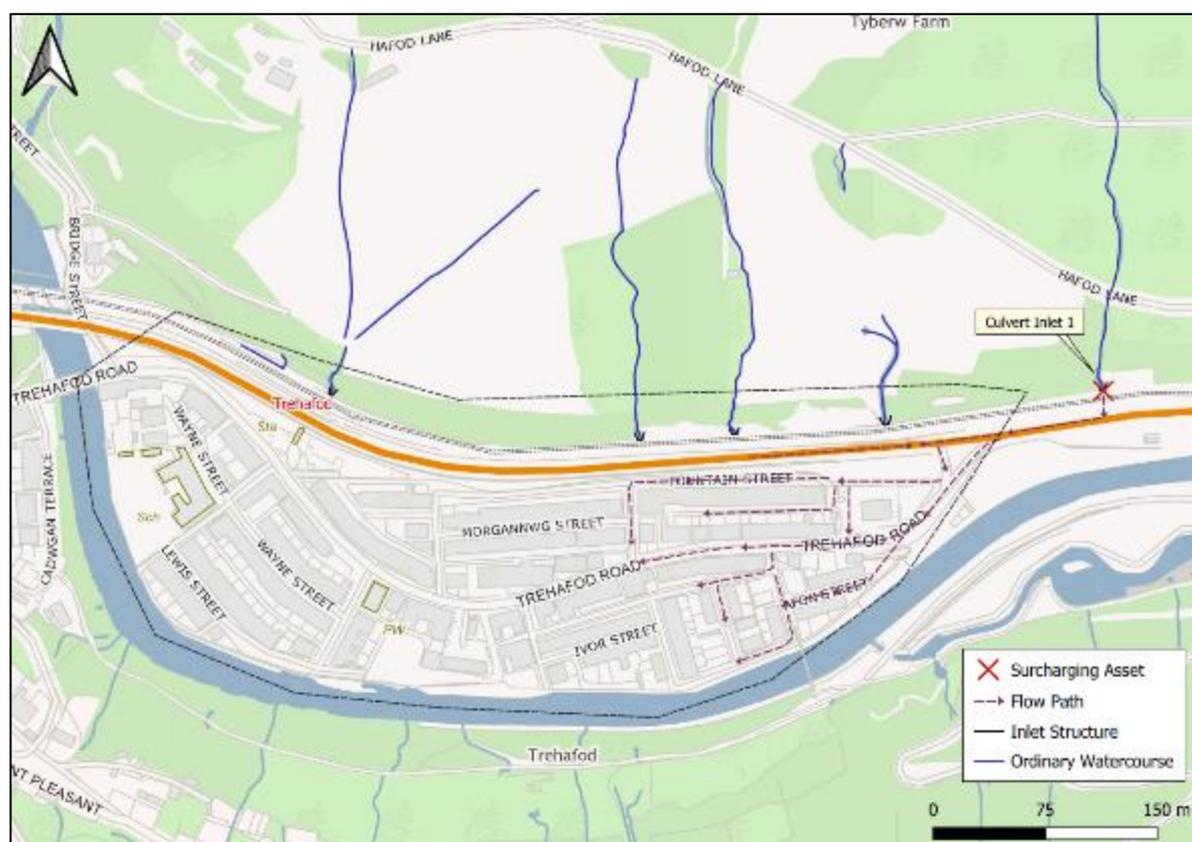
Figure 5: Observed flow paths within RCT18 during Storm Dennis (15-16th February 2020)

Upon an inspection carried out by RCT's Flood Risk Management officers in the days following the storm event it was reported that a localised landslip resulted in the obstruction of 'Culvert Inlet 1' (shown in Figure 5) to the north of the railway line. The obstruction subsequently led to the surcharging of 'Culvert Inlet 1', resulting in flooding to the railway line and the conveyance of flood water over the retaining wall and onto the highway (Figure 6 and 7).

As illustrated in Figure 5, surface water flows accumulated along the A4058 (Gyfeillion Road) and conveyed towards Trehafod Road highway junction before travelling towards Fountain Street via a 50-metre-long pathway connecting the street with the adjacent road. Evidence of silt and debris deposited by the surface water flow path towards Fountain Street is shown in Figure 8.

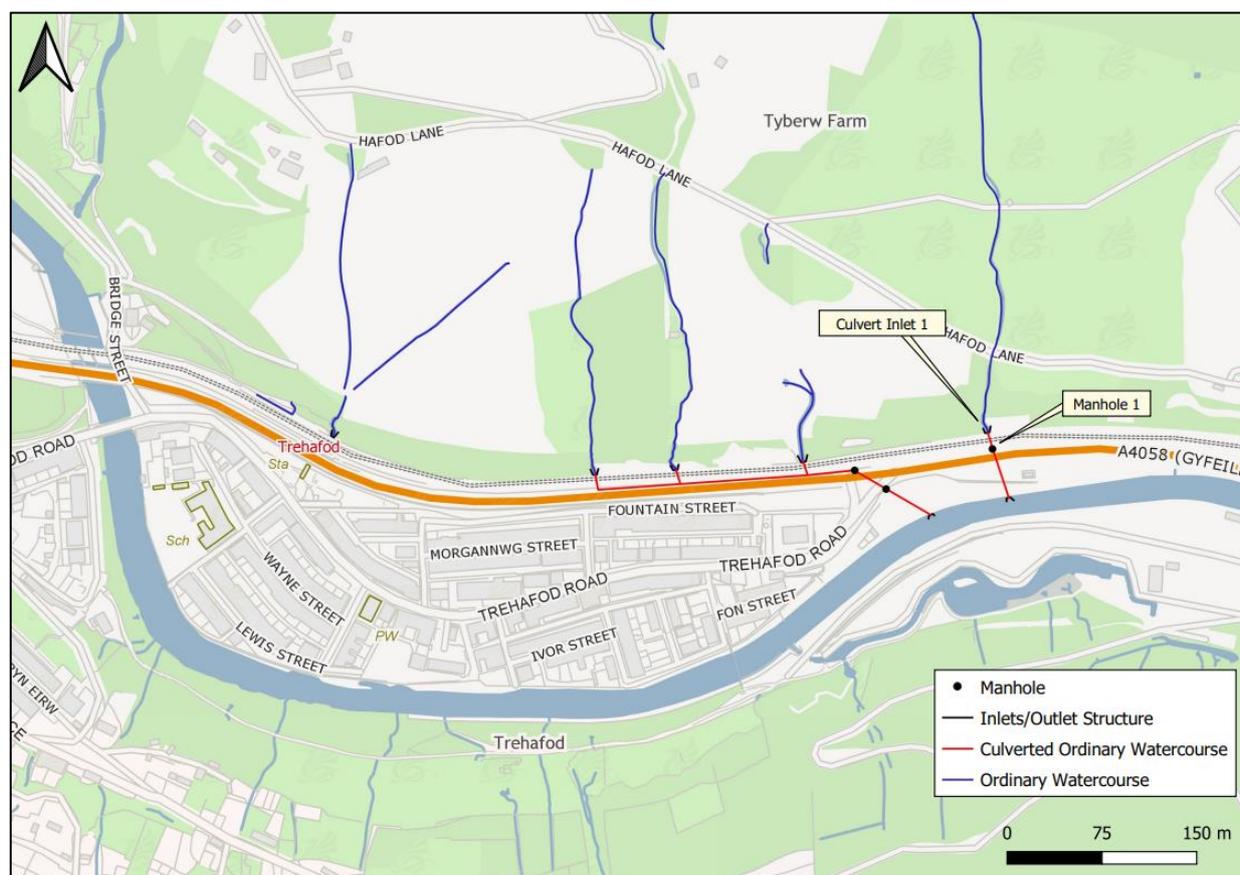
Figure 12: Map of the known culverted ordinary watercourse infrastructure within RCT18

As depicted in Figure 12 there are 5 culvert inlets situated north of the investigation area above the railway track. The 5 culvert inlets are identified as falling under the ownership and responsibility of Transport for Wales (TfW). At the time of Storm Dennis in February 2020, prior to the transfer of ownership of the Core Valley Lines network to TfW in March 2020, the culvert inlets were the responsibility of Network Rail.

The culvert inlet known to have surcharged during the storm event is labelled 'Culvert Inlet 1' in Figure 12. 'Culvert Inlet 1' was last examined by Network Rail in August 2018 as per their 'detailed inspection' cycle.

The culvert inspection report provided by TfW on behalf of Network Rail (Completed August 2018), reported no significant defects present at 'Culvert Inlet 1' however it was noted that the internal condition of 'Culvert Inlet 1' structure was unable to be surveyed due to access restrictions.

Following Storm Dennis, RCT undertook a CCTV survey inspection of the culverted ordinary watercourse networks illustrated in Figure 12 to ascertain both the operational condition of the networks and its structural integrity, however, the extent of the surveys were limited due to high-water levels within the downstream network and access restrictions within the upstream sections.

The results however, identified significant debris deposition within sections of the culvert network illustrated in Figure 12. Figure 14 shows the volume of debris, consisting primarily of silt and stonewash, within 'Manhole 1' (highlighted in Figure 12). The debris depicted at 'Manhole 1' shows an 80% reduction in cross sectional area within the culvert network downstream of 'Culvert Inlet 1'. It's not possible to say what debris identified in the survey was mobilised and deposited as a result of the storm event and what had been deposited by previous events however, it is considered that the reported landslip on the hillside above 'Culvert Inlet 1' contributed to the accumulation of debris within the culvert network, and the associated loss in hydraulic capacity to manage the flow of water.

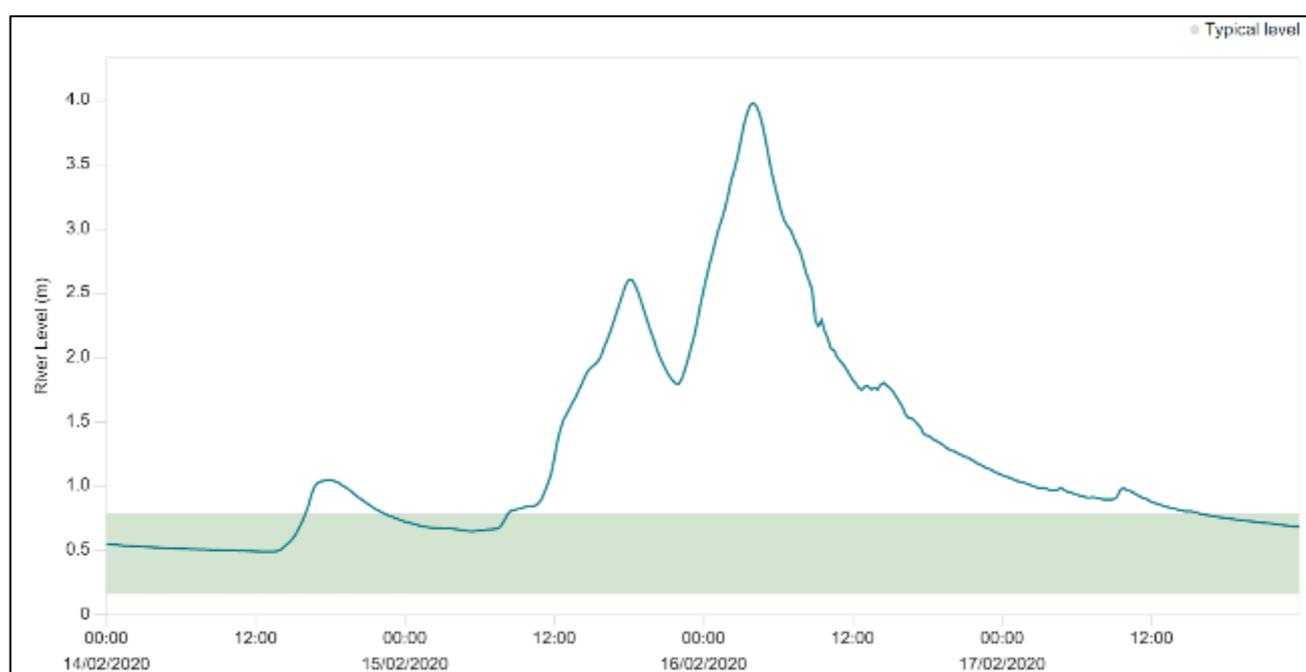
Figure 16: The River Rhondda levels at Trehafod station between the 14th and 17th February 2020 (Natural Resources Wales)

The hydrograph in Figure 16 illustrates the rapid rise in levels of the River Rhondda in response to rainfall, captured at NRW's Trehafod station. The River Rhondda at Trehafod reached its highest peak recorded at approximately 05:00 on 16th February 2020, reaching 3.977 metres.

The green bar displayed on the hydrograph shows the typical level of the River Rhondda at Trehafod station, ranging between approximately 0.2 and 0.8 metres. At its peak, the Rhondda River was over 3 metres higher than its average level, stressing the extreme and unprecedented levels that RCT's rivers rose to during the storm's peak intensity.

There is no evidence from this investigation to suggest that the River Rhondda significantly contributed to the recorded flooding of properties in investigation area RCT18 during Storm Dennis, however, based on the relative high levels recorded within the River Rhondda during the storm event, it is considered likely that the outfall conditions of the culverted ordinary watercourse, surface water and sewer structures

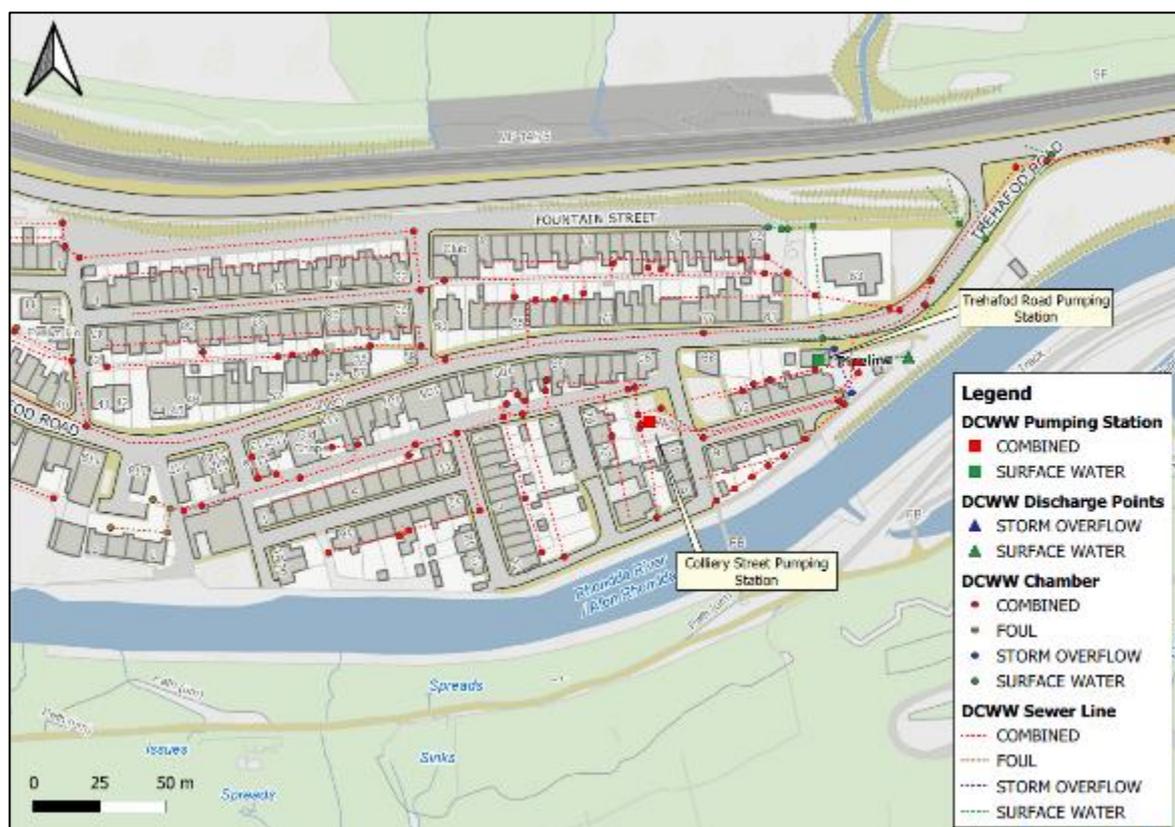
Figure 18: DCWW infrastructure within the eastern half of RCT18

Several responses received by residents during the public engagement exercise expressed concern that the flooding experienced during Storm Dennis was caused wholly or partially by DCWW's surface water pumping station, labelled 'Trehafod Road Pumping Station' in Figure 18, located in the southeast of the investigation area.

Members of the local community inferred that the pumping station did not function adequately during the storm event resulting in surface water surcharging through several combined sewer and surface water manholes in the area. Public engagement responses also noted the receding of surface water soon after a DCWW operative attended the pumping station at approximately 07:30 on the 16th February 2020.

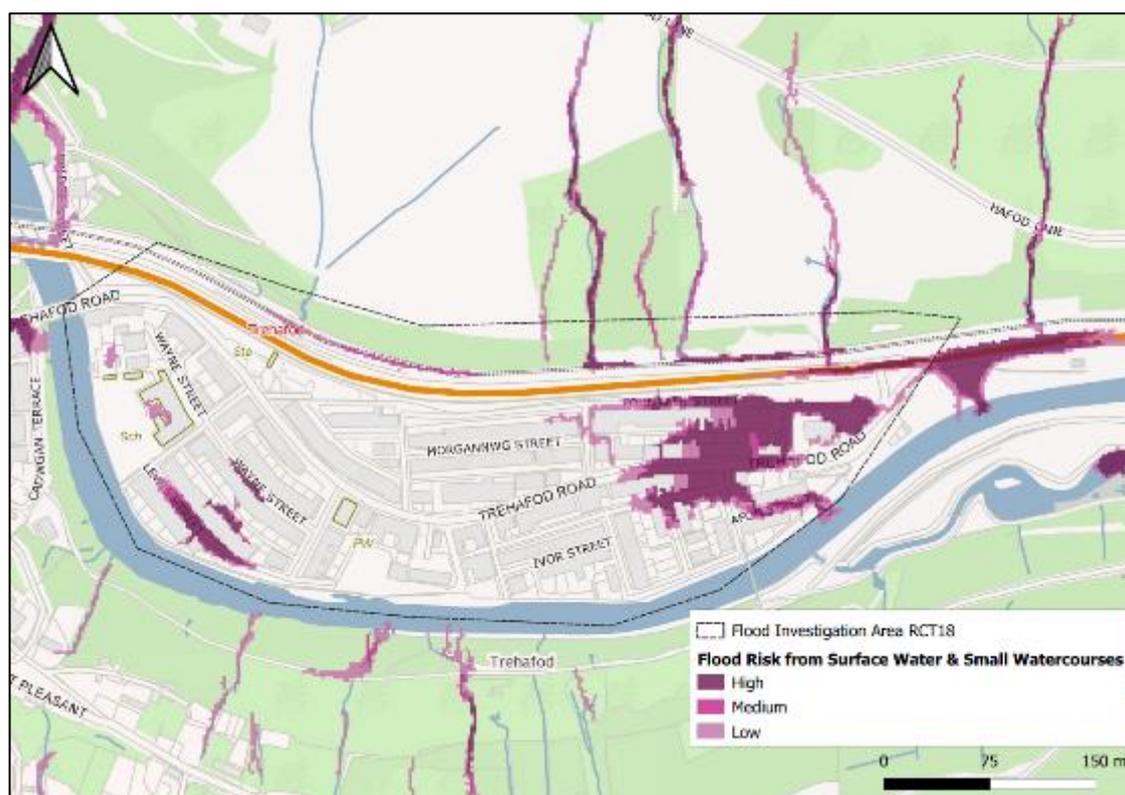
Figure 20: Natural Resources Wales' Flood Risk Assessment Wales (FRAW) map for Surface Water and Ordinary Watercourse sources at RCT18. Contains Natural Resources Wales information © Natural Resources Wales and database right. All rights reserved.

Properties impacted by surface water flooding at Fountain Street, Trehafod Road, Afon Street, Western Street and Colliery Street are identified at high and medium risk of surface water and ordinary watercourse flooding, as depicted within Figure 20, which is an extract from NRW's FRAW mapping exercise and depicts the surface water and ordinary watercourse flood extents. The darker shading identified areas at higher risk of flooding (more frequent/less extreme rainfall events) and lighter shading showing the lower risk areas (less frequent/more extreme rainfall events).

It is noted that Figure 20 does not depict surface water and ordinary watercourse flood risk at the western areas of Trehafod Road where two residential properties reported internal flooding. The primary cause of flooding to both properties has been attributed to the highway drainage network becoming overwhelmed by surface water and rainfall accumulated at localised low points.
